# The structural history of Sutton Lodge, Brighton Road, Sutton

| Address | Sutton Lodge, 139 Brighton Road, Sutton SM2 5SW |
| Author | John Phillips |
| Date surveyed | 29 April and 3 November 2010 |

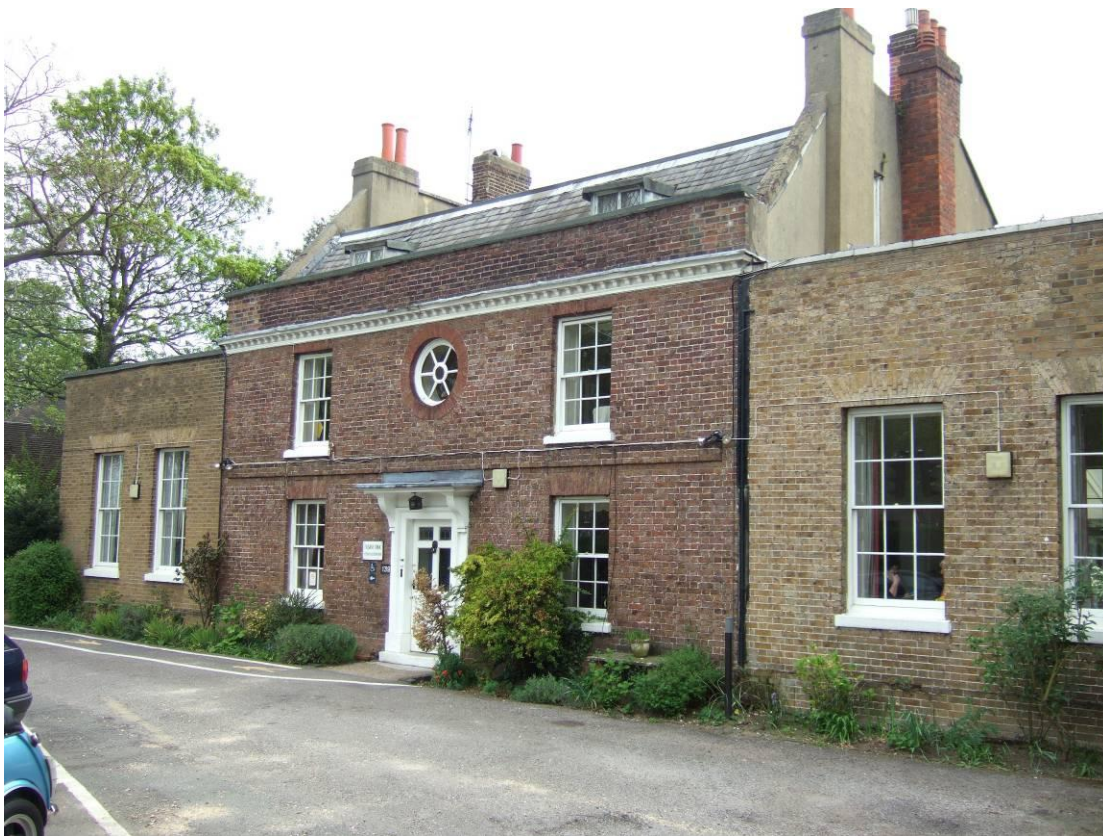
The front of the central block is of yellow to red brick laid in Flemish bond. It is two storeys high and three bays wide (figure 1). There is a door in the centre with a circular window above it and sash windows to either side. The windows have straight tops of cut and rubbed brick and stone sills. There is a cornice with a parapet above it.

Figure 1. The front looking north.

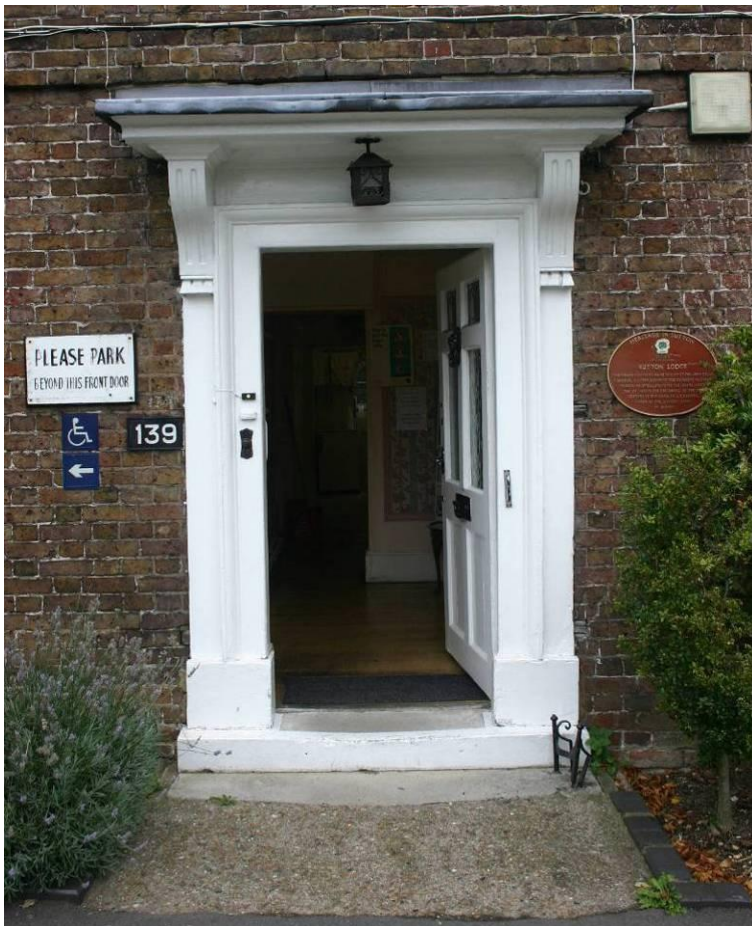
The door frame appears to be original. It has a hood or porch supported by brackets with guttae at the bottom. The door itself is divided into six panels. The woodwork appears to be original but the upper four panels have been replaced with glass (figure 2).

Figure 2. The front door.

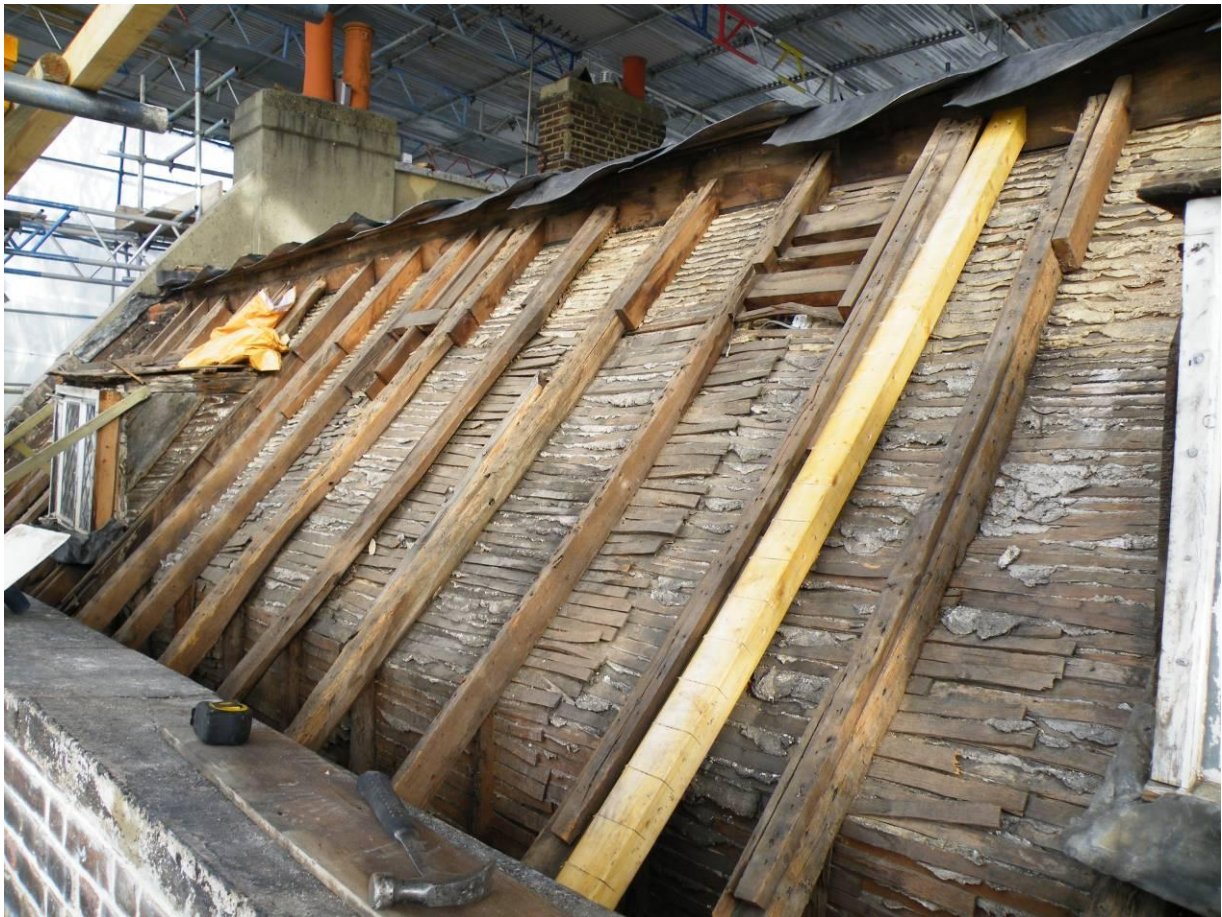
During the building work the slates were taken off the front of the roof (figures 3 and 4). The rafters rested on a ridge piece and were of rather mixed timber, some with waney edges and a few with mortises suggesting reuse. There were various pieces of reinforcement and more were inserted during the work. The dormer frames were recent.

Figure 3. The front roof looking north during the repair work.

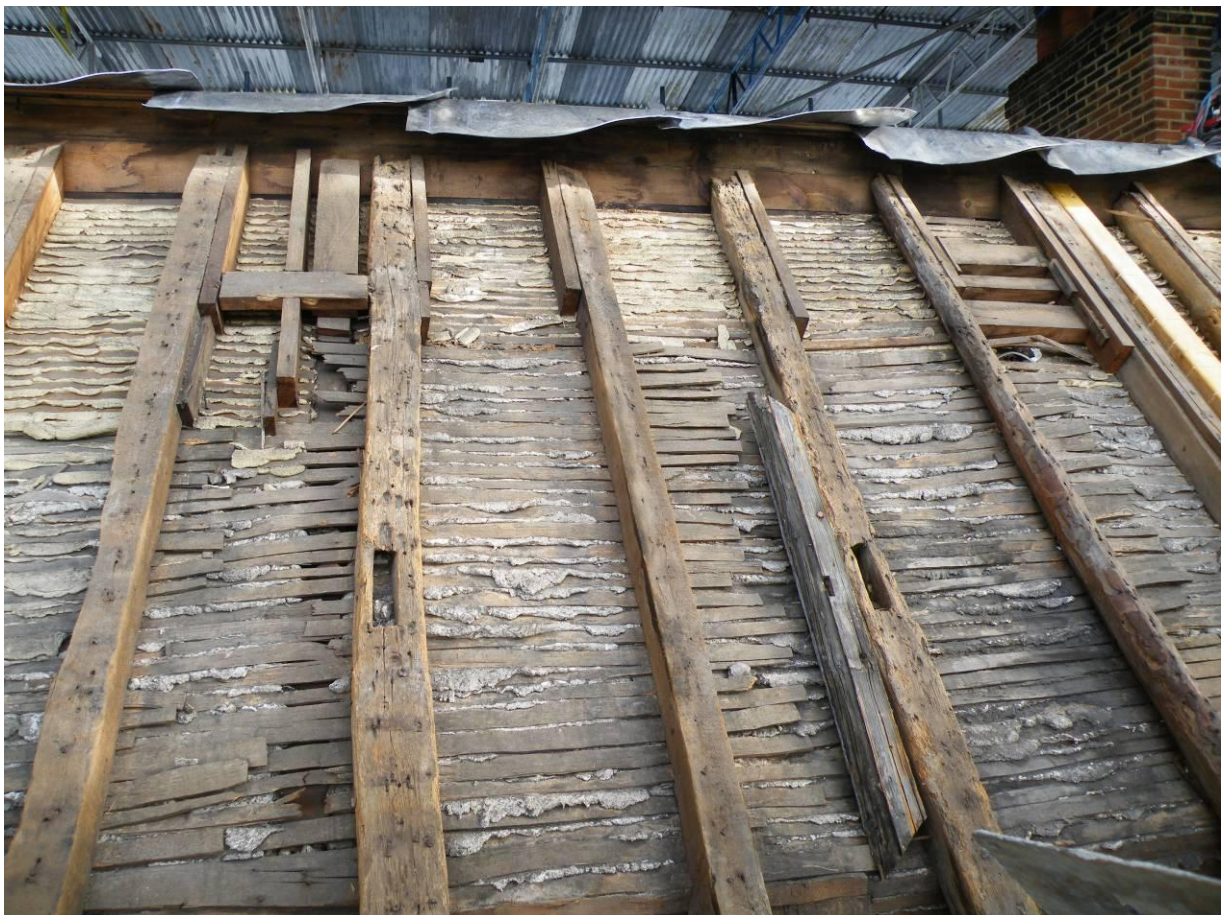
Figure 4. Reused timbers in the south end of the front roof.

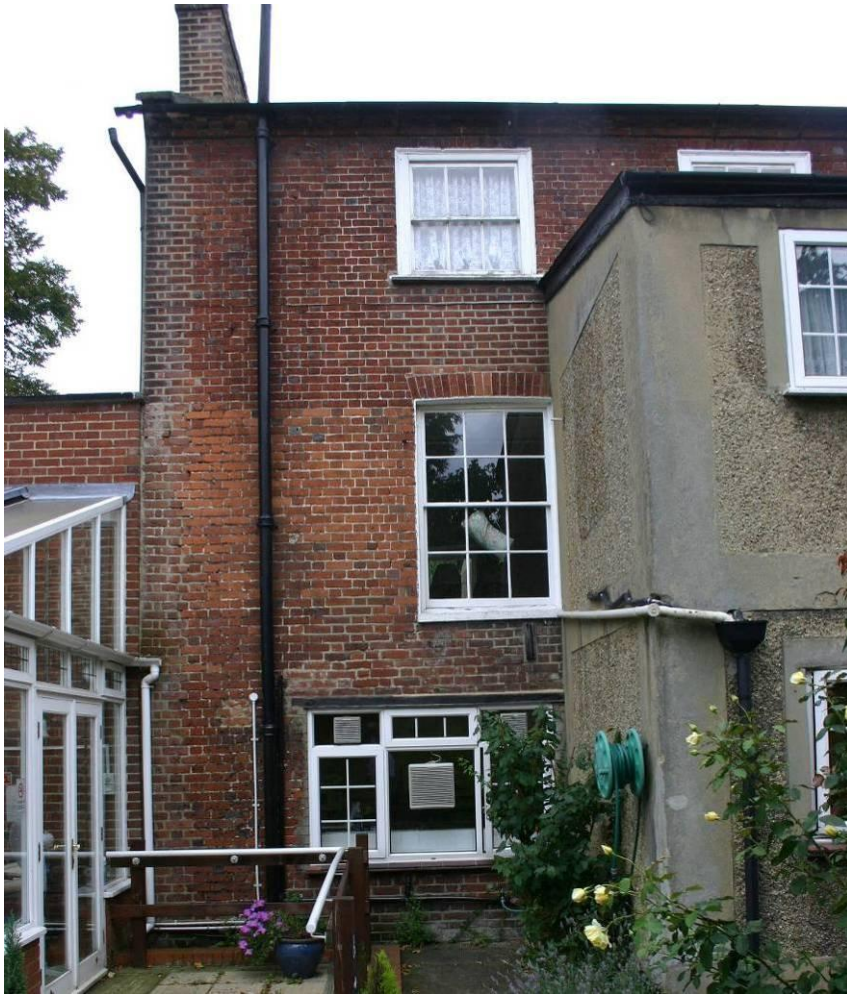
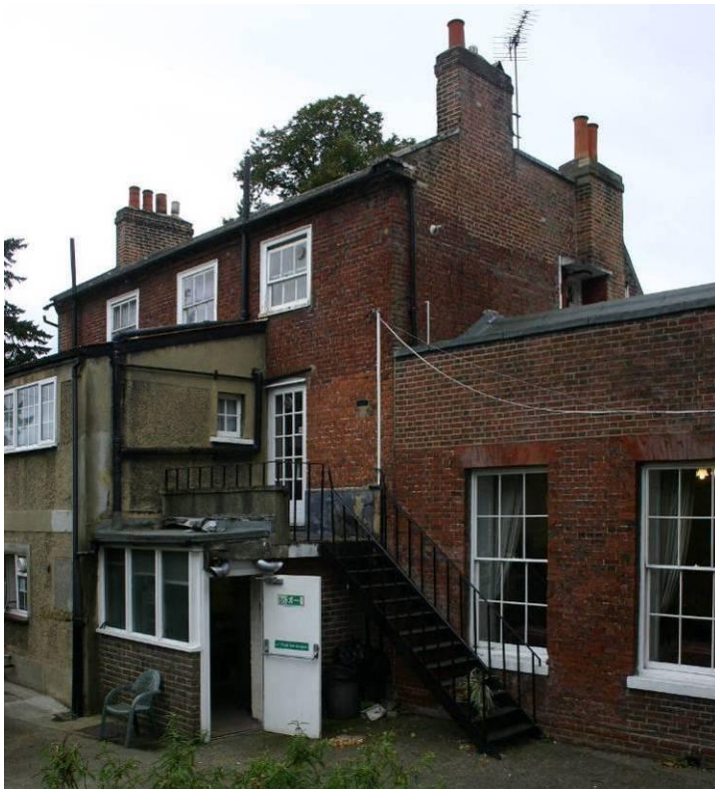
Here, the central block is a three bay, three storey structure, in soft red brick laid in Flemish bond (figures 5 and 6). There is a two storey cement rendered extension in the centre and a small single story extension to the north of it with a fire escape over the top of it. The latter looks very modern – perhaps from the 1970s. These extensions mean that there is only one surviving window on the ground floor which has been widened and replaced in UPVC.

Figure 5. Central block, back, south end.

Figure 6. The back of the central block looking southwest.

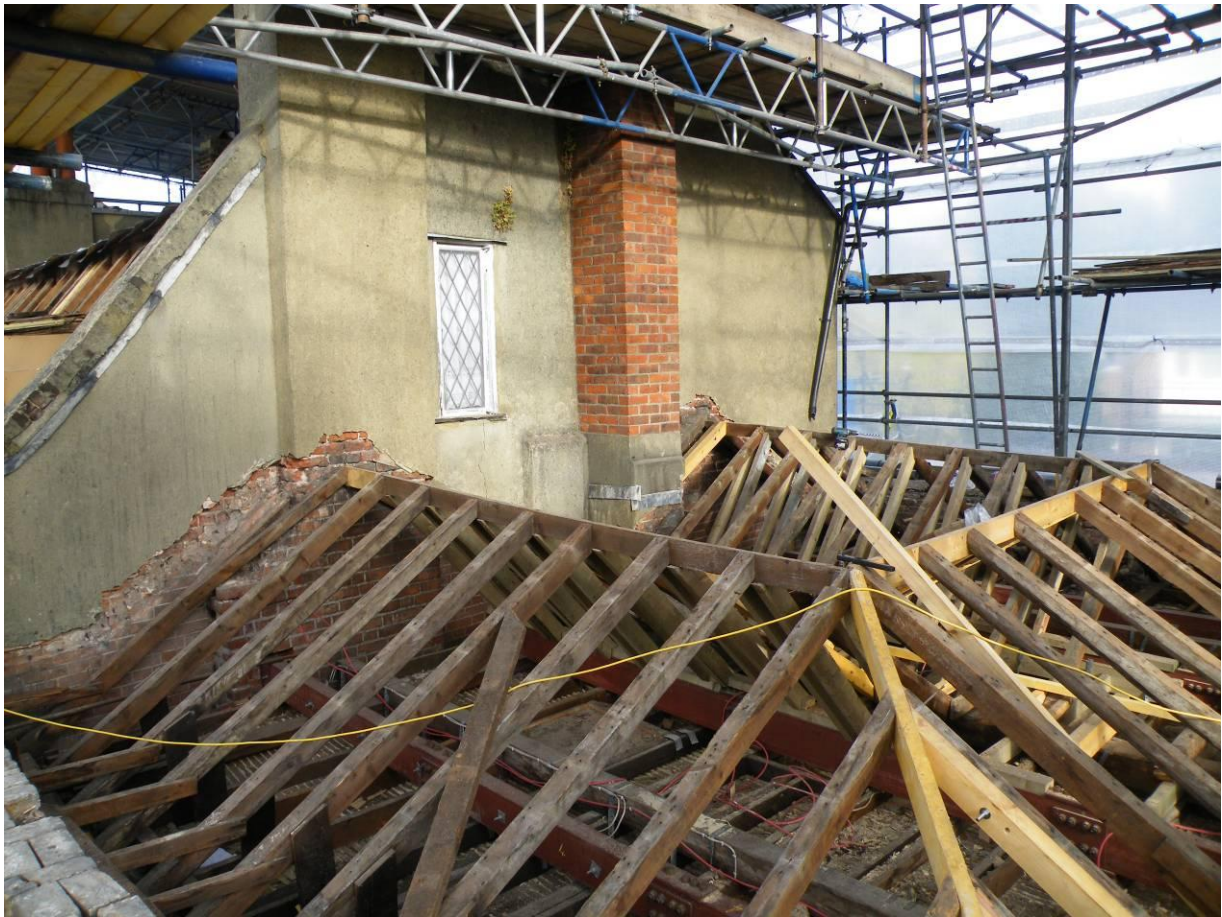
Above the extension the south wall is covered with cement render. When the roof of the south wing was removed mathematical tiles could be seen below the cement render at the western (front) end of the wall. They appeared to extend east to the edge of the chimney stack (figure 7).

Figure 7. The south side of the main block and the roof of the south wing during building work, 3 November 2010.

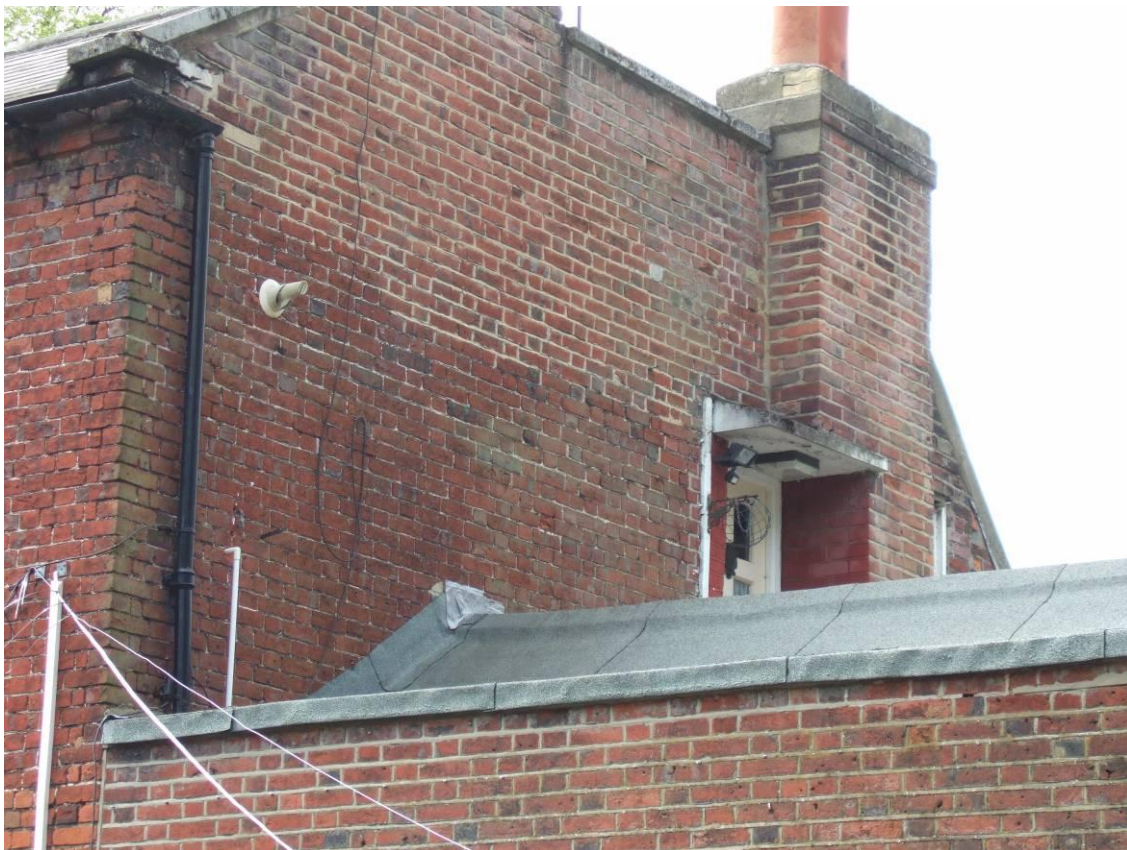
This is mostly of red brick laid in Flemish bond (figure 8). There are two chimneys. The eastern one is flush with the wall on or close to the back roof ridge while the western or front one projects from the wall behind the front ridge. A high parapet wall links the two chimneys above roof level. A door has been cut into the eastern side of the front chimney to give access to the caretaker's flat. There is a narrow window on the west or front side of the chimney stack and then a vertical bonding break. The wall to the west (front) of this is covered with mathematical tiles (figures 9 and 10).

Figure 8. The north gable of the main block from the east.

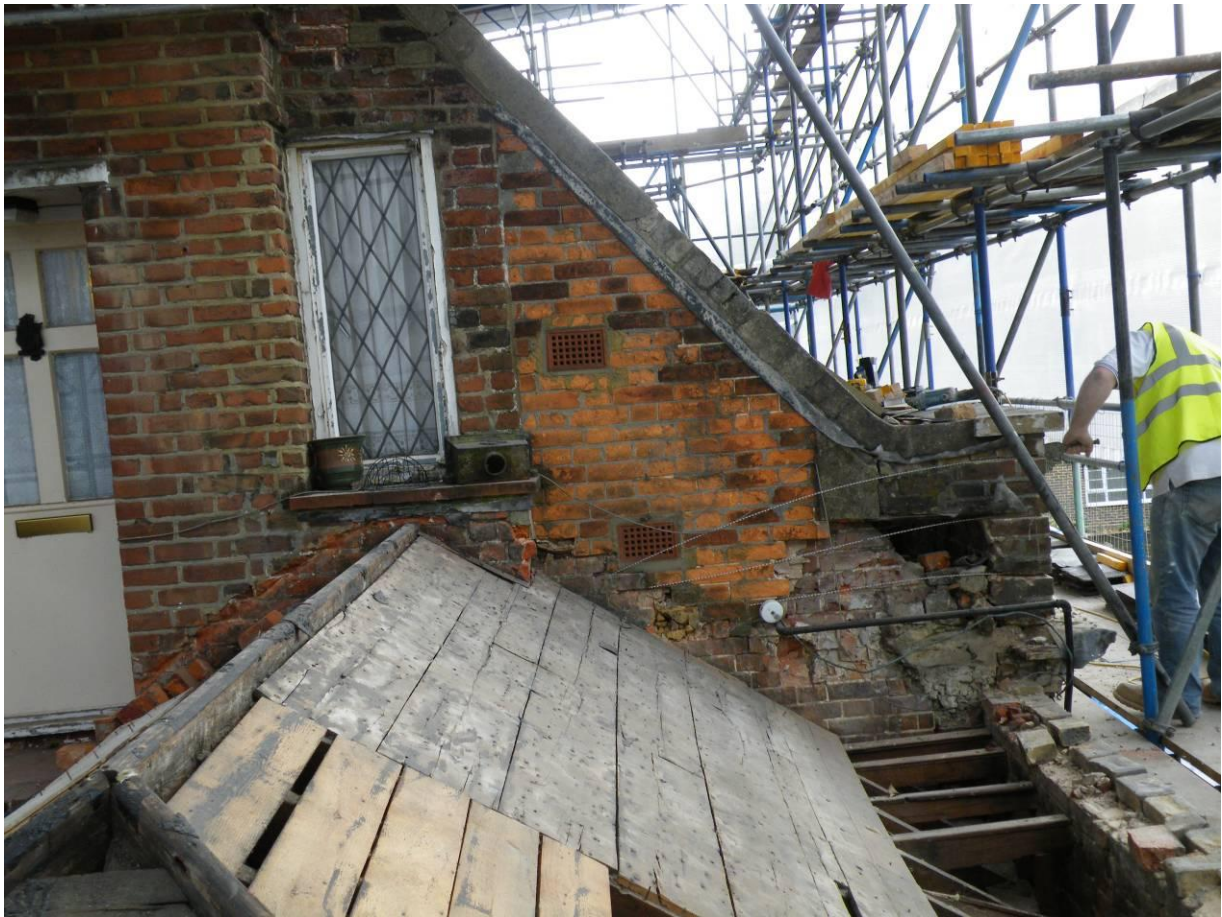
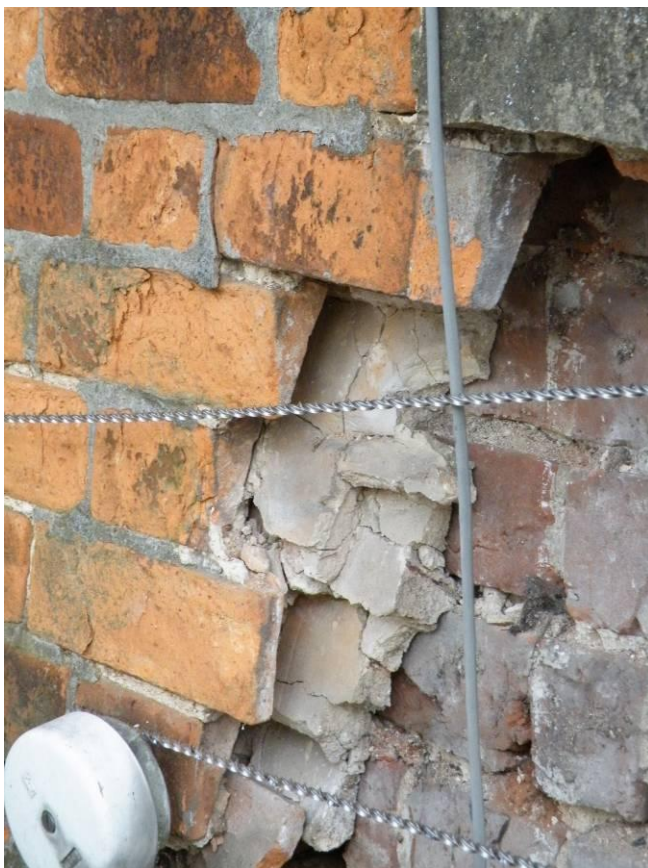
Figure 9. The western (front) end of the north gable of the main block. Note the bonding break and mathematical tiles to the right.

Figure 10. Detail of the mathematical tiles on the western end of the north gable of the main block.

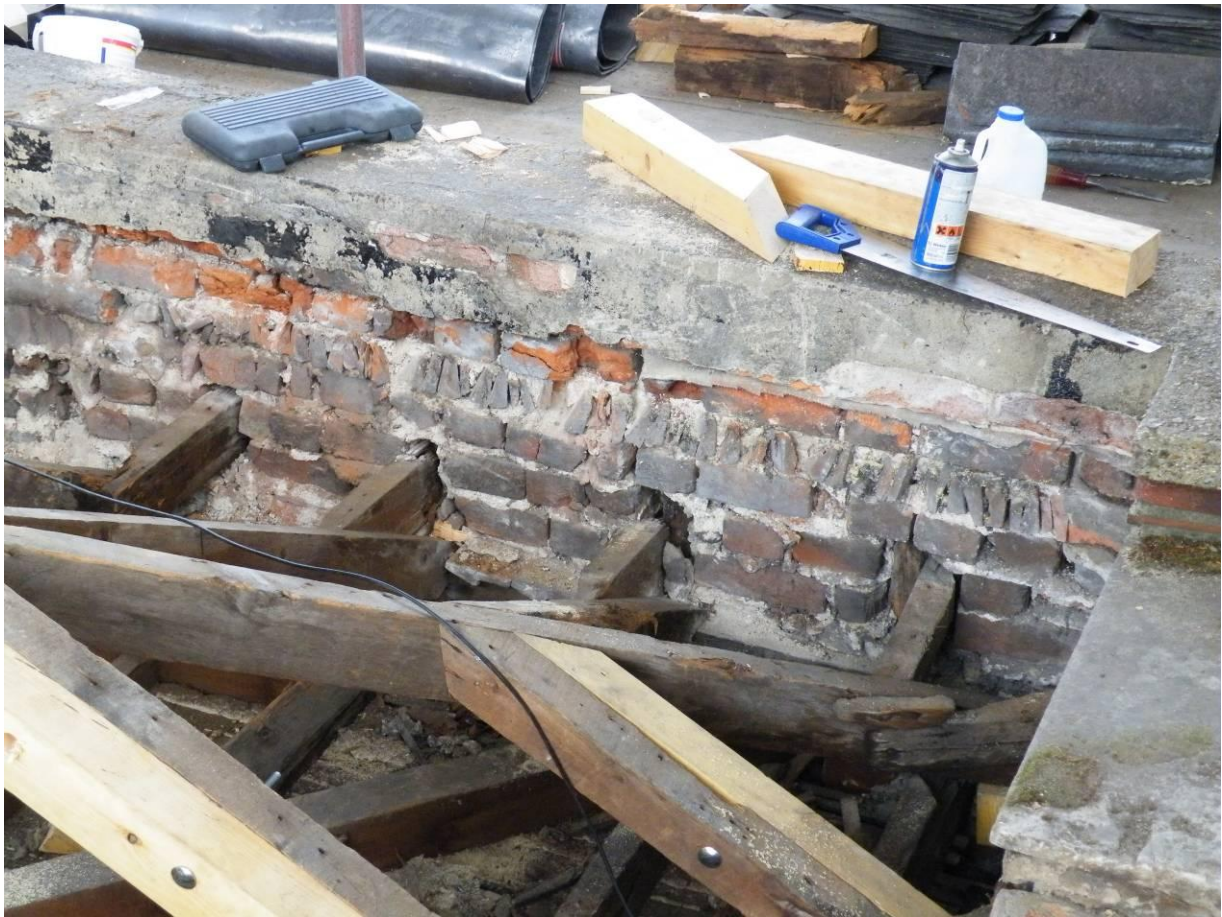
This has a conservatory built against it. The brickwork has been replaced or extensively repaired in the fairly recent past. On the inside top the wall incorporates a line of reused mathematical tiles (figure 17).

Figure 17. The wall top at southeast corner of the south extension looking east. Note the line of broken mathematical tiles.

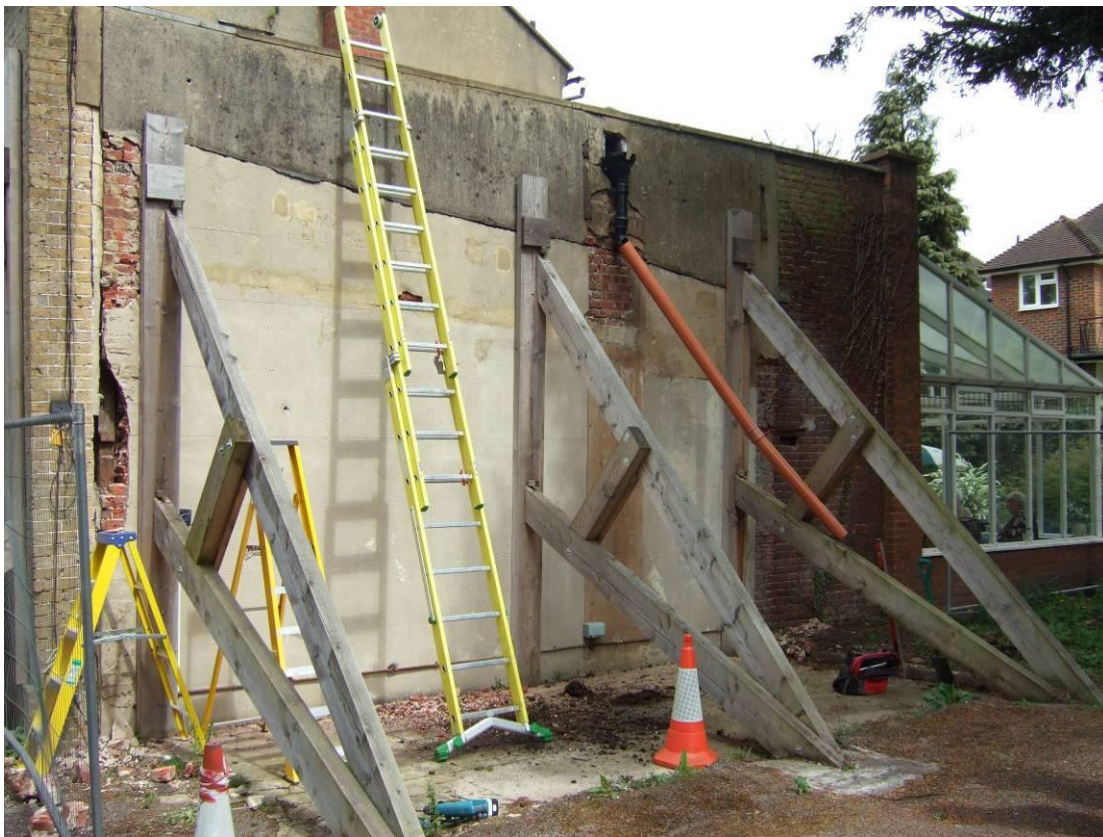
There is a clear bonding break between the yellow brick of the front and the soft red brick of the side. The latter is laid in Flemish bond where it is visible (figures 18 to 20).

Figure 18. The south wall of the south wing.

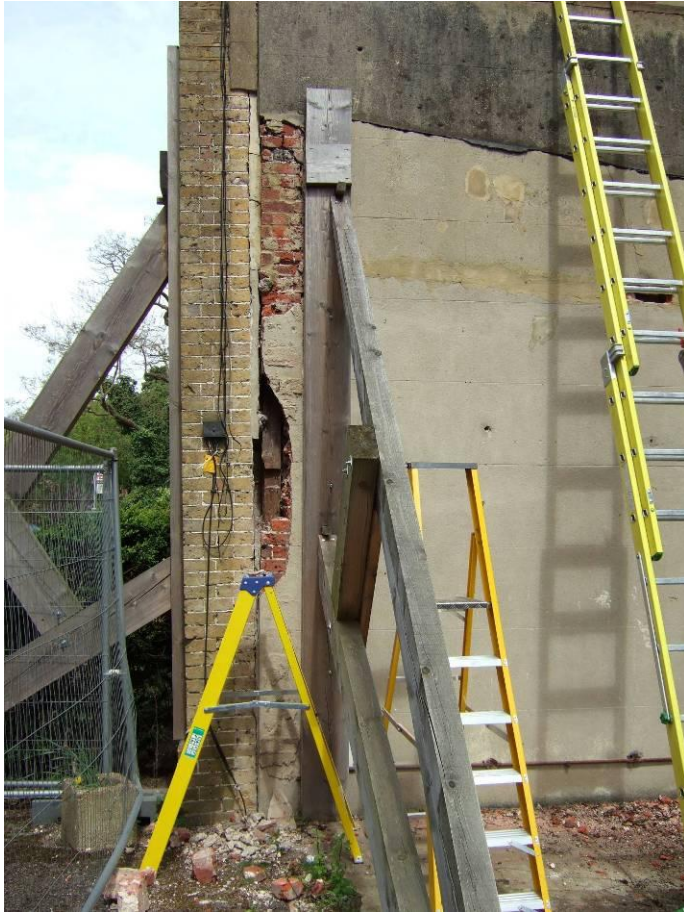
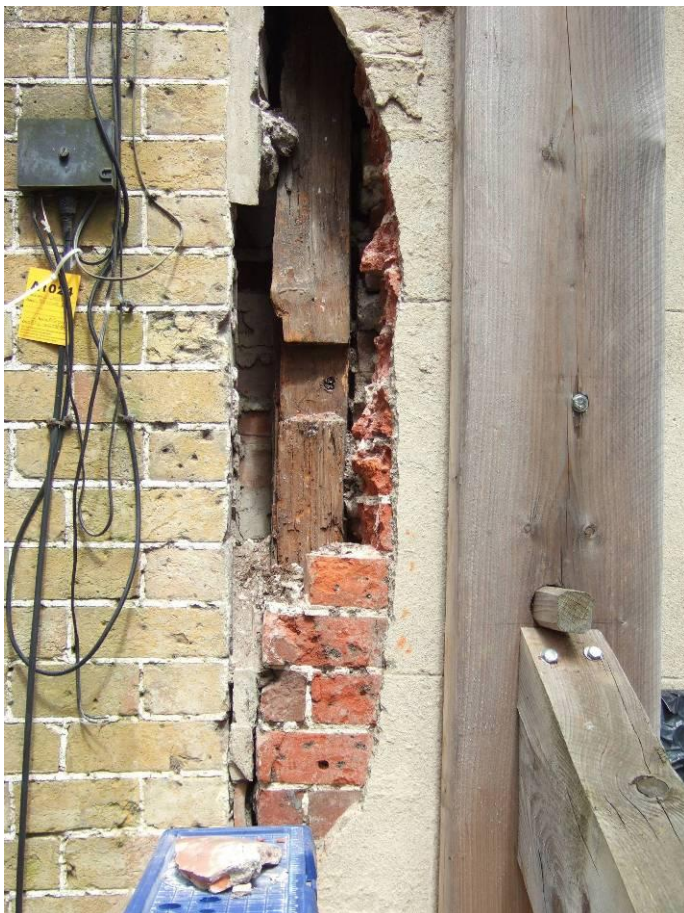
A vertical timber has been exposed at the southwest corner of the building behind the red facing brick (figures 19 and 20). This contains a halving for a horizontal timber which is now

At the southwest corner there appears to be a brick wall or skin inside the timber, a mass of rough brick work beside it and then the red brick external facing which has bulged outwards.

There is a very clear and clean bonding break between the front and side wall of the south wing. The timber post exposed at the western end of the side wall and the small fragment of rail at the eastern end suggest that this wall was originally timber framed and was presumably covered with either peg tiles or mathematical tiles. This timber work appears to be backed by a brick wall which must carry the 19<sup>th</sup> century decoration on the inside of the wing. It seems that an underlying brick structure was originally faced with tiles. The most likely explanation for this curious arrangement was to increase the water resistance of a wall which was exposed to the southwest winds and not directly visible from the front. If the arrangement dates from the first half of the 19<sup>th</sup> century, peg tiles are a much more likely covering than mathematical tiles. If so the arrangement cannot have lasted long as the present soft red brick wall looks eighteenth or nineteenth century.

Figure 19. The western end of the south wall of the south wing.

Figure 20. Detail of the western end of the south wall of the south wing showing the timber post with the halving and the brickwork behind it.

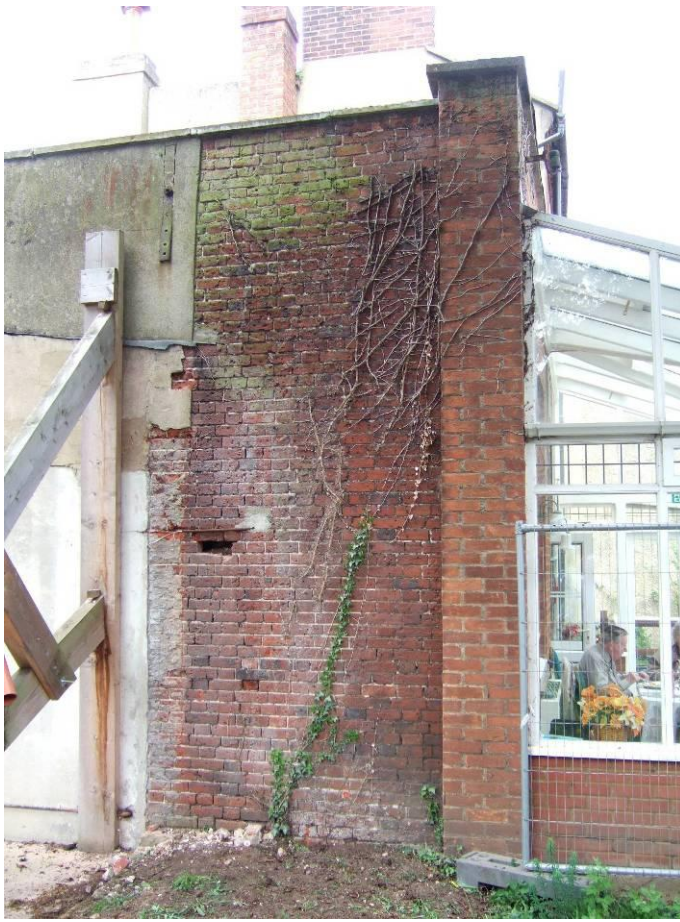
missing. A fragment of horizontal timber has been uncovered at the about the height of the halving towards the east end of the elevation.

Figure 21. The eastern end of the south wall of the south wing.

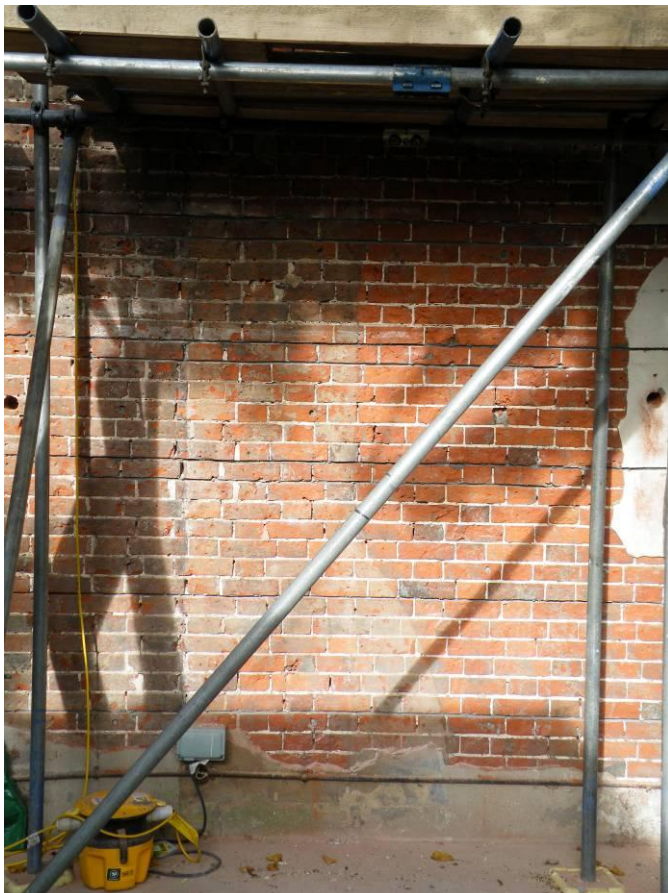
Most of the wall face is covered with Portland cement rendering which has been lined out in blocks. The line for an eastward sloping roof cuts through it for an outbuilding which has now gone. The cement rendering was removed when the repair work was done exposing soft red brick laid in Flemish bond (figure 22).

Figure 22. The brickwork in the centre of the south wall of the south wing after the removal of the render.
