The Greenhouse in detail

The greenhouse was built against the east end of the north boundary wall. It has been demolished but much of the floor and some other features remain. The Ordnance Survey maps suggest that it was constructed between 1896 and 1913.

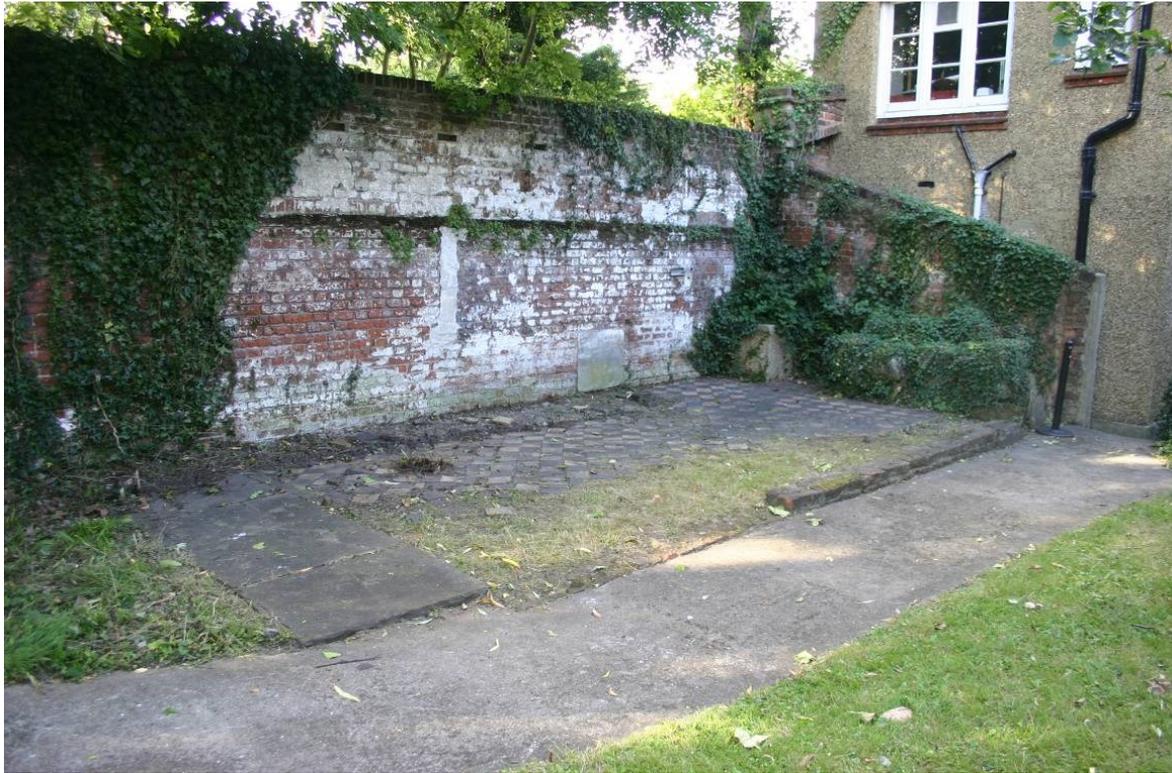
This runs along the west side of the greenhouse and gives access to the west door. It is of York stone or similar slabs and is in reasonable condition (figures 3, 4 and 5). There is a cast iron boot scraper on the west side of the path at the north end (figure 9).

Figure 3. The remains of the greenhouse in 2008.

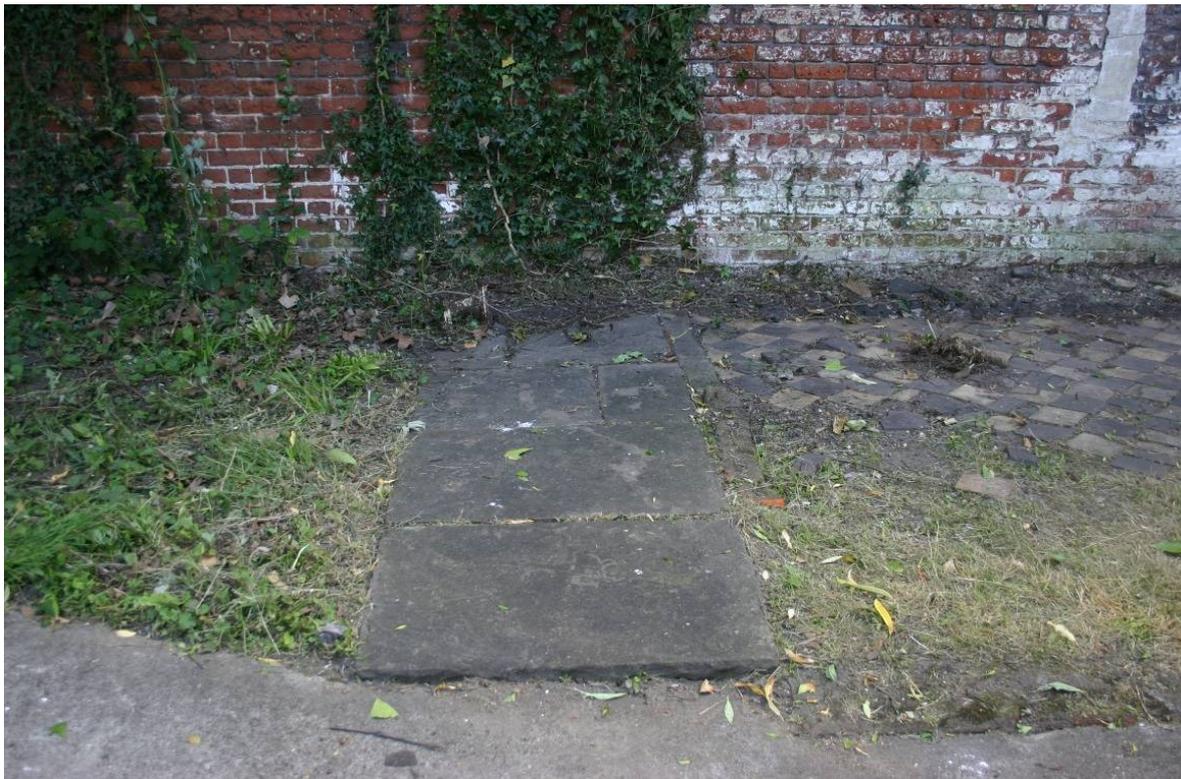
The western door appears to have opened directly into the main greenhouse. It had a sandstone lintel which is still in situ (figures 4 and 5).

Figure 4. The stone slab path to the west door with the remains of the greenhouse floor on the right. in 2008.

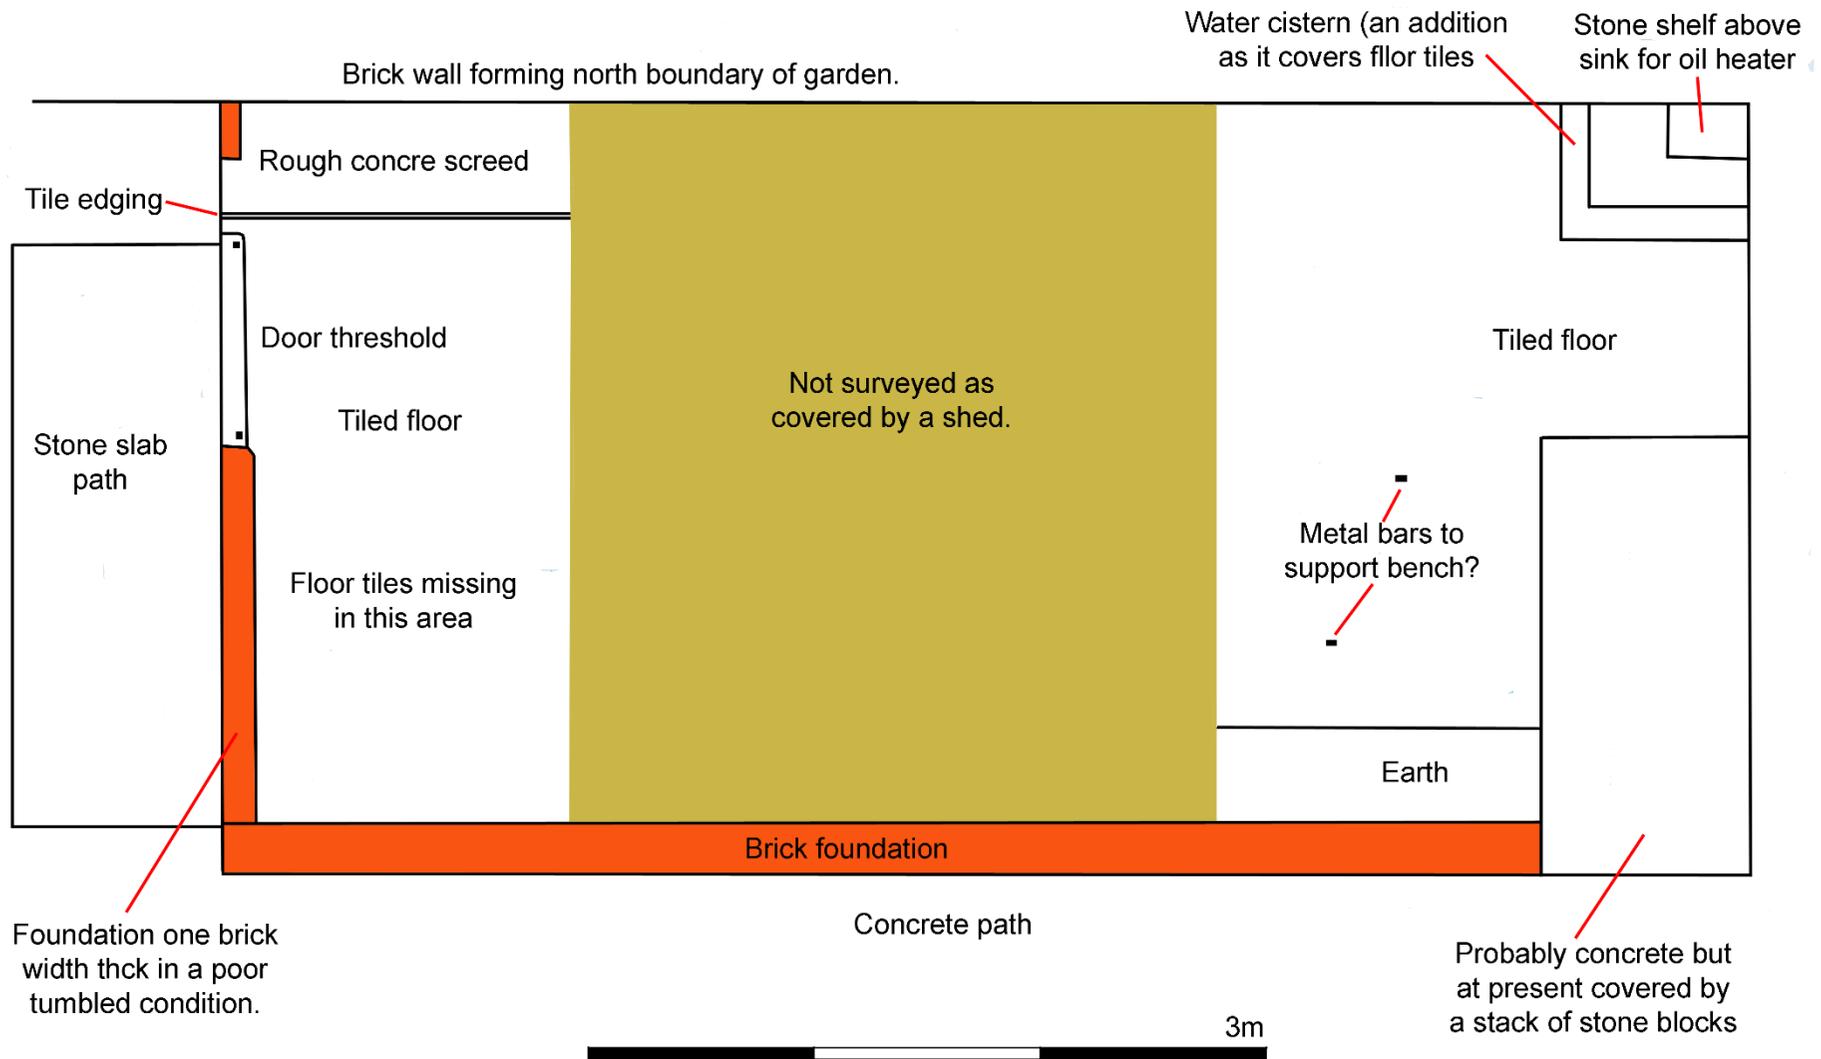
The south door seems to have opened to a short concreted floored passage with a second door at the inner end (figures 5 and 7). The 1921 air-photo does not seem to show the outer door so this may have been a later addition.

Figure 5. Plan of the greenhouse. North at the top.

Slots for timbers to support the roof shaded green

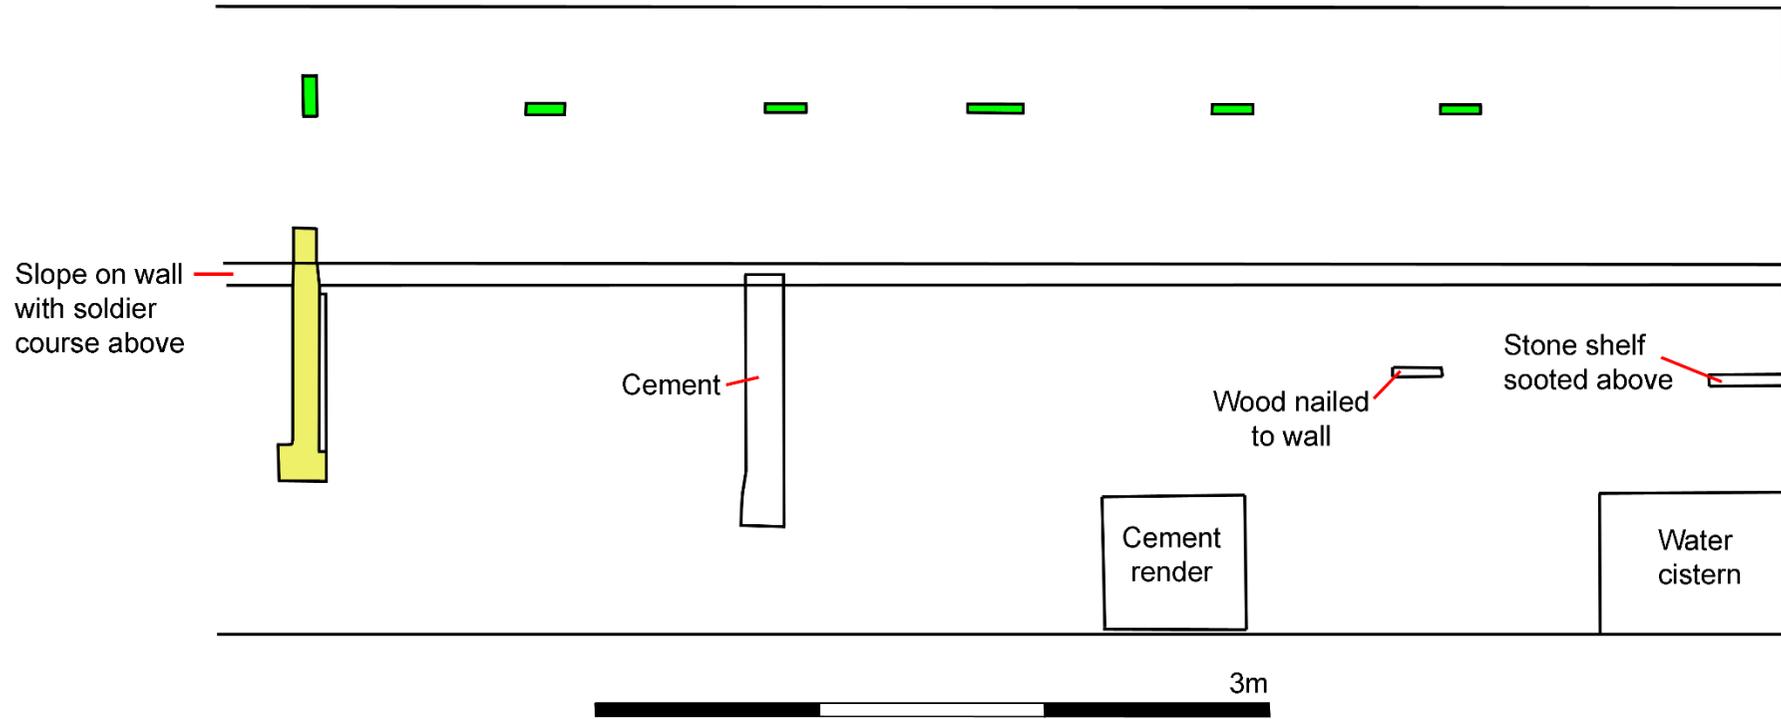
The north wall has a line of five slots the tops of which are 2.36m above floor level (figure 6). These are not evenly spaced and do not accord with the number of glazing bars shown in the 1921 air-photo. They must therefore have supported a horizontal timber which, in turn, supported the glazing bars.

There is also a slot to support the foot of the west gable (figure 6). The Stephanie Batstone watercolour appears to show shaped barge boards but the detail is unclear. The watercolour also shows an elaborate finial at the apex of the western end of the roof.

Figure 6. The north wall of the greenhouse.

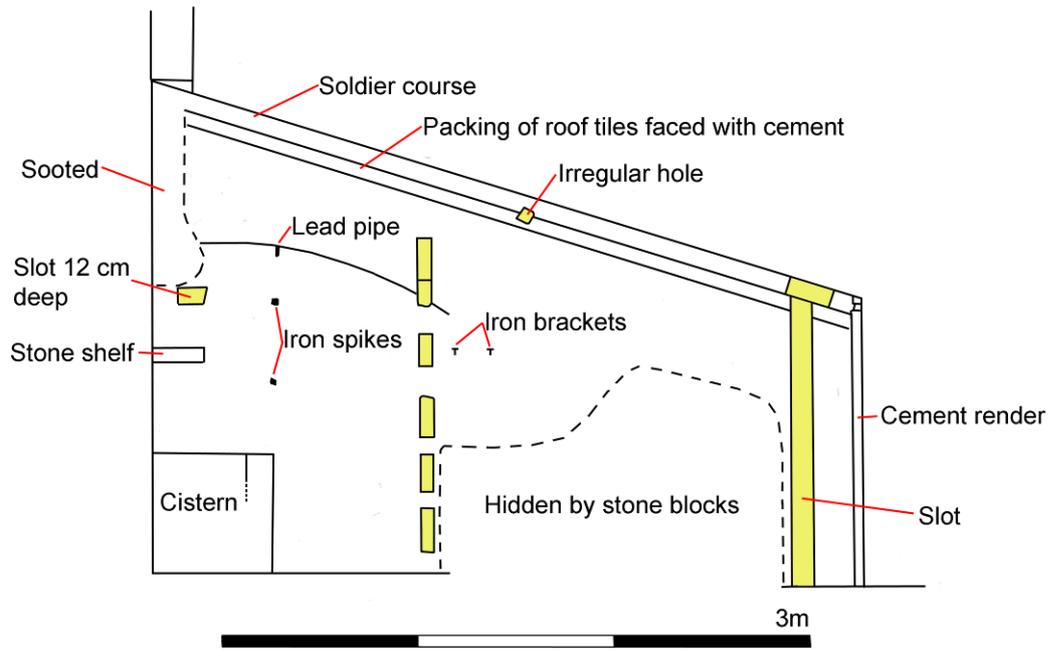
Figure 7. The east wall

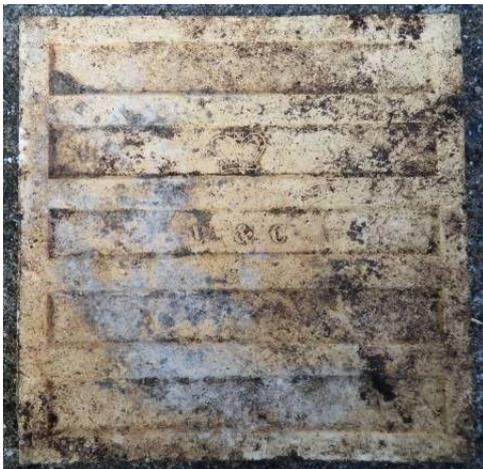
The centre part of the floor was covered with a chequer of yellow and dark grey ceramic tiles which are marked with a crown and 'W & C' on the underside (figure 8).

Figure 8. The back of one of the floor tiles showing the crown and 'W & C' mark.

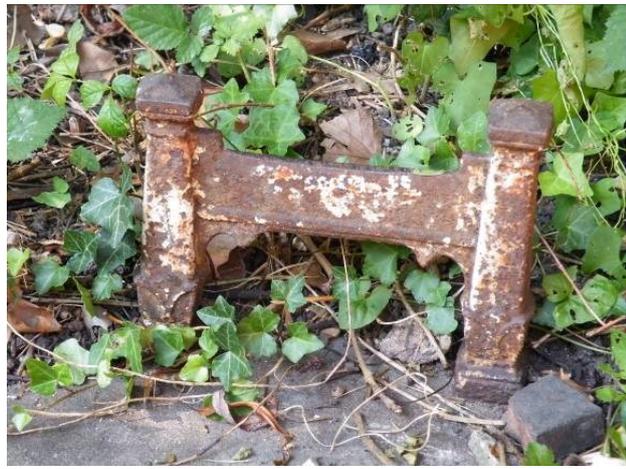
Figure 9. The boot scraper by the west door.

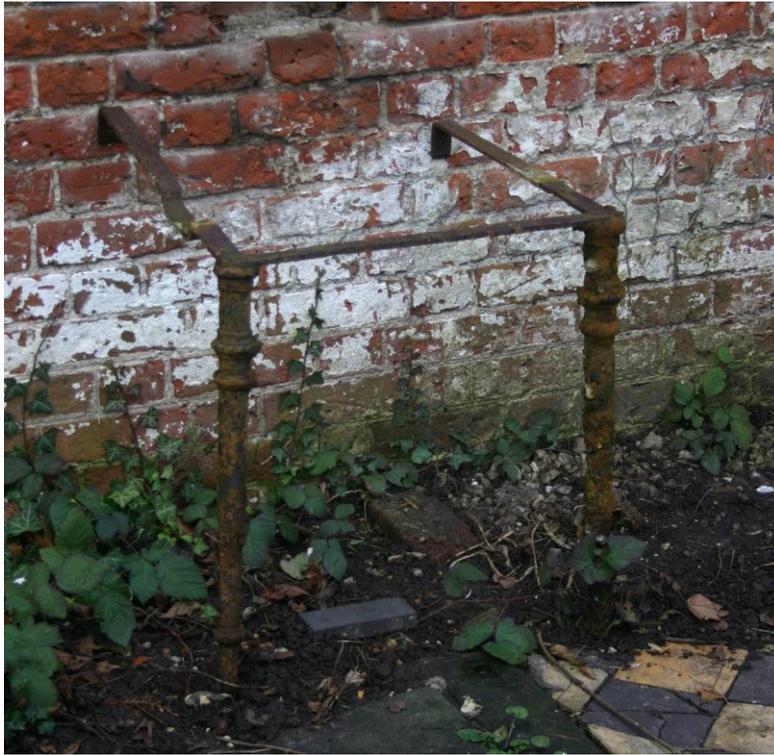
An iron frame to support a greenhouse bench was found in the culvert where the stream enters the garden (figure 10). It seems likely that it came from this greenhouse as it is nearby. It almost certainly came from the south side of the greenhouse as there is a planting trench against the north wall. It had 0.61m high cast iron legs moulded to look like turned wood.

Figure 10. An iron frame for a greenhouse bench found in the culvert within the garden.
