The rectangular pond in detail

The rectangular pond in the northeast corner of the garden is about 7.5m north – south 2.34m east – west.

The pond was cleared and studied in an archaeological investigation in the summer of 2010.¹

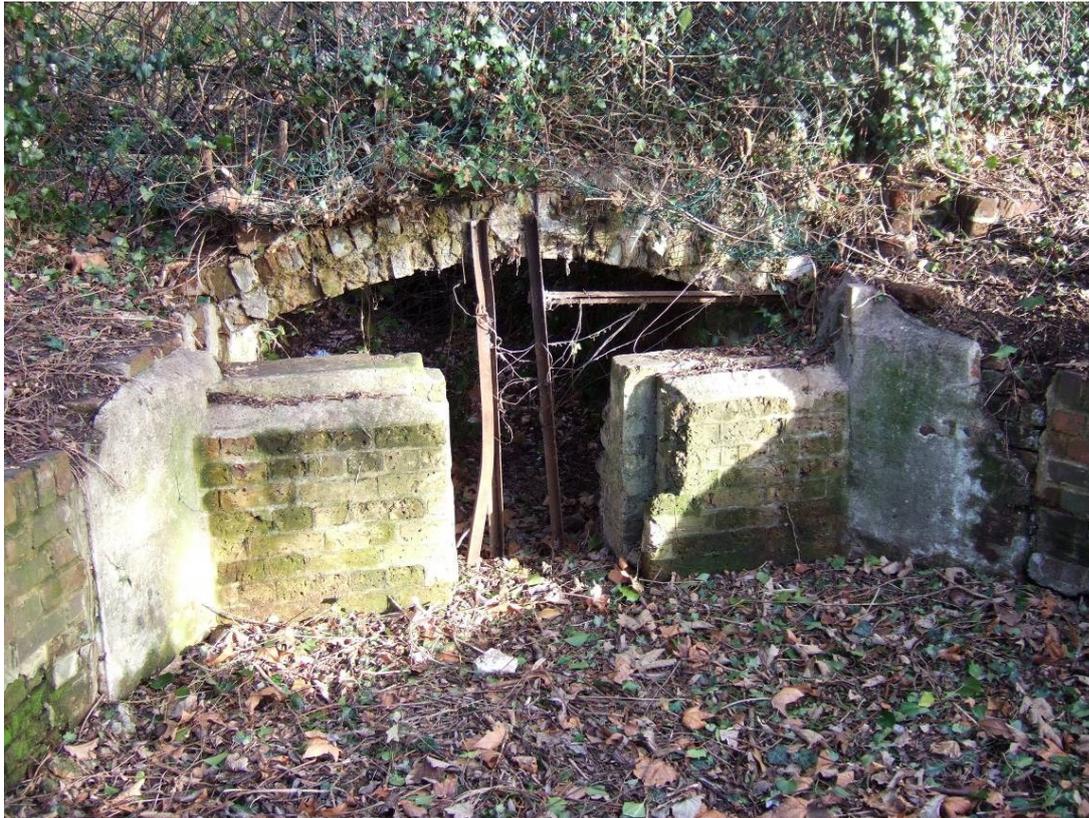
This modern weir was not part of the garden but is of significance because it retains the pond to the west of the garden and the feeder channels to the round pond and grotto are on the upstream side of it. The weir links the two upstream ends of the retaining walls for the older weir. In plan it has a somewhat irregular curve so the centre is slightly upstream of the sides. There is a 0.8m wide section in the centre which is lower than the rest. The weir top to the north of this has a length of 2m, to the south 1.25m. The central lower section has a crown of somewhat uneven cement which is about 7cm below the top of the main part of the structure. It carries all the stream flow and has rarely been overtopped.²

Figure 1. The weir where the stream enters the garden in December 2007. View of the upstream side looking towards the garden.

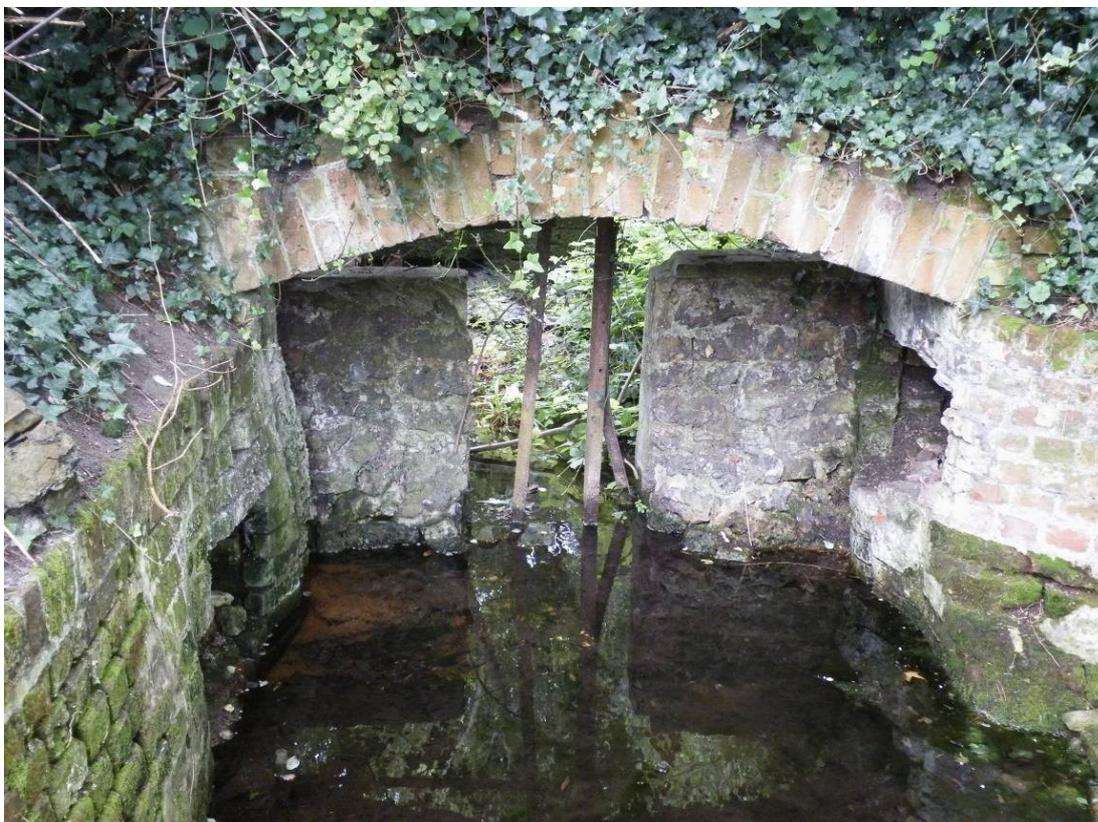
The stream then flows a metre or two to another older weir on the west side of the garden boundary. This consists of a wall of yellow stock bricks with a 0.59m wide gap for a sluice in the centre. The sluice gate has gone so the weir no longer functions. On the north side the structure is topped by a 5cm thick slab of York stone and there was presumably once a matching one on the other side. The downstream edge of the crown of the weir had a total length of 2m. The downstream side is decorated with a thick steeply sloping face of burr-brick in hard greyish mortar with pale brown spots very different from that in the grotto.

There is a little limescale on the side of the sluice opening and a somewhat thicker deposit in the south side channel wall. This was presumably deposited by spray from the fall or the sluice. It is more or less absent from the bottom two courses of brick which suggests that they were normally below water level.

Figure 2. The weir where the stream enters the garden and rectangular pond. Downstream side. Note the holes in the channel wall caused by leakage around the weir.

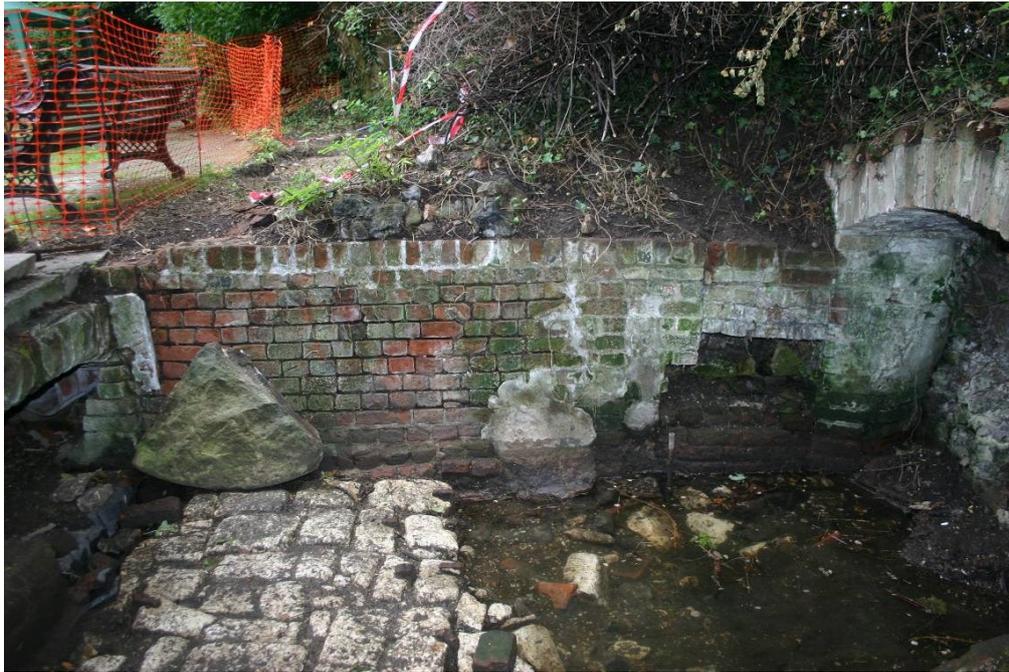
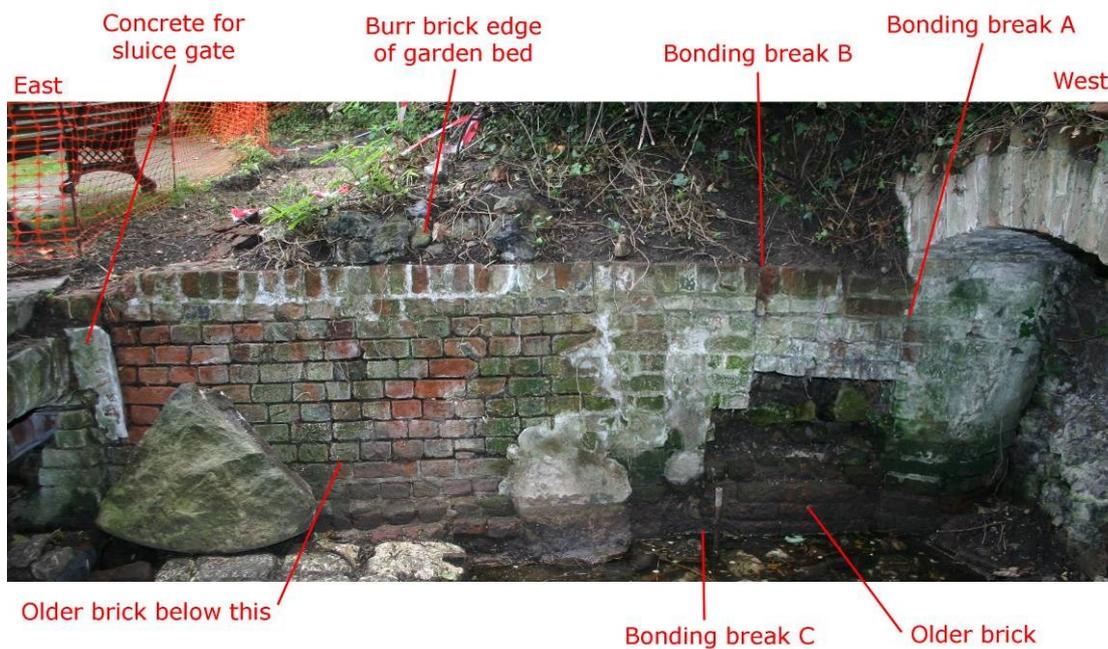
Figure 3. The south wall of the pond.

Figure 4. Interpretation for figure 3 showing the south wall of the rectangular pond.

This is largely of brick with some areas of cement rendering. At the west end there is a bonding break in line with the face of the arch which carries the garden boundary over the culvert (A on figure 4).

The lower few courses of the wall appear to be of older soft red brick while the upper parts are of more recent looking paler red brick. There is a soldier course along the top. There have been repairs and re-pointing with hard grey mortar but the mortar deeper in the joints has not been investigated.

There is a bonding break in the upper part of the wall 0.54m from the west end (B on figure 4) The upper part of the area between the two breaks consists of five courses of brick including the soldier course that runs along part of the top. Below this there is a void where the brick has fallen away exposing soil and chalk rubble.

The lower part of the void has a width of 0.72m as it widens eastwards to another bonding break (C on figure 4). The area below the void is filled with older red brick into which bonding break B probably does not extend.

At the west end of the wall there is a slot in the brickwork and an area of concrete which appears to have provided the setting for a sluice gate (see below).

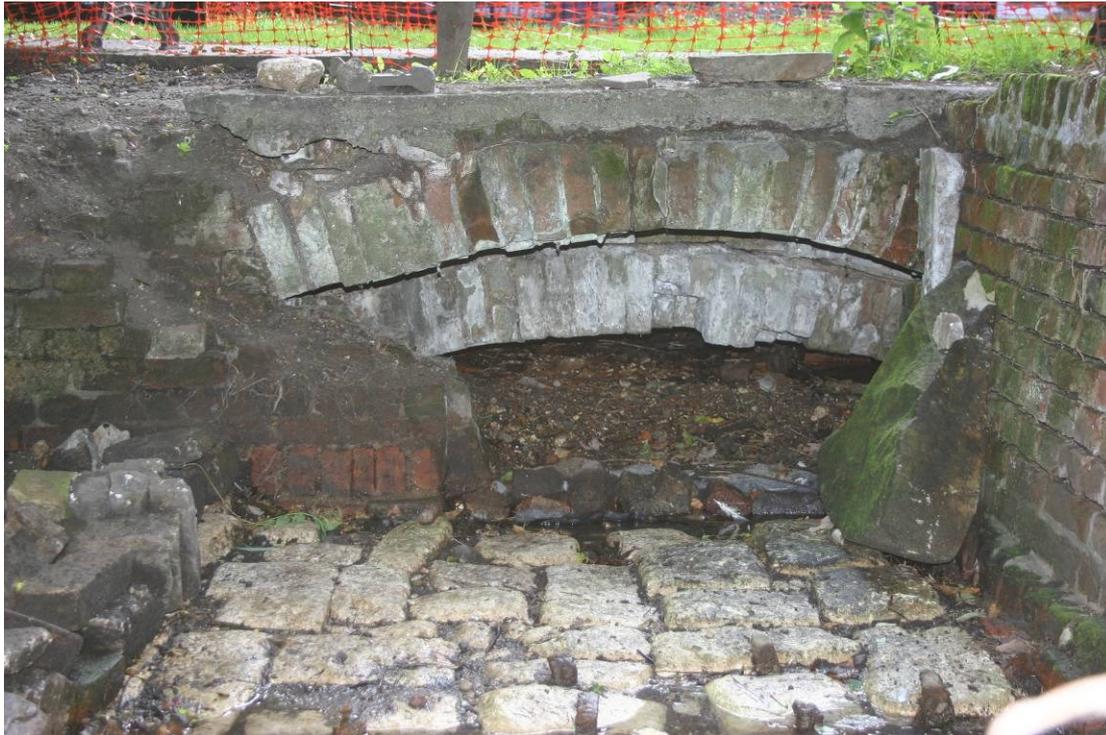
The stream leaves the rectangular pond through a culvert passing through the south end of the east wall and running under the lawn to emerge at the back of the house (figures 5 and 6). The main part of the culvert has a shallow segmental brick arch.

Beyond the sluice the channel passes through the east wall of the pond which is represented by broken stubs on both sides of the channel. It widens on both sides to a total width of about 1.9m. Both sides of the channel are made of rather roughly laid brickwork. A stoneware drainpipe from the oval pond enters the south side through a rough break. The central part of the channel floor below the sluice is covered with red bricks laid on end. The full extent of these is unknown. The roof is a segmental arch of brick which rests on the south side wall of the channel and the broken ends of the east wall of the rectangular pond.

This section of the channel has a length of 0.89m. The roof then drops and the channel continues under a very low segmental brick arch with only a narrow gap between it and the gravel stream bed.

Figure 5. The exit from the rectangular pond into the culvert. Note the higher outer arch and the lower inner one. The stacked brick on the left-hand side of the pond floor had been placed to retain the backfill. The Portland stone block leaning against the wall to the right has been in the pond for many years but is of unknown origin.

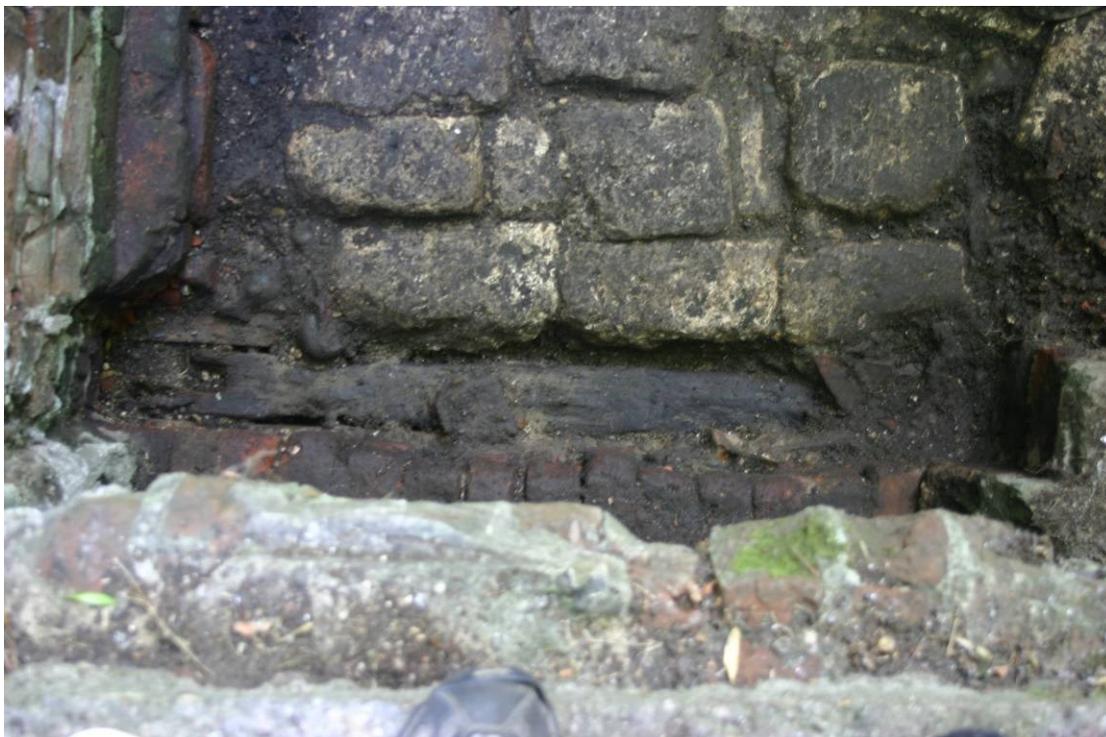
There are the remains of a sluice about 1m wide at the entrance to the culvert. This consists of slots in the brickwork on both sides of the channel and a slot in the floor with a wooden beam in it. The south wall also has a patch of concrete which appears to have sealed the gap between the timber and brickwork. The sluice must have regulated the water level in the pond.

Figure 6. The remains of the sluice at the exit from the rectangular pond. Seen from above with west at the top. Note the timber cill beam and the slots for the gate.

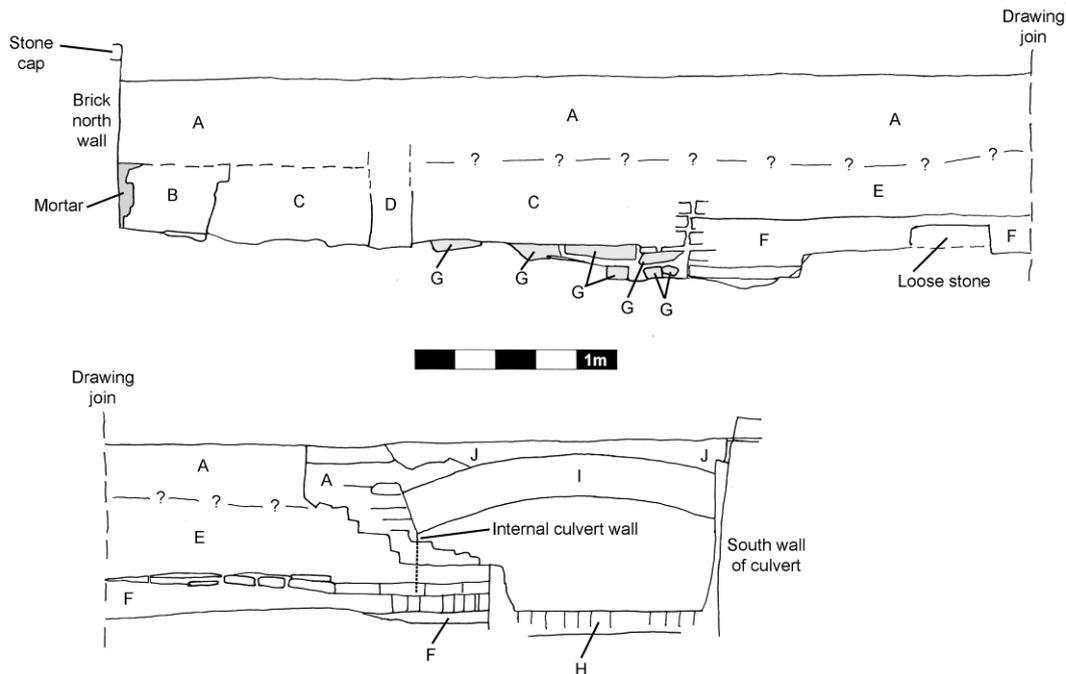
Figure 7. The east wall of the rectangular pond.

- A Three courses of dark red brick with a fourth soldier course at the top. The pointing is in poor condition and they are disturbed. The brickwork looms different from the area E below but this may be the result of its poor condition. It is more or less laid in English bond.
- B Red brick similar to C.
- C Brickwork similar to E. Possibly the same as A more or less in English bond.
- D Shallow slot in the brickwork.
- E Brickwork similar to C. Possibly the same as A more or less in English bond.
- F Red brick earlier than C and E. In places peg tiles and part bricks have been used to
- G Chalk blocks.
- H Culvert floor of bricks laid on their ends.
- I Brick arch over the exit culvert.
- J Modern concrete.

This wall is largely of red brick and has an obvious history of alteration. The lower part of the wall is divided by a bonding break 1.8m from the northeast corner of the pond (figures 7, 8 and 9). The lowest courses to the south of this appear to be older than the brickwork above and towards the culvert part bricks and peg tiles have been used to level up the structure before it was raised or refaced.

To the north of the bond break the lower part of the wall is chalk for about 1.25m. The wall above can be divided into two sections, upper and lower. The difference in appearance may be due to the poor condition of the upper courses rather than the original construction. The wall is topped by a soldier course of yellow stock bricks.

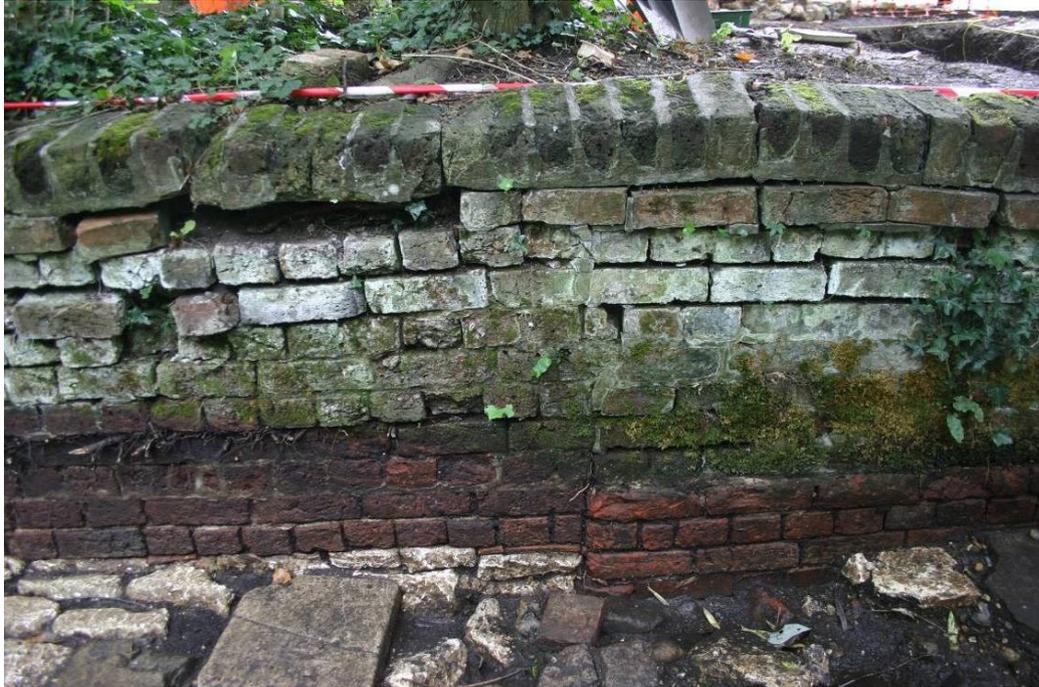
Figure 8. The bond-break in the east wall of the pond.

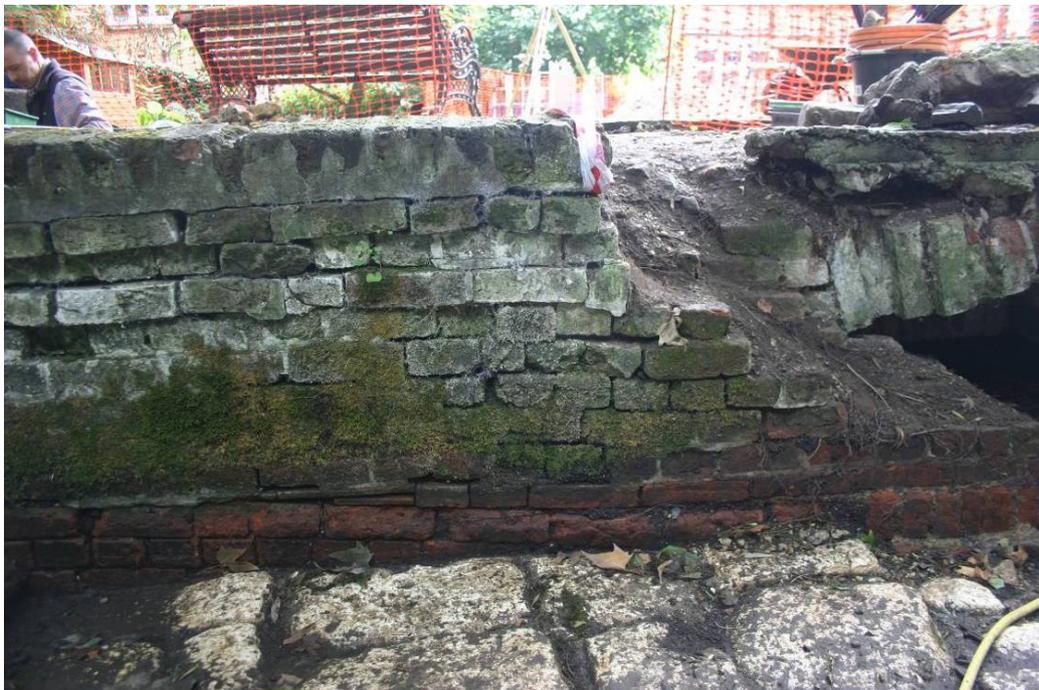
Figure 9. The south end of the east wall adjacent to the culvert. Note the packing to level up the lowest brick courses.

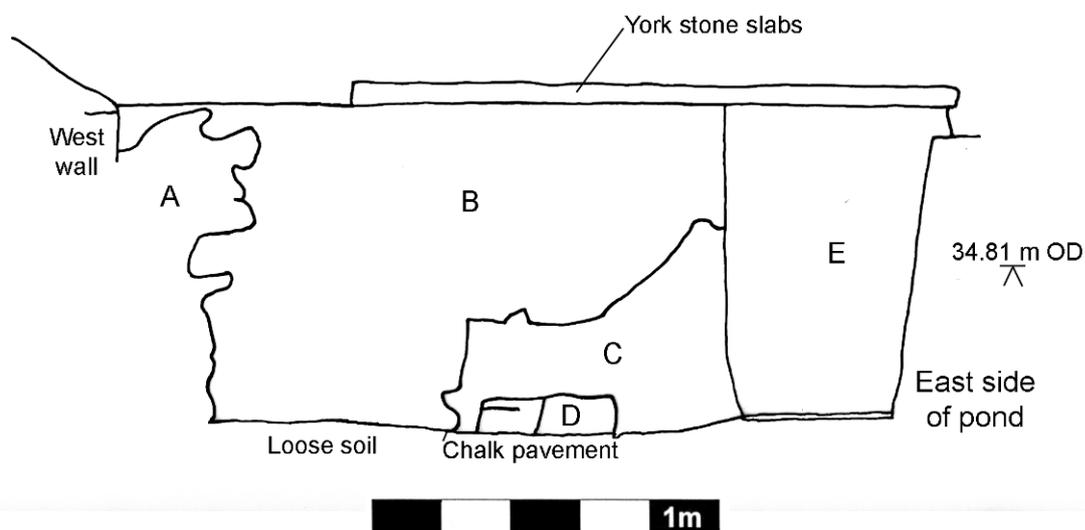
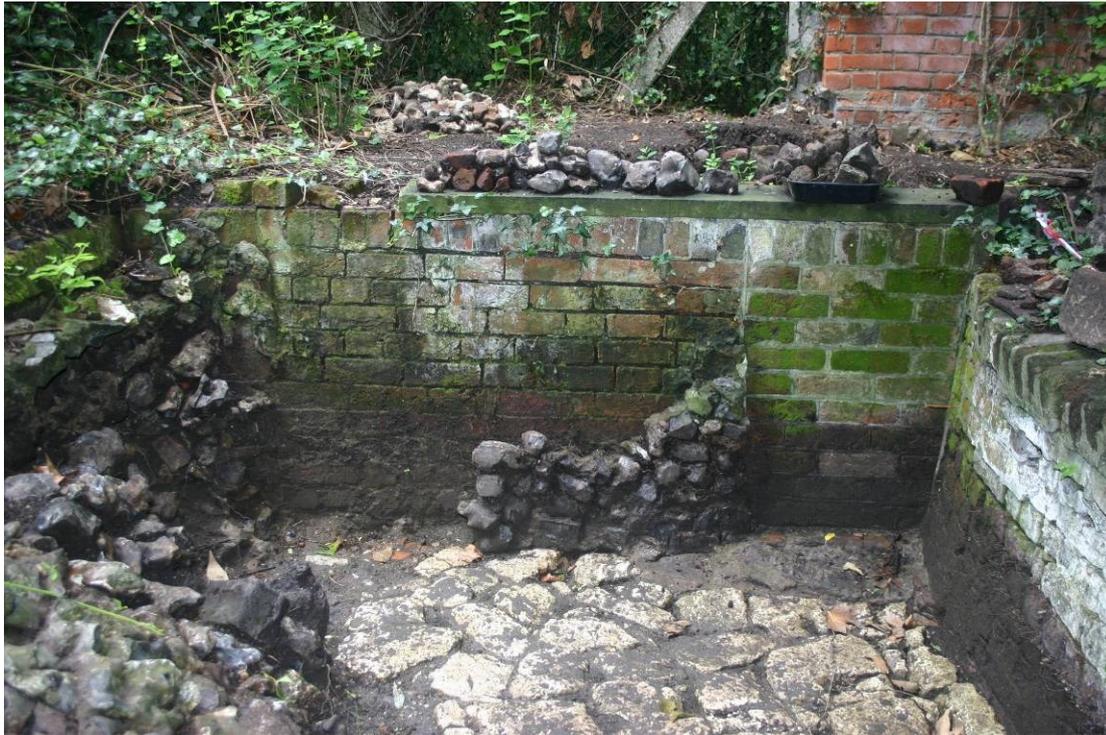
The north wall of the pond is of brick with patches of applied decoration and a York stone cap (figures 10 and 11).

The brickwork is divided into two parts by a vertical bonding break about 0.5m from the northeast corner. The shorter section, to the east of the break, consists of recent looking brick with a soldier course below the stone capping. This blocks off a 19th century brick culvert seen in an excavation in 2010.

The other longer section to the west is of red brick with a soldier course along the top. The lower part of the east end has a patch of flint decoration with some heavily glazed over-fired brick at the bottom. Both are bonded with brown Roman cement.

Figure 10. The north wall of the pond.

- A Decorative facing consisting of burr-brick, shell and slag.
- B Red brick.
- C Flint bonded with brown Roman cement.
- D Heavily glazed brick.
- E Recent looking red brick.

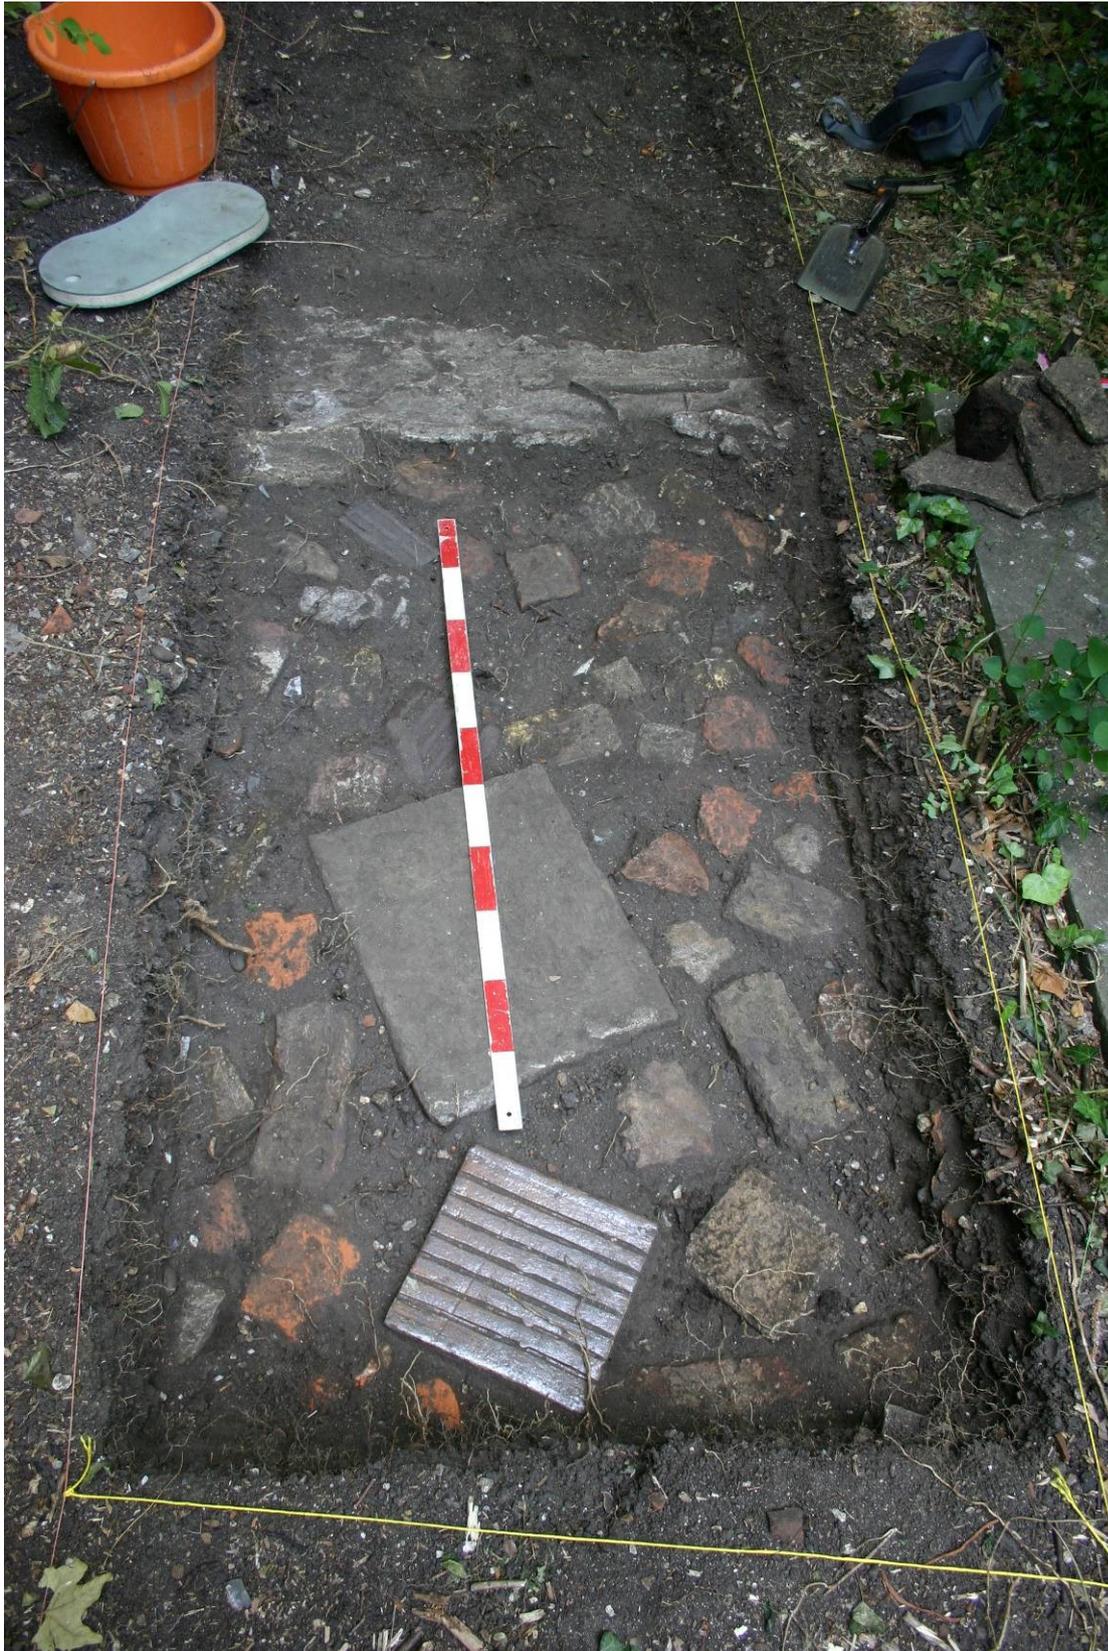
The first edition 25-inch Ordnance Survey map of 1868 appears to show a small building at the north end of the rectangular pond. The structure also appears on the 1896 and 1913 maps but had gone by 1933. It may be the ‘framed temporary summer house with boarded floor back and side Boarded and felt roof’ mentioned in the 1869 inventory of landlord’s fixtures.³ The 2010 excavation exposed part of a rough foundation on the site (figures 12 and 13). This consisted of brick, a salt glazed stoneware slab, flint, concrete, the ceramic side of a fire grate and a York stone slab forming a rough surface with large soil filled gaps between the materials. There was an irregular grey concrete foundation on the east side of this. The materials suggest a 20th century date, perhaps a later rebuild.

Figure 12. The western end of trench C looking east showing the top of layer [C4] interpreted as a rough floor or foundation for a summer house or similar building associated with the concrete foundation [C3] which can be seen the background.

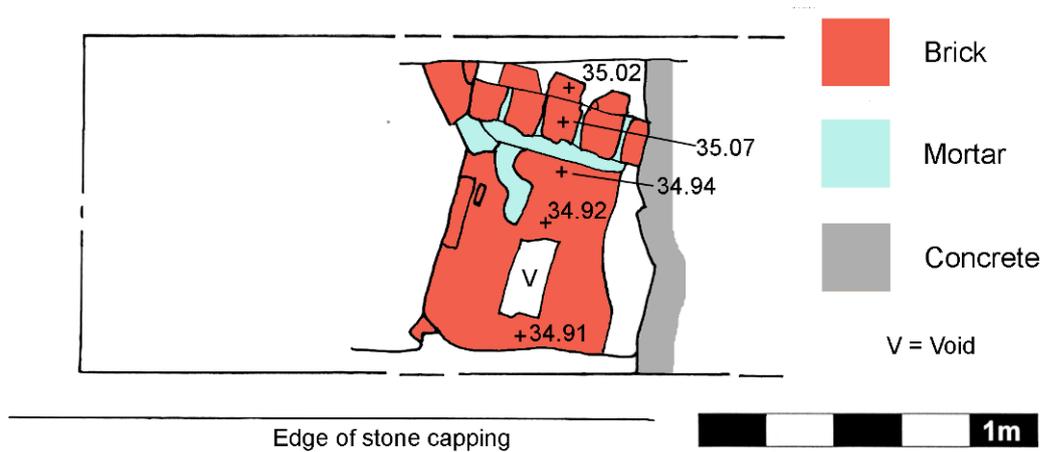
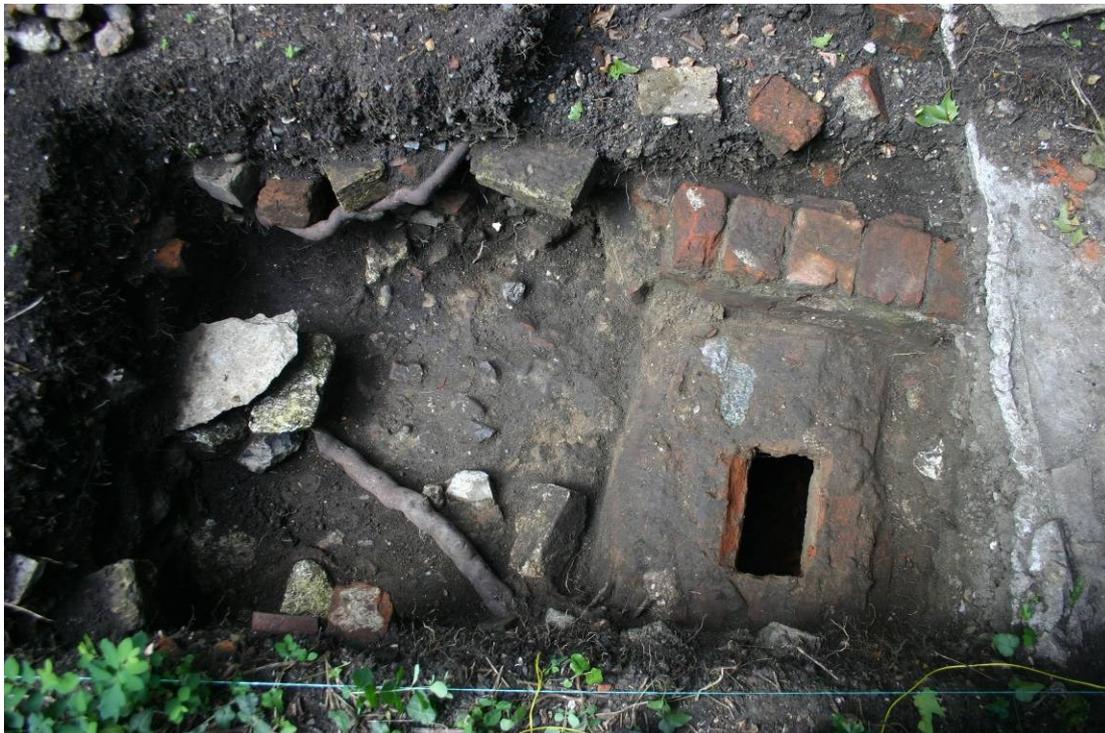
The area of recent brickwork at the east end of the north wall of the rectangular pond blocked off a northward running culvert. The culvert was constructed in two sections separated by a bonding break. One section, at the south end, ran about 0.7m from the pond to the bonding break while the other continued to the northeast (figures 14 and 15). Two bricks were removed to allow a view of the inside.

A small retaining wall [C7] crossed the top of the culvert close to the north side of the trench (figures 14 and 15). It consisted of two courses of soft red brick. The top one was of half-headers which were roughly broken off at the south end. The wall below this was roughly constructed. On the north side the mortar bonding the top course had spilled out over the brick suggesting that it is not a fair face. The second course also stepped out about 6cm at the base. The wall was not excavated below this. At the west end the wall appeared to turn at about 60 degrees and almost immediately passed into the north side of the trench. The wall is bonded with soft brown sandy mortar which is both softer and coarser than the mortar in the first section of the culvert.

The relationship between the wall and the underlying culvert was not entirely clear. There appeared to be a bonding break along the south side of the retaining wall but it was partly concealed by mortar. A break was visible from the underside but its exact position could not be determined from the photos. Neither side of the wall was convincing as a fair face.

Figure 14. The top of culvert and the retaining wall. North at the top.

Figure 15. The top of culvert [C12] with retaining wall [C7] at the top. North at the top.

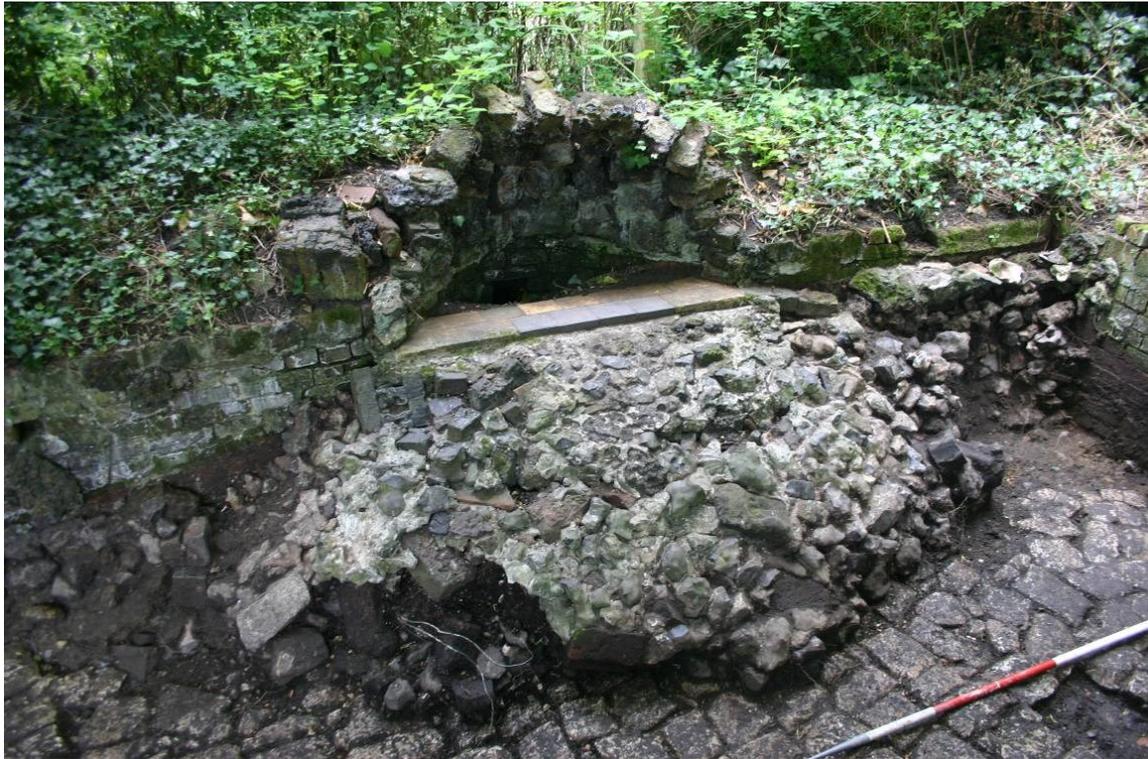
The sloping cascade consists of flint, shell and other decorative materials joined with Portland cement. The foot of the structure has been broken or eroded by seeping water exposing a core of dark earth which contained a piece of electric flex suggesting that it is of no great antiquity. The core is similar to the soil overlying the lower part of the cascade prior to clearance.

Figure 16. The grotto and cascade. Note the electric wire protruding from the bottom left hand side of the cascade.

The foot of the cascade has been broken or eroded by seeping water exposing a core of dark earth which contained a piece of electric flex suggesting that it is of no great antiquity. It was not part of the 1990 garden work as there is a photo taken at the time showing pond with the lower part of the cascade covered with newly laid or newly cleared soil (figure** 44). A second photo shows Sandra Willis, the parks service landscape architect, standing by the south end of the pond before it was cleared (figure 19). The floor was covered with ivy and other weeds but there appears to have been a substantial amount of soil in the bottom. Sandra Willis planned to turn the pond into a bog garden and she may have had additional soil laid. This is consistent with the stratigraphy found in the 2010 excavation. This showed that the south side of the cascade overlay a deposit of dark soil and rubble. Similar soil also overlaid the lower part of the cascade. There must, therefore, have been two deposition episodes, one before the cascade was constructed and one after. There two deposits were, however, very similar and could not be clearly distinguished in the excavation. Both contained recent finds. If the cascade was not built by Sandra Willis in 1990 it must be the result of some other fairly recent episode. The obvious candidate was a Manpower Services Commission job creation project which restored various features along the Carshalton Wandle in 1983-4. The weirs of Margaret's Pool and the Wandle Lodge pond immediately behind Honeywood were rebuilt at this time but I have not found any evidence for work in the garden at Honeywood. It is however, likely.⁴

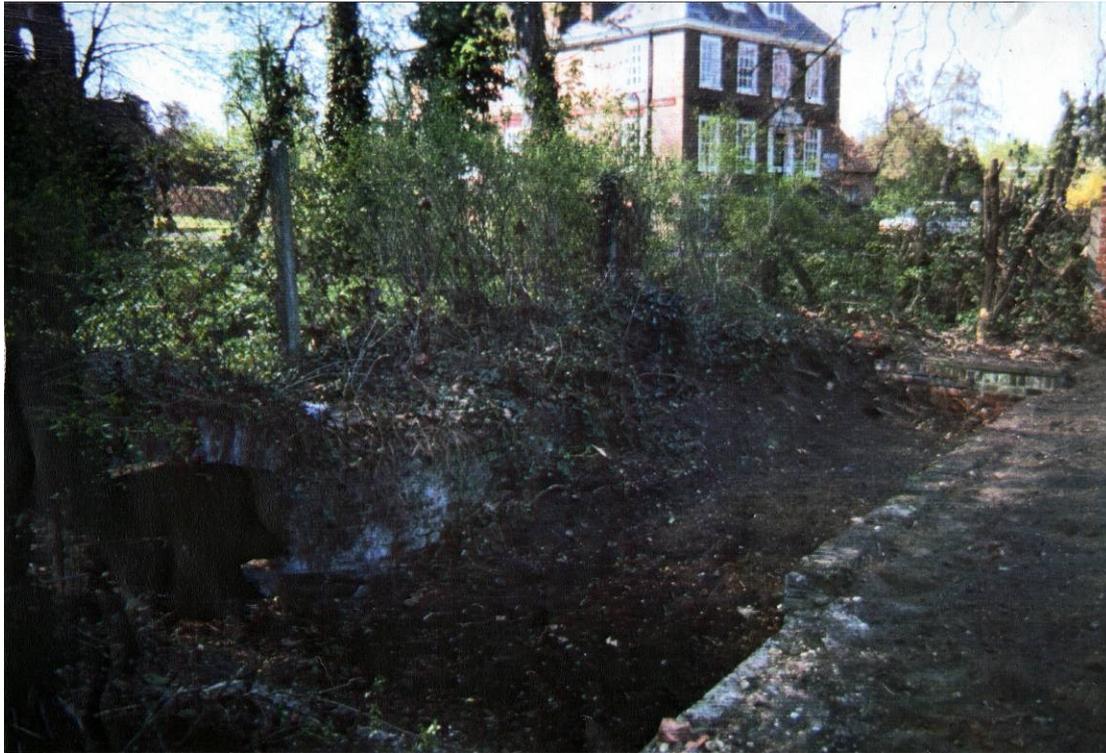
Figure 19. The rectangular pond in 1990 after clearance. More soil has been added covering the cascade.

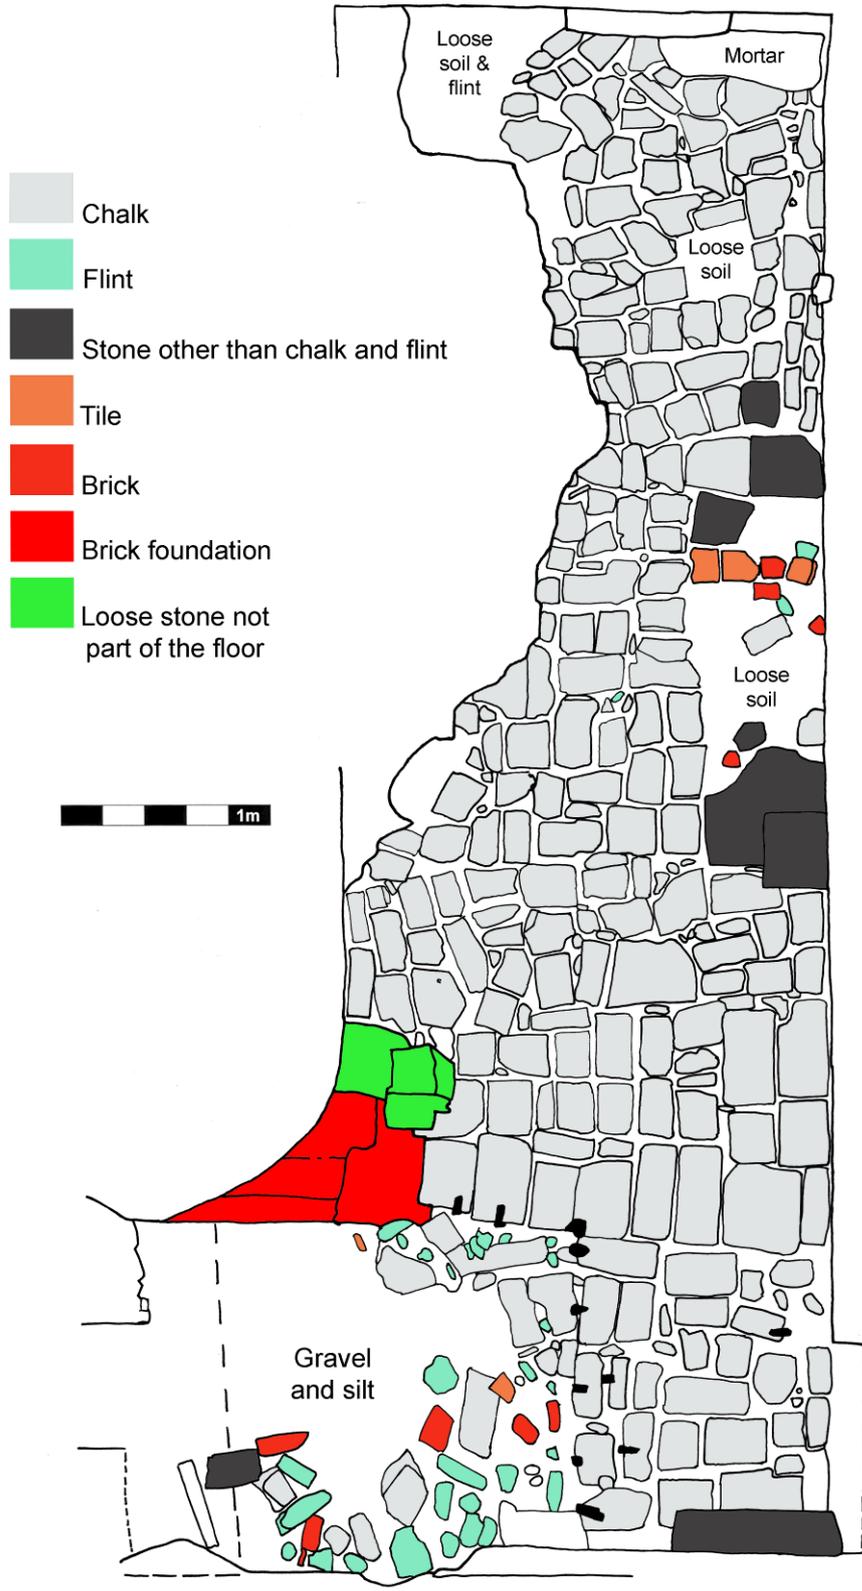
The pond floor was covered with a thick layer of earth contained many very recent finds. This was cleared in 2010 exposing a floor of large chalk blocks of variable character. A line of large blocks carries the line of the entrance channel across the pond (figure 20). To the north of this the blocks gradually become smaller and less well arranged those at the north end being particularly small and irregular. There are several gaps in this area either where the chalk blocks are missing and there is dark soil over gravel or they have been replaced by other materials. The area where the stream crosses falls into two parts. At the west end below the weir the blocks are missing or displaced and a hollow has been washed in the underlying gravel. This is clearly a plunge pool eroded by the water falling over the sluice. The blocks survive at the eastern end. A series of iron pins have been installed along the upstream edge of the surviving blocks to keep them in place. In some places the grotto cascade can be seen to cover the chalk blocks.

Figure 20. The pond floor showing the materials used.

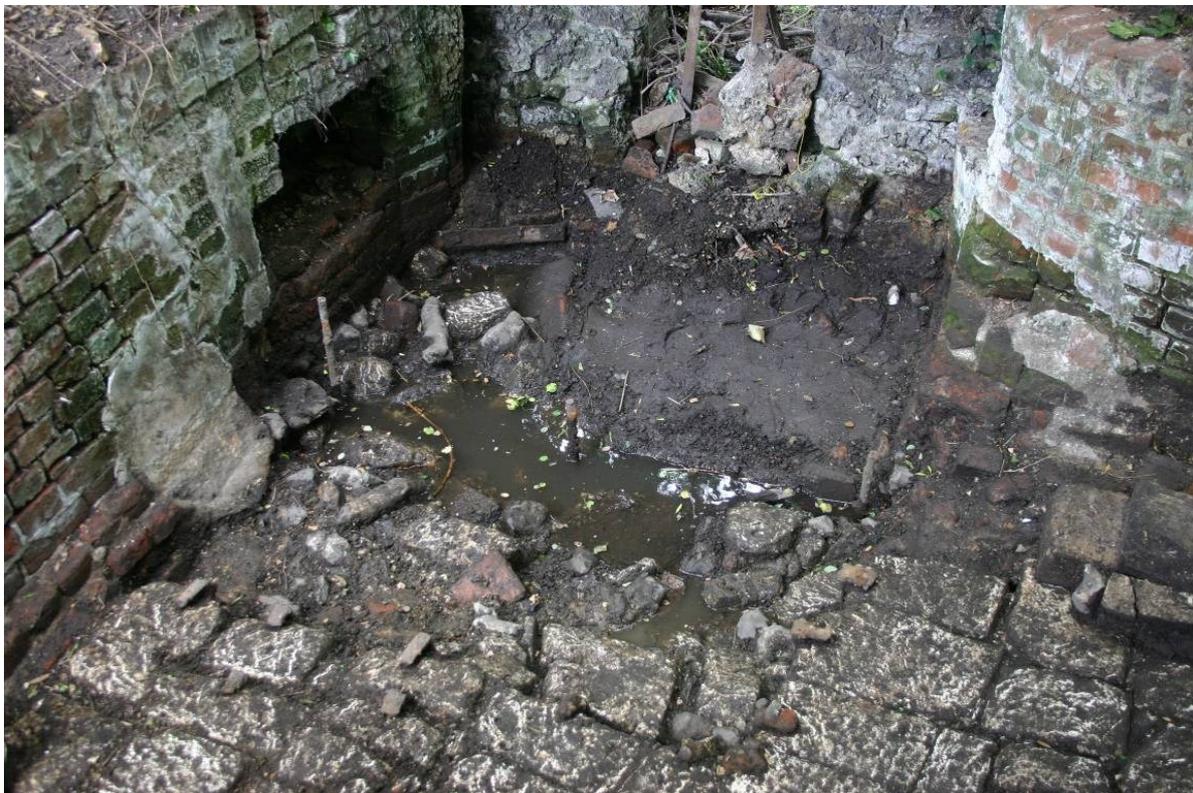
Figure 23. The pond floor where the stream enters. Note the damage to the floor, the iron pins used to secure the edges of the chalk blocks and, on the right, the foundation projecting from below the west pond wall.
