# The Old Rectory, Carshalton: a historical survey

Address	The Old Rectory, Festival Walk, Carshalton SM5 3NY
Grid ref	TQ 277 645
Author	John Phillips
Date of investigations	6 April 2009, 14 and 20 August 2015
Revised	26 September 2015

## 1. INTRODUCTION

This is the report on a historical survey of the Old Rectory which was carried out on 14 and 20 August 2015. It incorporates the material gathered in a brief survey made on 6 April 2009.

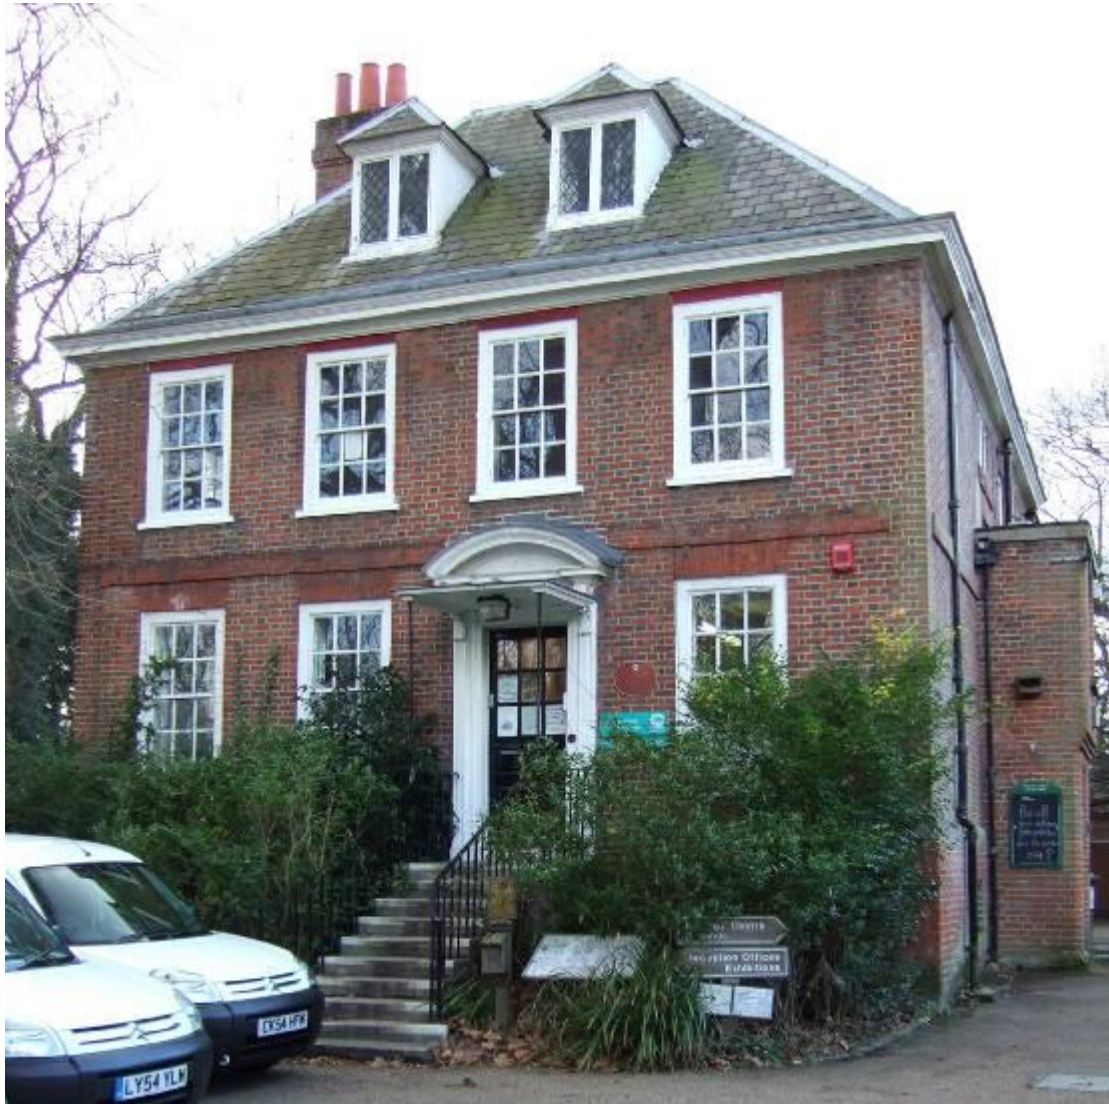
The east side is the front. It is four bays wide with the door off centre to the north. The wall has sash windows with rubbed brick heads. There is a projecting four course rubbed brick band at first floor level. There are two dormer windows with diamond shaped leaded lights. The basement windows are modern replacements.

Figure 1. The east side of the house on 21 January 2006.

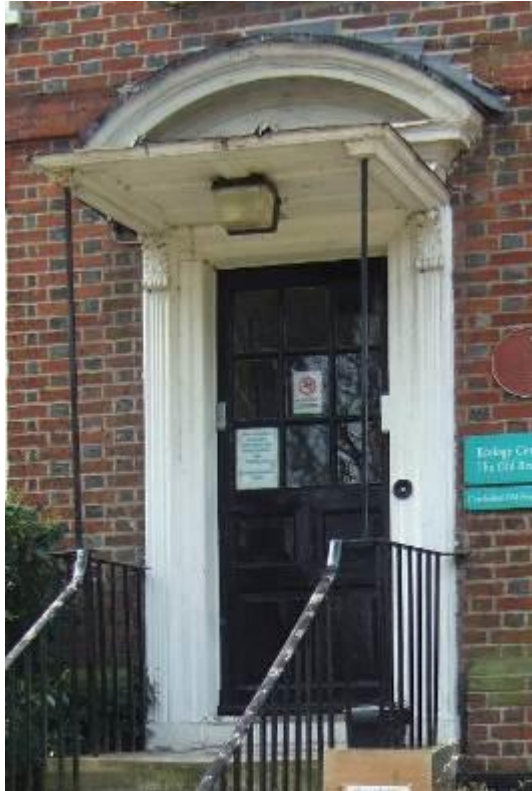
The front door is approached by a flight of ten stone steps lined with plain iron railings and supported by brickwork. The door frame has a segmental head and

cornice supported by foliate consuls above a fluted pilaster. There is a small flat porch which is attached to the door frame half way up the consuls and is supported at the outer end by two iron bars which rest on the hand rail of the steps. This is presumably an addition.

Figure 2. The front door

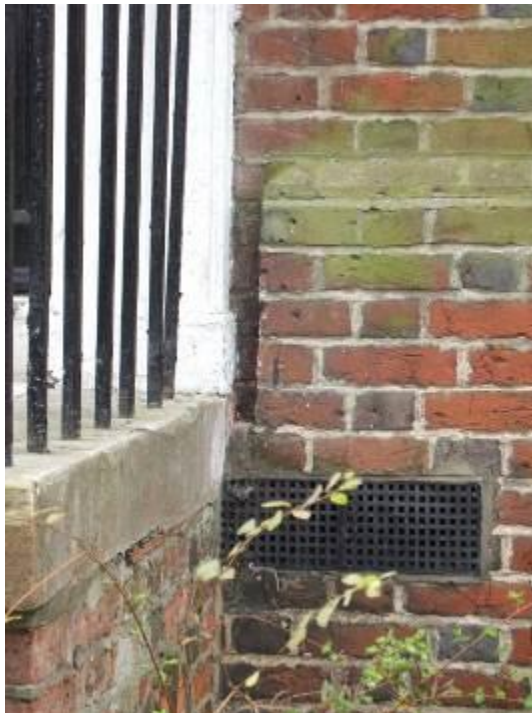
Figure 4. Junction of front steps and wall.

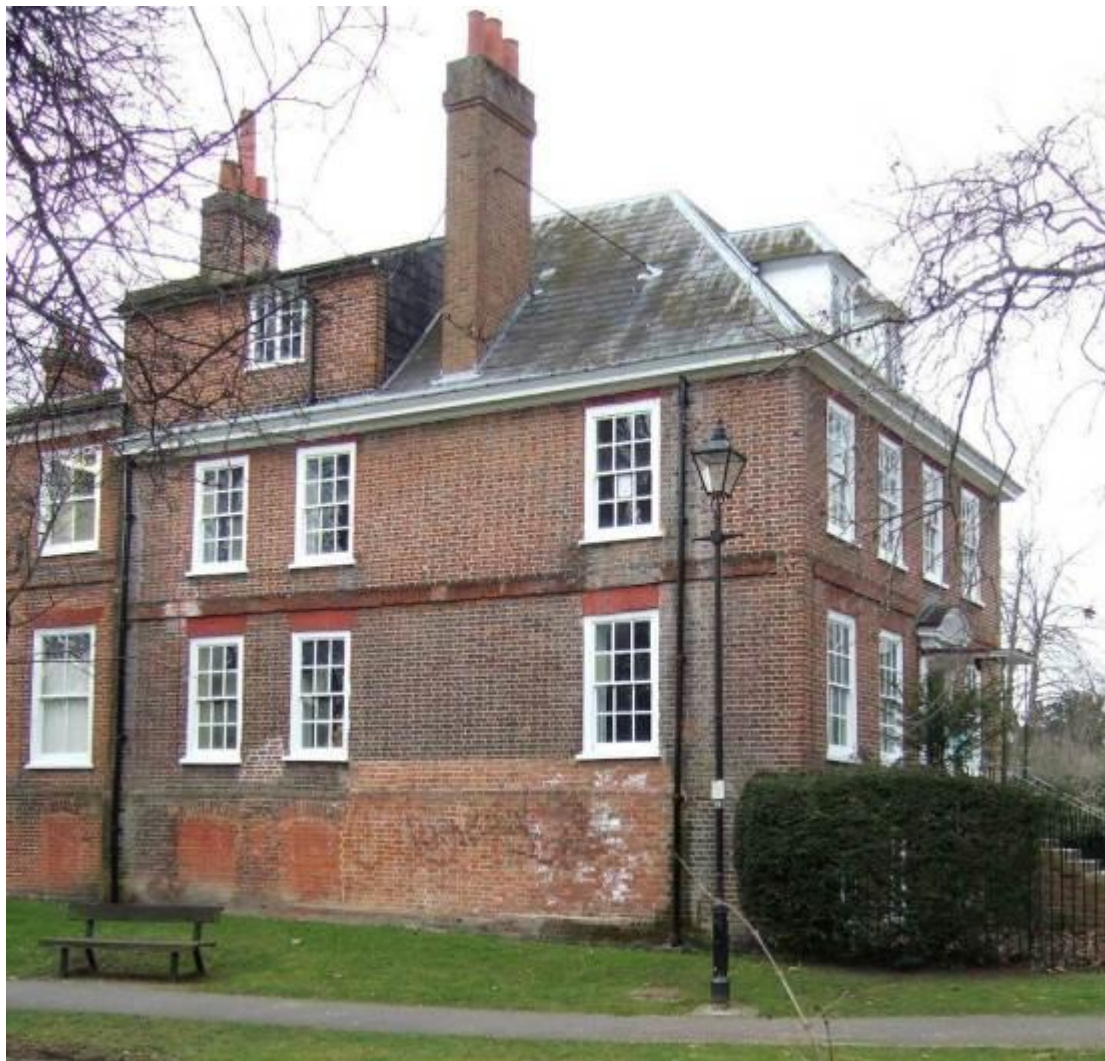
The south elevation falls into two parts: the original building and an extension added to the western side. The original building was four bays wide but the centre east bay has no windows as the space is taken by the chimney stack and fireplaces in rooms 2

and 11. The windows have straight heads with rubbed brick. There are two blocked segmental headed basement windows on the west side of the elevation. The east side has been refaced at this level and it is not clear if there were basement windows there. A large brick fronted dormer has been inserted into the west end of the roof. It has a casement window with a total of 12 lights and is probably 19th century. There is a band at first floor level and an offset above the basement windows.

The 19th century extension to the west end of the house is of two bays with two windows on each floor. The eaves are higher than the original part of the house and there is a horizontal band between the windows which are also set higher. The windows have rubbed brick heads and the sash windows have four large lights as opposed to twelve in the older part of the house. There is one narrow basement window with a segmental head at the east end of the extension. This is now blocked.

Figure 5. The Old Rectory from the southeast.

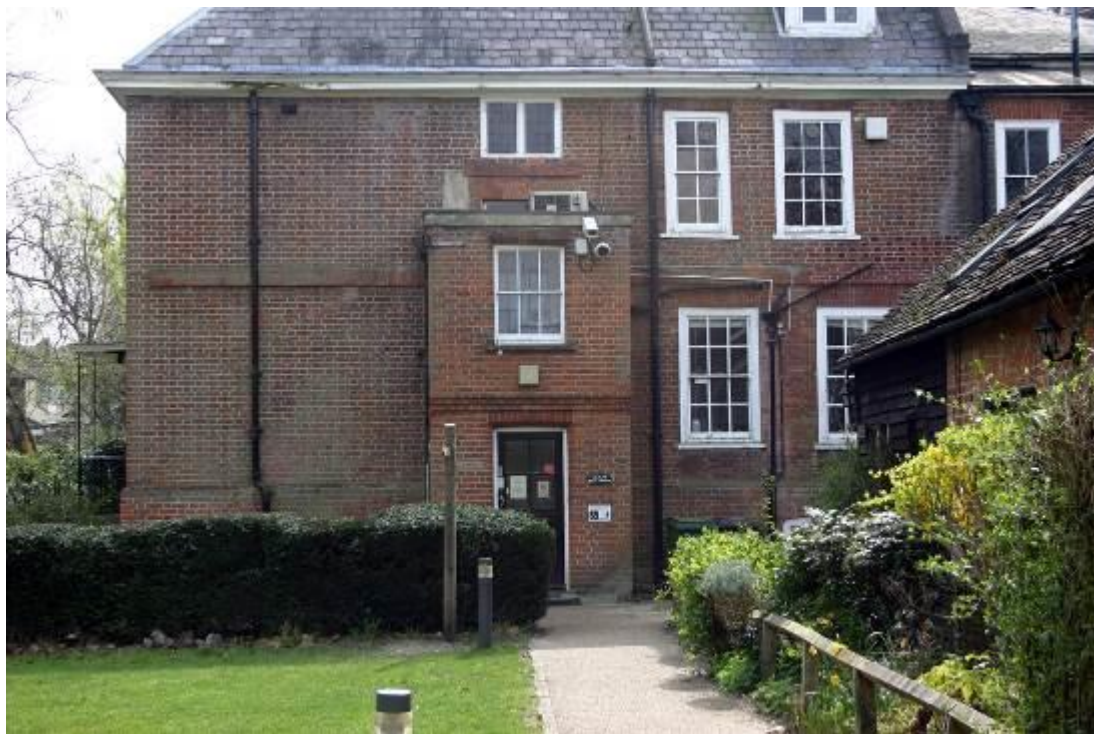
This falls into three parts: the original building, a porch and the extension at the west end.

The original house was four bays wide. There are no windows in the eastern bay to accommodate the fireplaces and chimney in rooms 1 and 10. The chimney stack has now gone from the roof making the front less symmetrical.

The second bay from the east contained the staircase. This was lit by a small casement window immediately below the eaves and a large window below which is now partly obscured by the porch. There was presumably always an outside door at ground level.

There are four windows in the old building to the west of the porch, two on the ground floor and two on the first. The ground floor windows are the same size and are regularly spaced. The eastern first floor window is narrower than the others allowing the adjacent window to be displaced eastwards. The reason for this is unclear. There is one segmental headed basement window at the west end of the original house.

The porch is a two story structure which rises somewhat above the band on the original building. There is a door at ground floor level and a six light sash window above. The two are separated by a curious piece of corbelling three bricks high.

On this elevation the west extension falls into two parts: the main block which is set back and a narrow tower like structure in the angle between this and the main building. The north side of the 'tower' has a small window on the ground floor and a four light sash above. The west side contains a round headed door with a line of three corbelled out bricks above it similar to the porch. The north wall of the main part of the extension is plain brick.

Figure 6. The north side of the house.

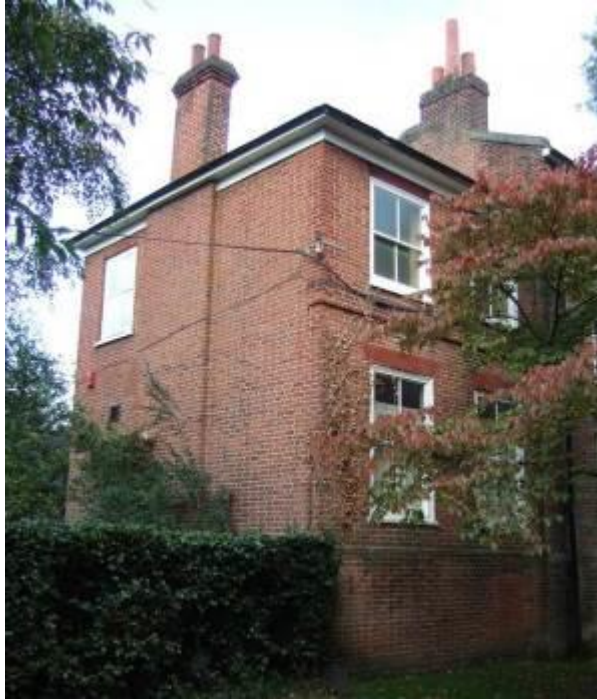
The west side of the original building is largely covered by the extension. The west side of the main part of the extension is of plain brick divided by a chimney stack which projects slightly in the centre. There is one casement window on the upper floor in the north of this and a basement door below it. There is no band at first floor level.

Figure 7 The extension from the southwest.

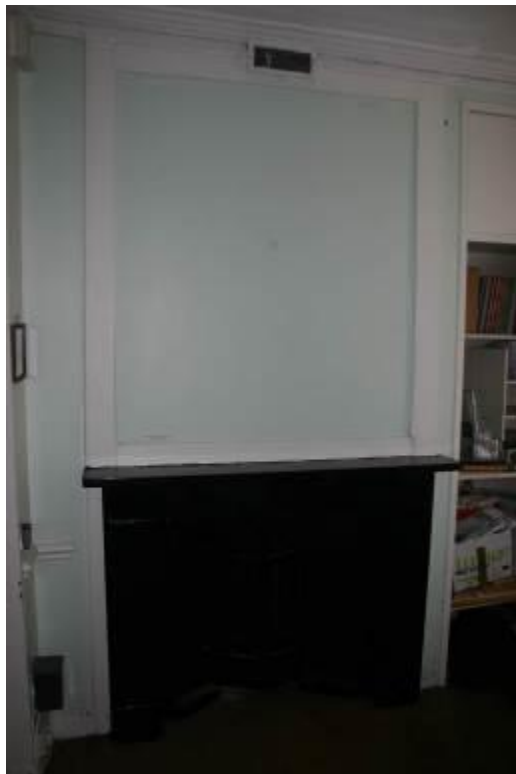
There is a fireplace in the centre of the north wall. The fire surround is of black marble or slate and looks early 19th century. It is now painted black. Within this there is a cast iron grate with six doors which are designed to convert it from an open grate to a stove. I have not found a close parallel for this but a Victorian date is likely. There is a walk in cupboard built into the niche on the west side of the fireplace. It projects forward of the chimneybreast. There is a row of coat hooks on the east side. The shelves look modern. The cornice runs around the top of the cupboard and the dado rail runs across the door so it is probably original. There is also a cupboard on the east side. This does not look original but the coving respects it and it is hard to see the space without one. The window surround projects inwards from the wall. The sashes are modern. The doors to the shutter boxes are split into two parts, upper and lower.

Figure 9. The panelling above the fireplace in room 1a.

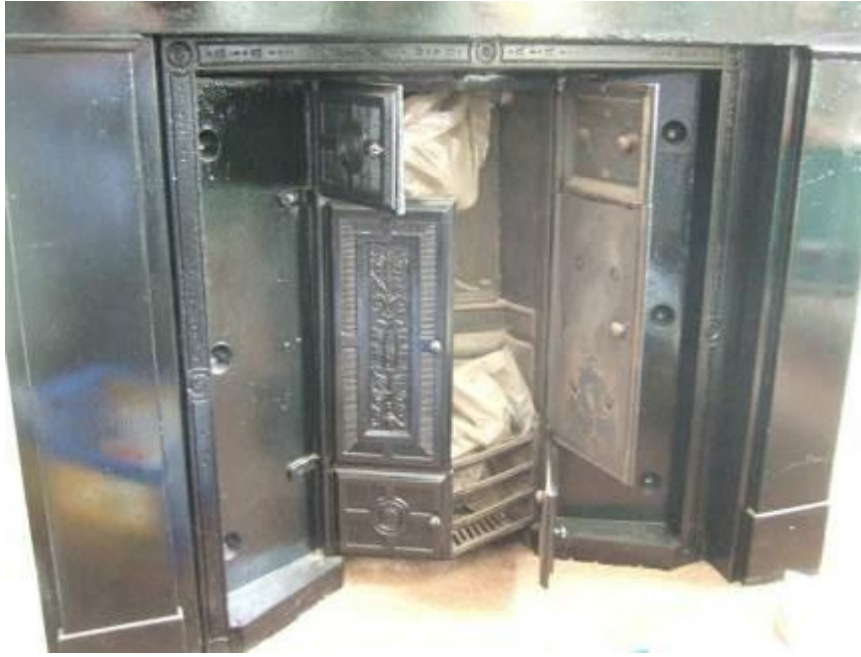
Figure 11. The cast iron grate in room 1a.

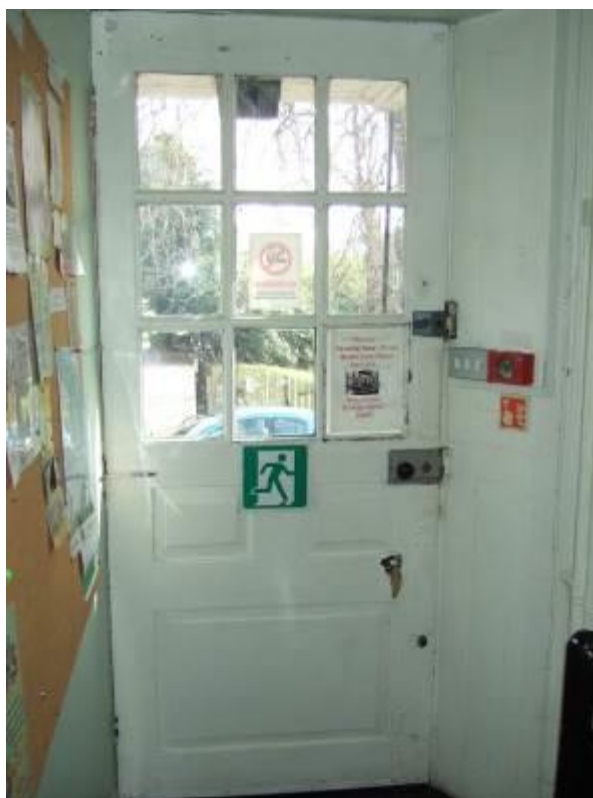
The present front door is probably largely 18th century. The upper part contains a six light window which is probably a modern insertion. Below this there is a pair of small panels in the middle of the door and a single large panel below them. The tenons visible in the edge of the door suggest that the glazing is an insertion and that the top half of the door once matched the bottom. The decoration is the same on both sides. Alcock and Hall illustrate a similar door which they date to 1725.<sup>17</sup>

There is a shutter box set at an angle on the south side of the door. This presumably held a shutter to cover the glazed upper section of the door as there are hinges for the top to open. The box is decorated with lightly incised panels which may be early 19th century.

Figure 14. The front door.

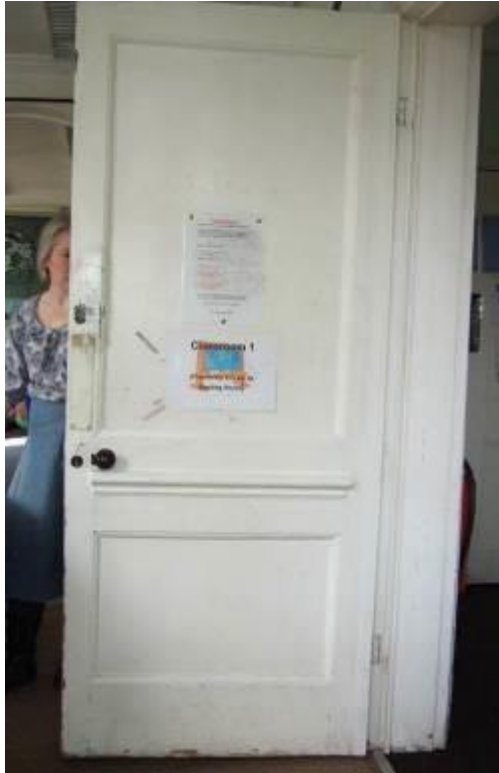
The room is panelled with large upper panels and smaller lower ones separated by a dado rail. Much of the panelling is covered by recent display boards. The door from room 3a (the present hall) respects the design of the panelling and the dado rail continues across the centre of it. The door fittings and hinges are modern.

Figure 16 . The door between room 2 and room1B which is now the hall.

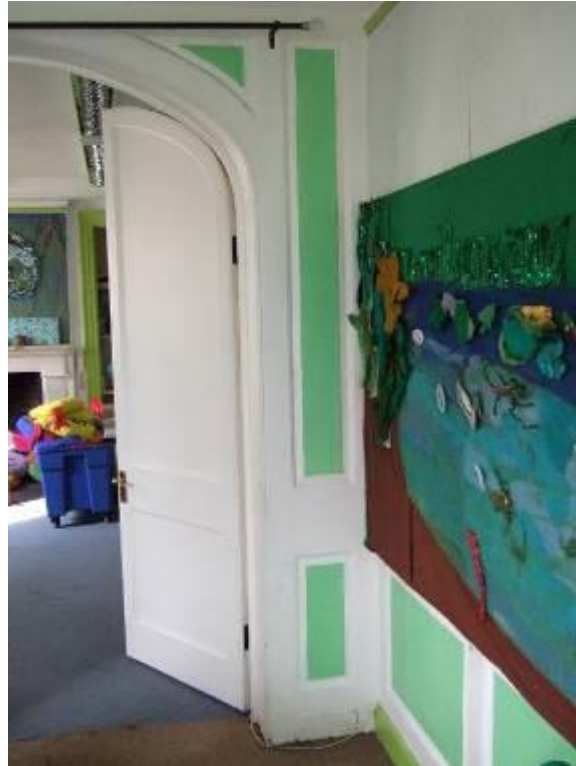
There is a wide arched opening to room 3 which is of a piece with the panelling. The dado rail has a correctly shaped end. The door jamb is however recent and is fixed with modern screws. The double doors do not look old and do not match the design of the panelling. The hinges are also modern.

Figure 17. The door between rooms 2 and 3.

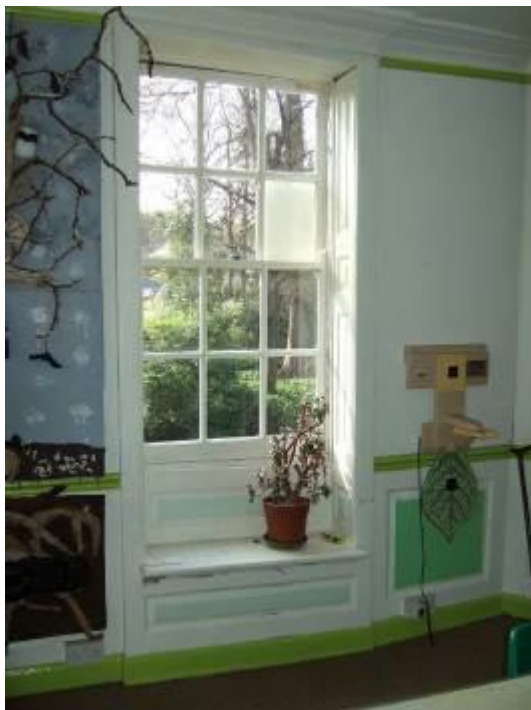
The cornice steps inwards above the windows and the window surround projects from the wall. There are seats window seats. The sash glazing bars have a round roll moulding with a filet at the tip. They appear to be modern replacements. The doors to the shutter boxes are split into upper and lower sections. They won't open.

Figure 18. Room 2 – window in the south wall.

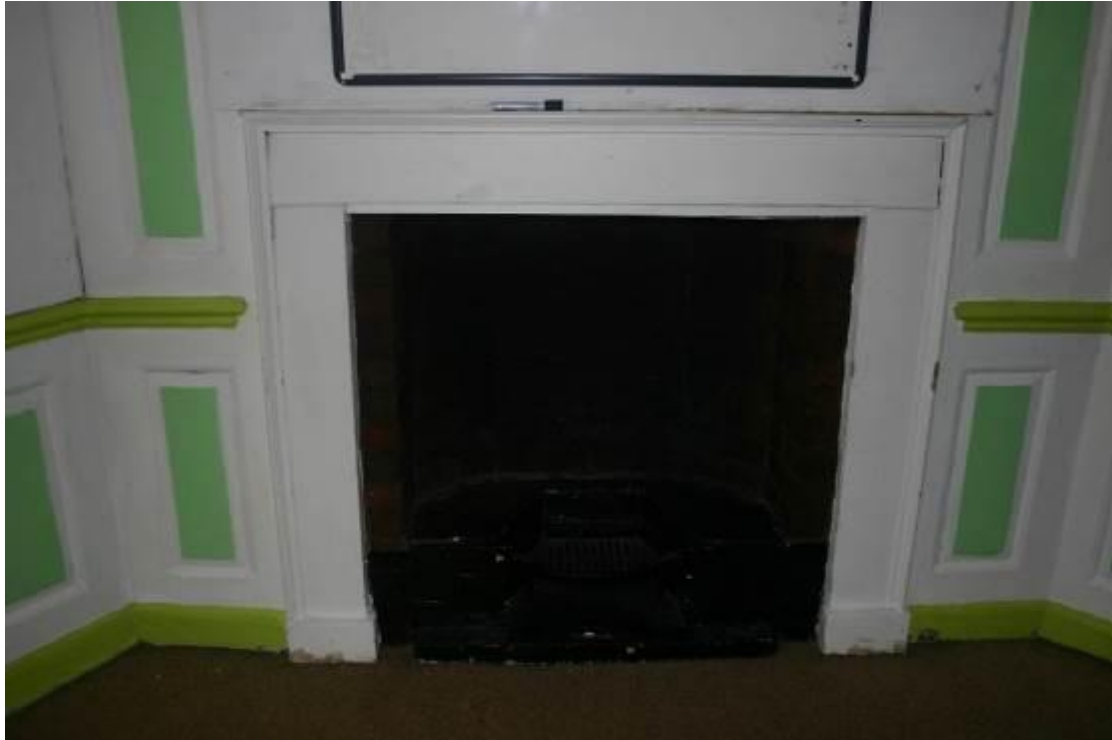
There is a fireplace in the southwest corner of the room. The surround has been painted but is probably of white marble with grey veins. The bricks around the grate

are marked 'EJ & T PEARS LIMITED STOURBRIDGE'.

Figure 21. The fireplace in room 2.

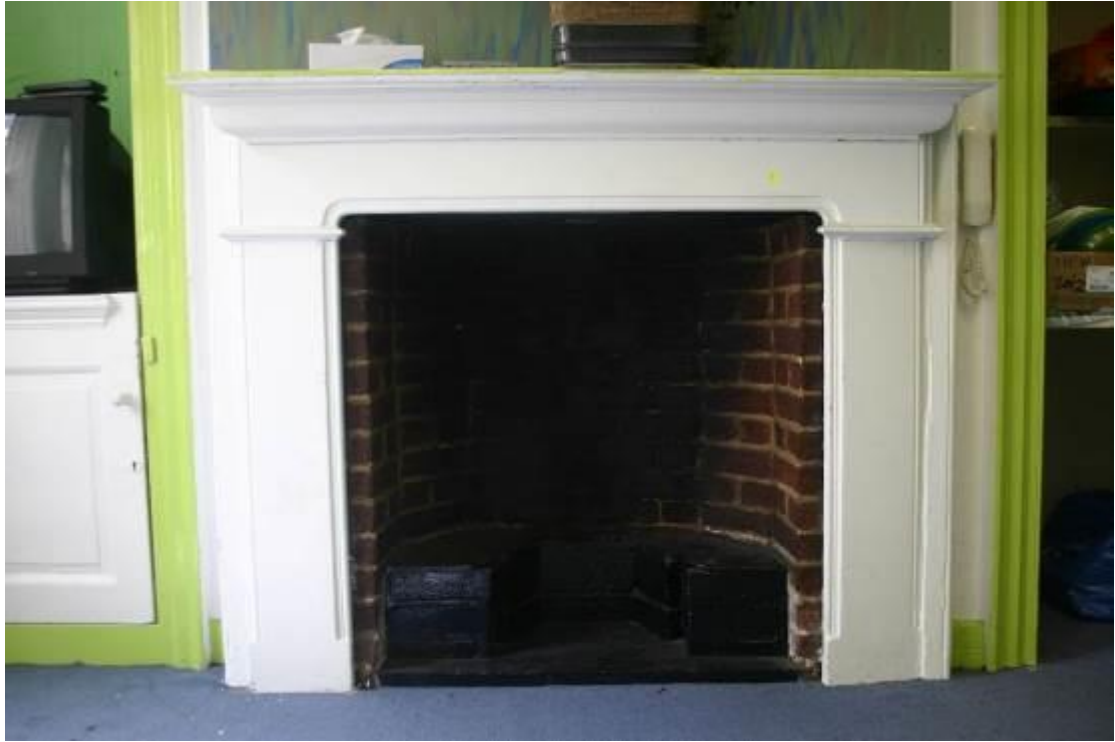
There is a fireplace in the centre of the west wall. The chimney projects into the room. There is a wood lined arched niche to the south of it. The bottom of the niche is level with the dado rail and there is a cupboard below. The dado rail continues onto the top of the cupboard door. There is a tall cupboard on the north side of the chimney which now lacks doors. The mouldings are similar to the door between room 1a and 2.

The fire surround is painted probably over white marble. The design looks early 19th century. The heavily moulded mantle shelf is probably an addition. The hearth is modern.

Figure 23. The fireplace in room 3.

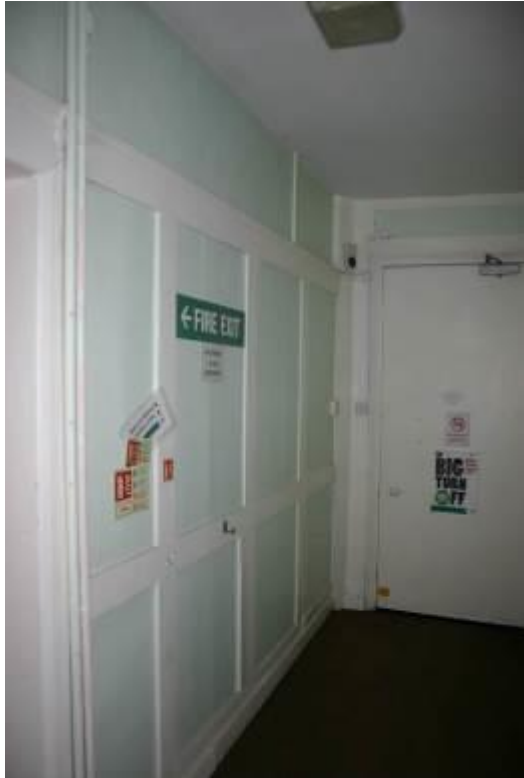
The wood panelling survives in good condition along the south side of room 4b. It extends up to the top of the door and is divided by an undecorated beam at dado rail height. The picture rail at the top appears to be modern. Panelling also survives on parts of the north and west walls of room 4a.

Figure 35. Panelling on the south wall of room 4b.

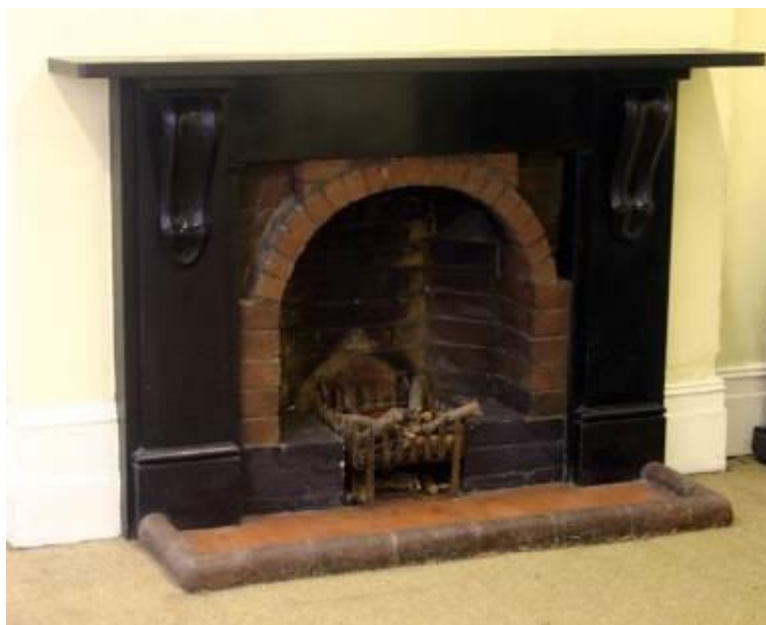
The skirting on the north wall is different from the rest and this, together with the off centre fireplace suggest that rooms 6 and 8 were created by partitioning 9.

Figure 39. The fireplace in room 9.

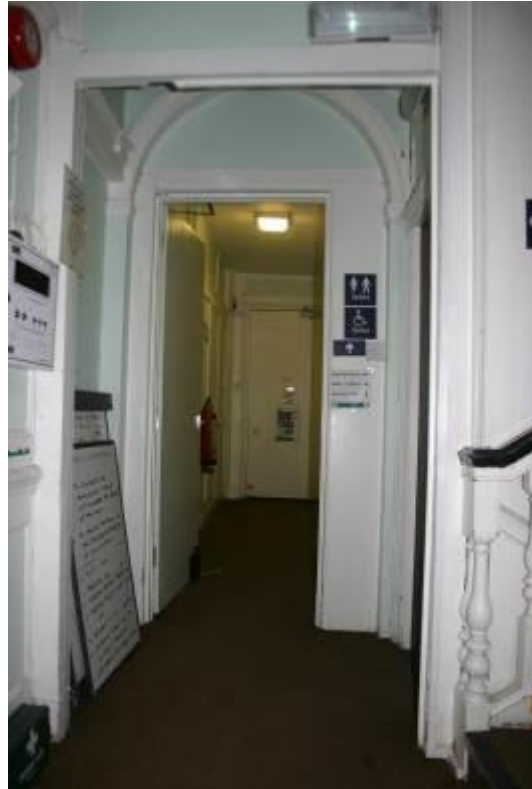
Figure 48. The ground floor stairwell looking west showing the inserted door frame at the stair turn.

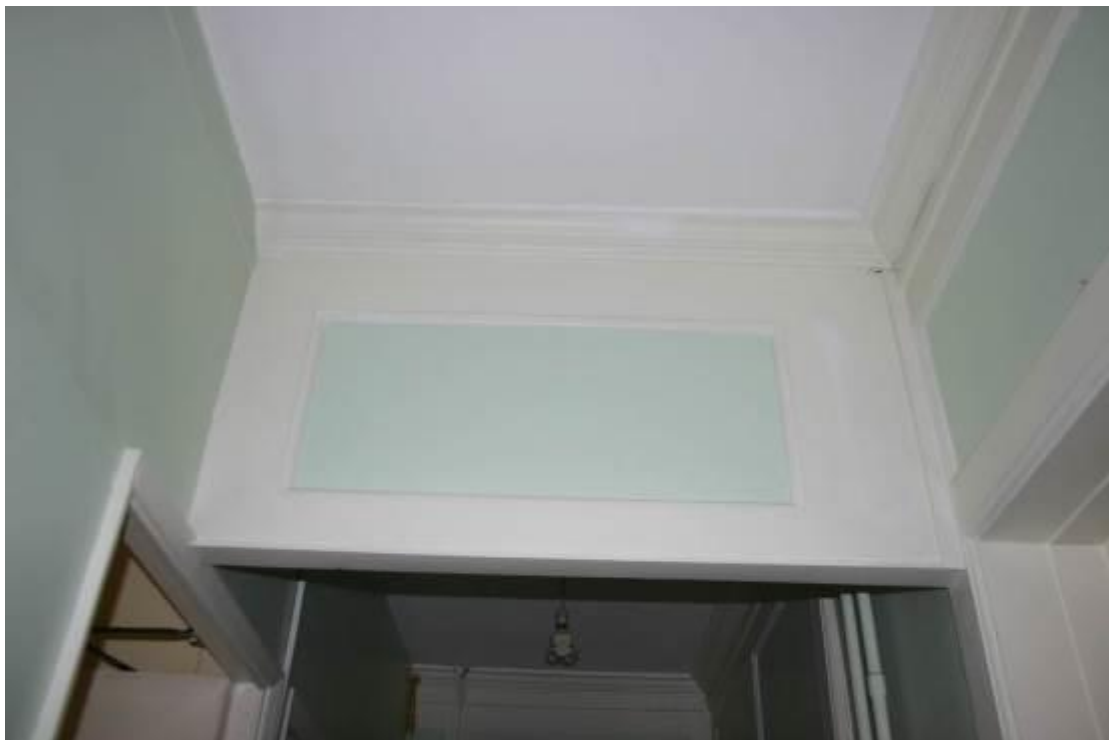
The panelled wall between rooms 13a and 13b does not look like Council work to accommodate the toilets. The two rooms have their own windows which are different but from the outside they both look old (figure 6). It is possible that the wall between 13a and 13b originally divided the whole space and it may have been inserted fairly early in the house's history to create a dressing room to 12a. The corridor 13a was probably created later to provide access to the upper floor of the Victorian extension.

Figure 69. Partition in the upper part of room 13c. The door to 13b is on the left and to 12 on the right.

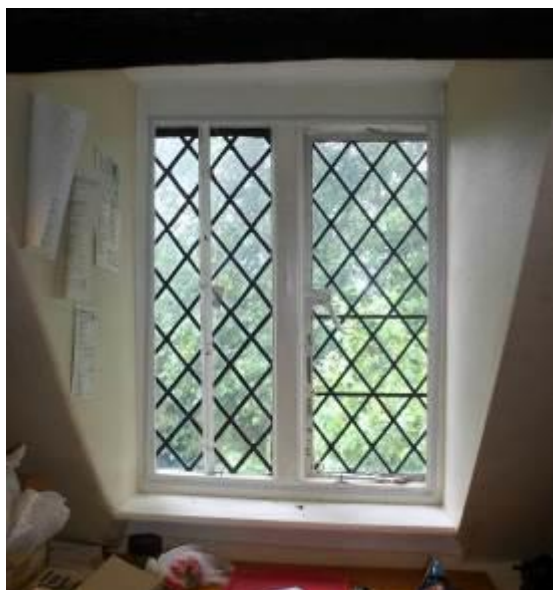
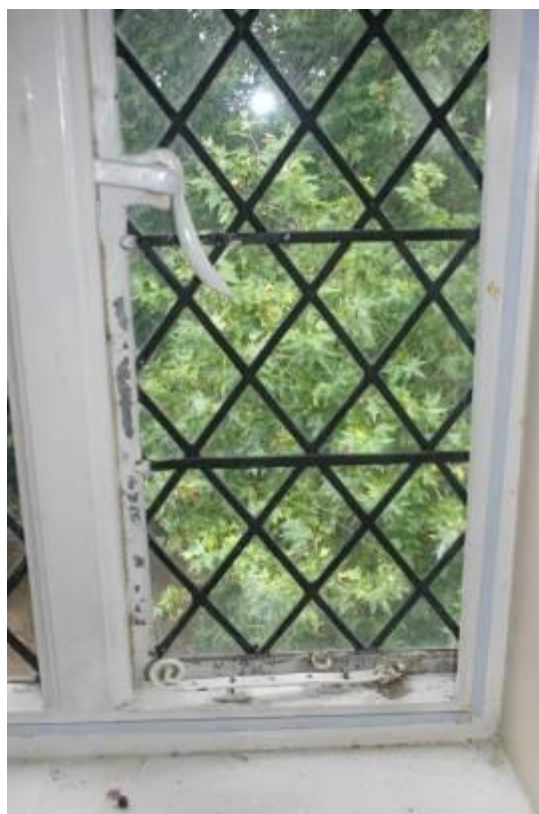
There is a dormer window on the east elevation. This has two lights with leaded windows set in a wooden frame. The northern light frame does not open and is divided by a vertical bar to which the leading is wired at intervals. The southern light opens. The latch could late 17th or early 18th century. The stay is fairly modern. There is a ring on the bottom of the window for a stay-hook which is now missing.

Figure 73. Above and left. The window in room 17.

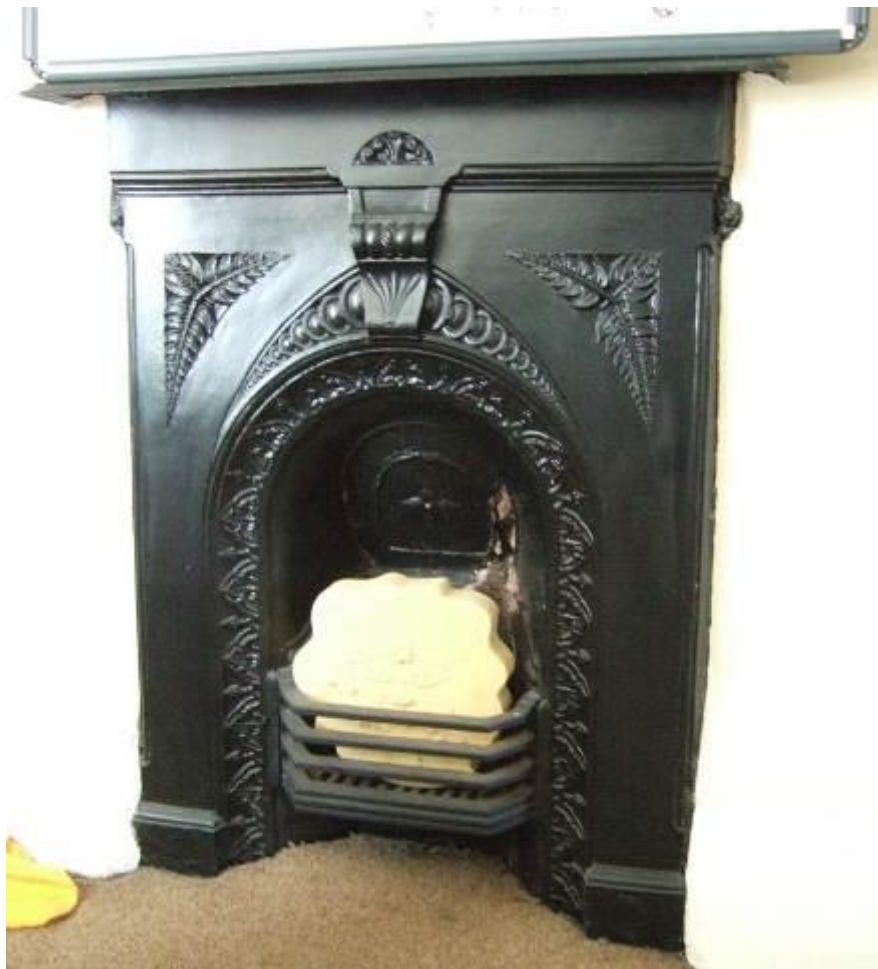
The western side has had a wide dormer inserted. This is lit by one window which is in the south wall and is off centre to the east. This is a wooden casement window with twelve panes of glass. The latch is somewhat similar to the one in room 21 and may have been reused. The stays are fairly modern. There is a chimney stack against the west wall with a very fine cast iron hearth.

Figure 75. Fireplace on the west side of attic room 18.

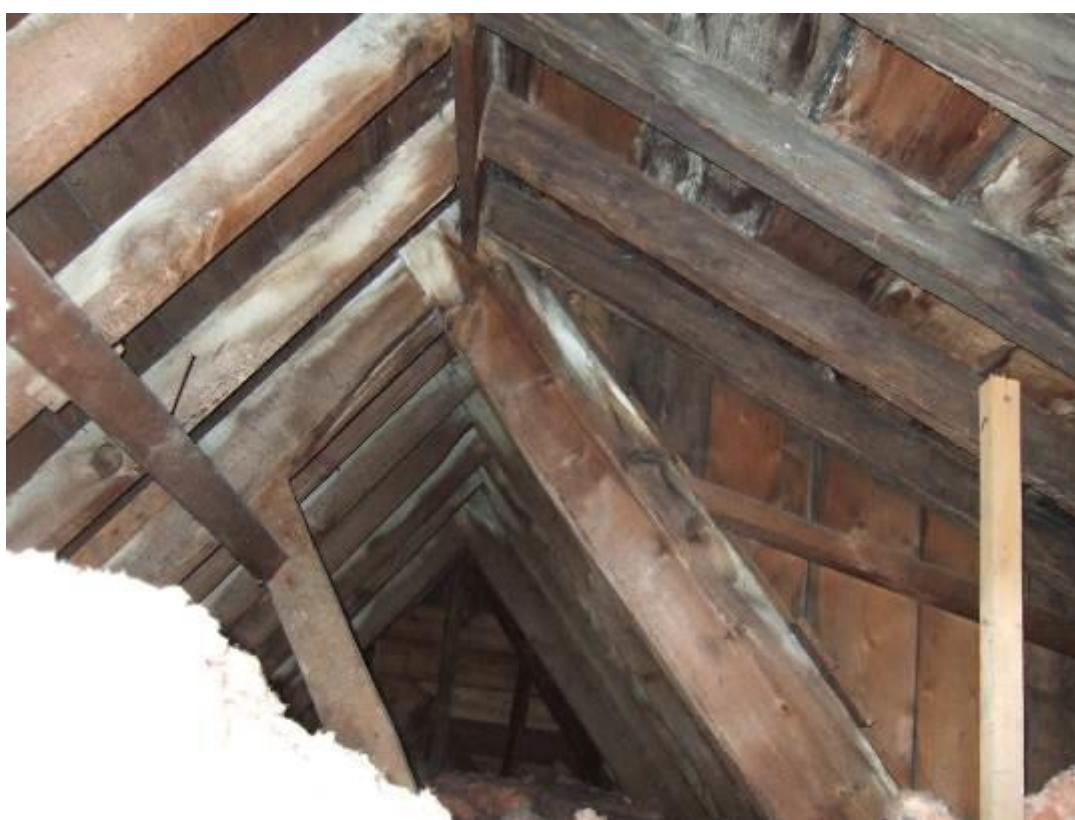
Figure 82. The roof seen through a trap door in the western half of attic rooms 18 looking east. The vertical boards to the right form the eastern side of the dormer. They may rest on a principle rafter.

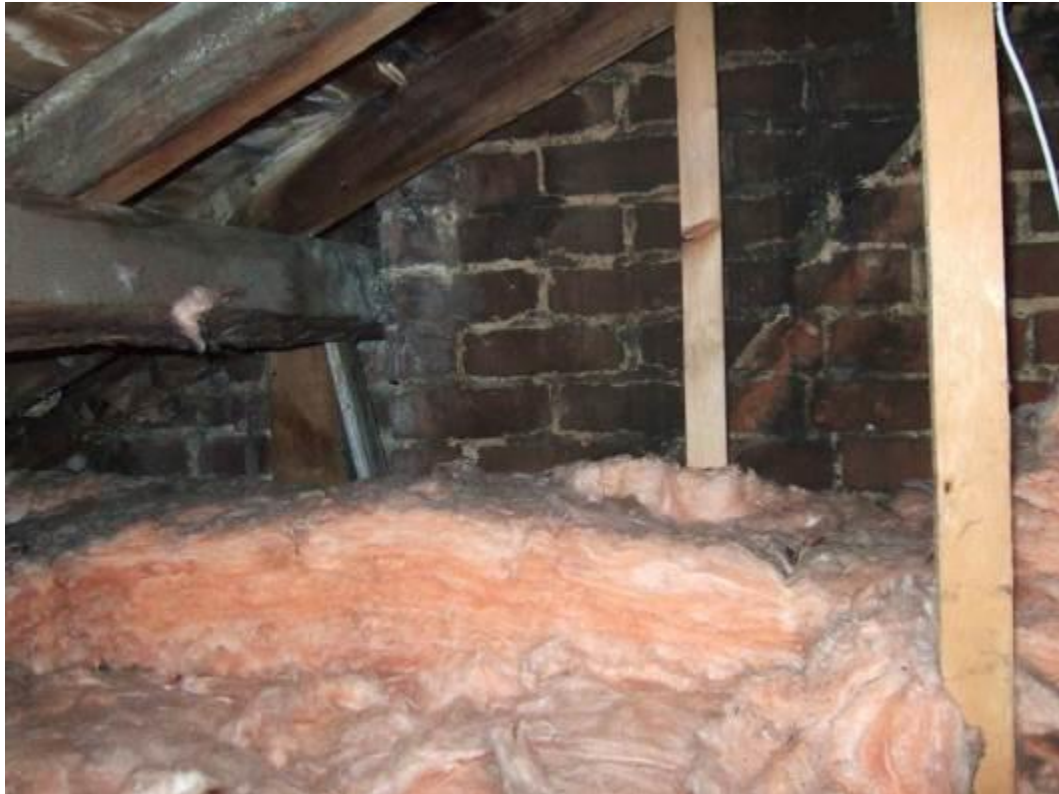
Figure 83. The western end of the south roof . The diagonal line on the brickwork of the chimneystack marks the original roof slope. The roof of the dormer can be seen top left resting on a reused timber.

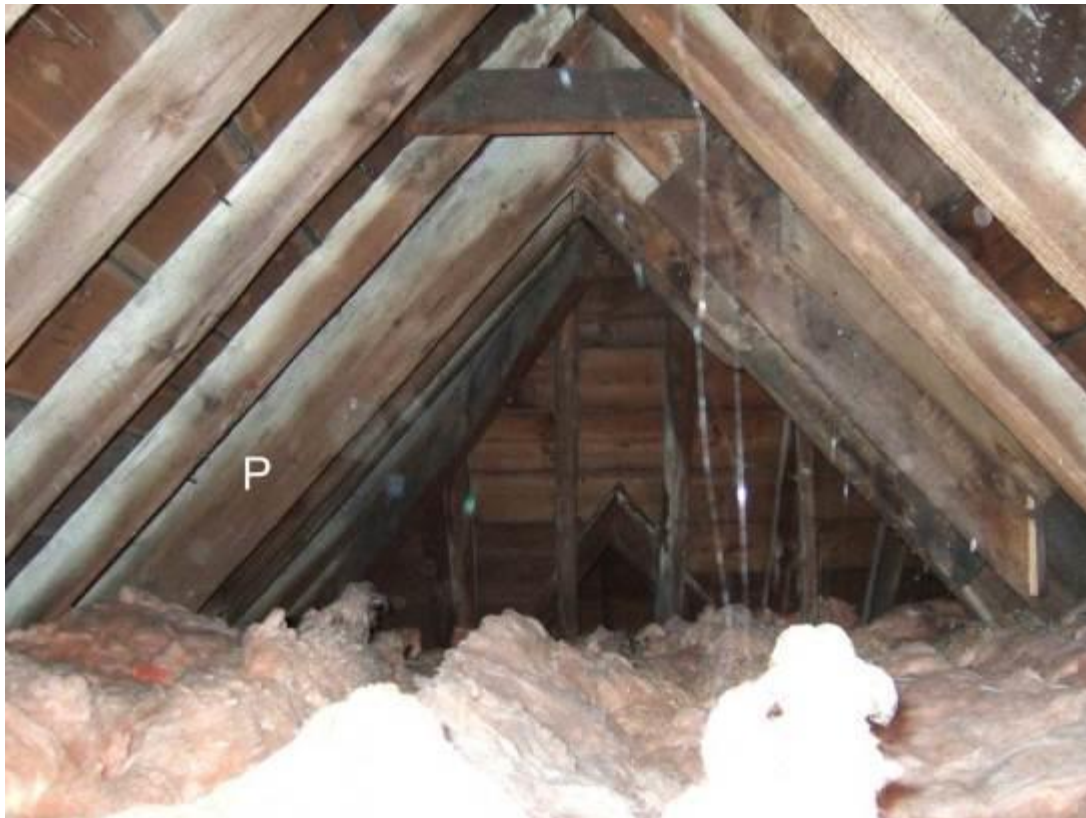
Figure 84. Looking east in the north side of the roof. The timber marked P is probably a principle rafter. The east slope of the roof can be seen in the background.

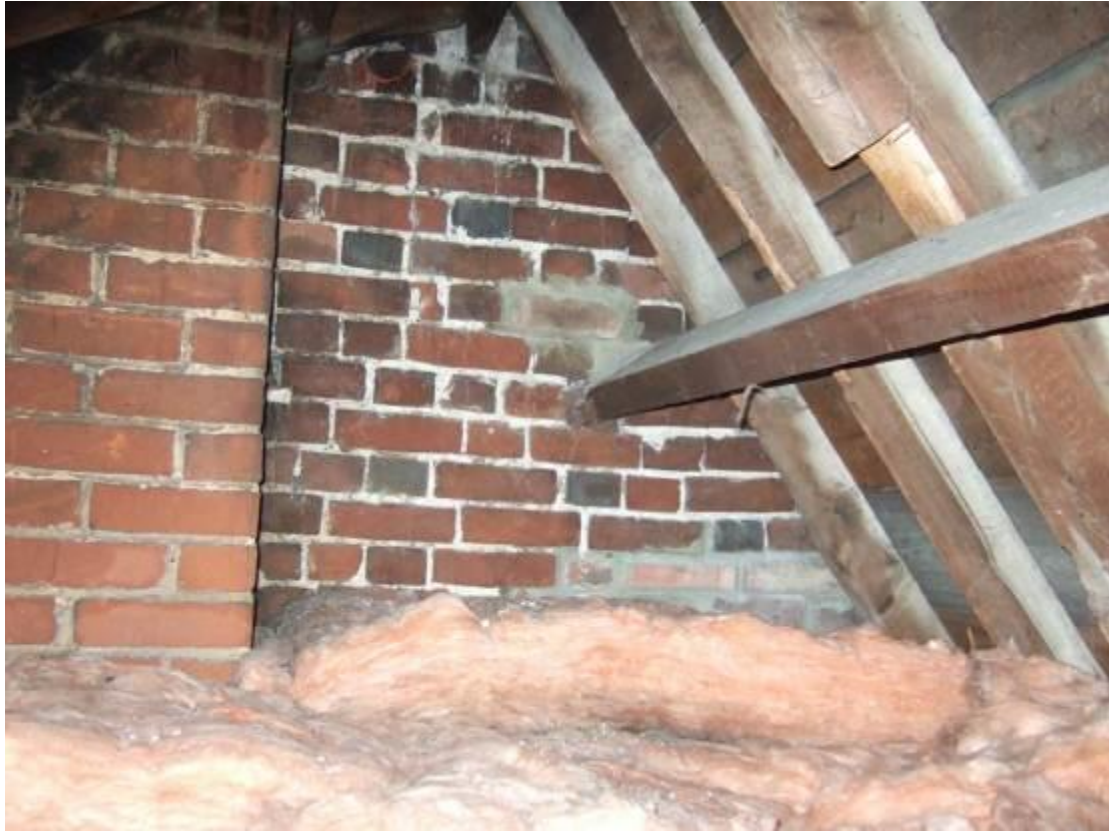
Figure 85. The inside of the gable at the west end of the north roof. The large slot cut in the principle rafter must have held a larger original purlin. This does not seem to have been fixed into the brickwork and may have been supported by a brace running down to the tie-beam.

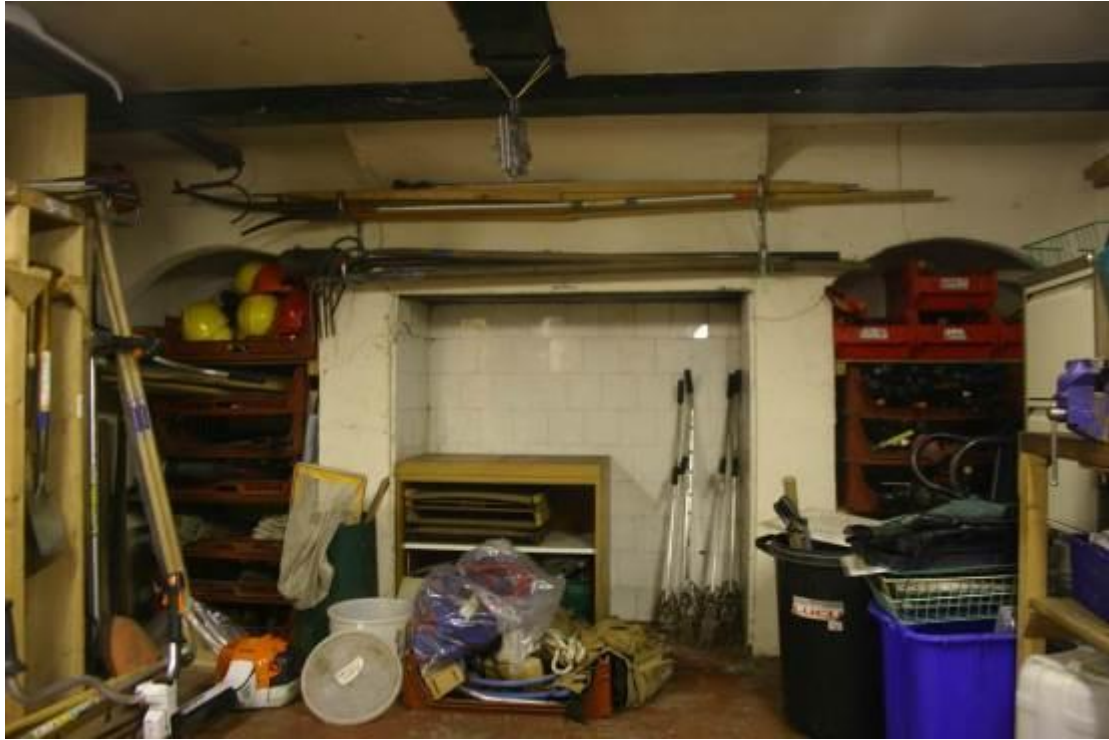
Figure 90. The fireplace on the west wall of cellar 23. The tiles suggest that it had been adapted for a cooking range.

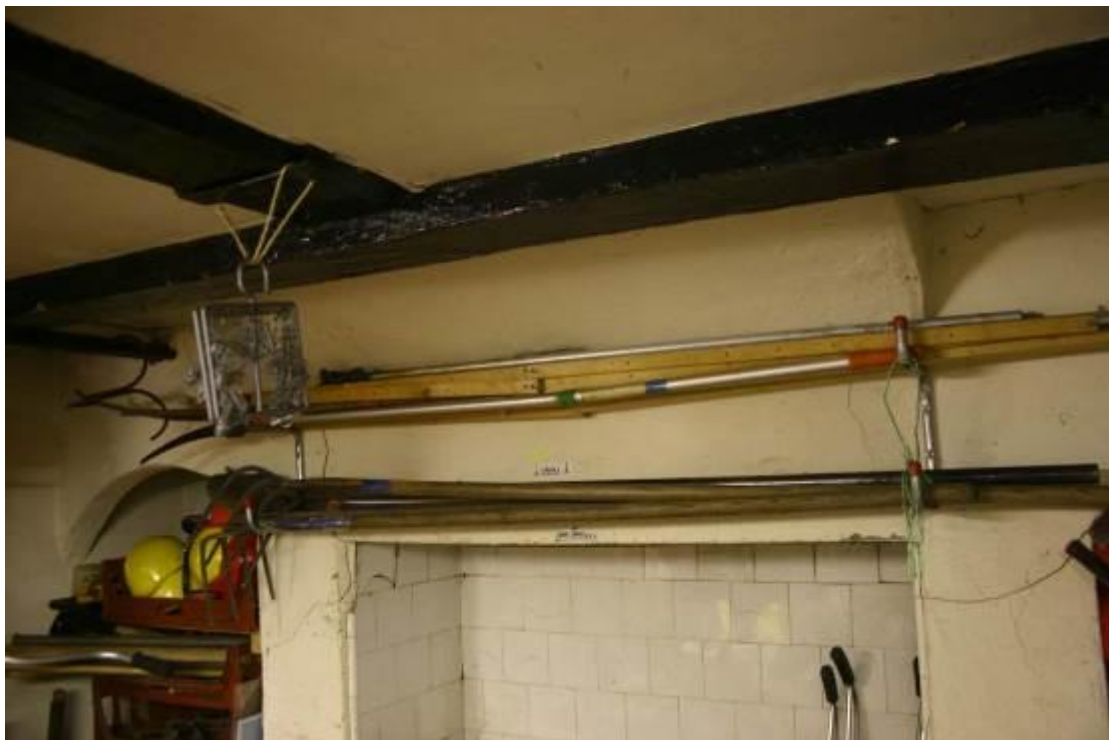
Figure 91. The bridging joist and cross beam on the west side of cellar 23.

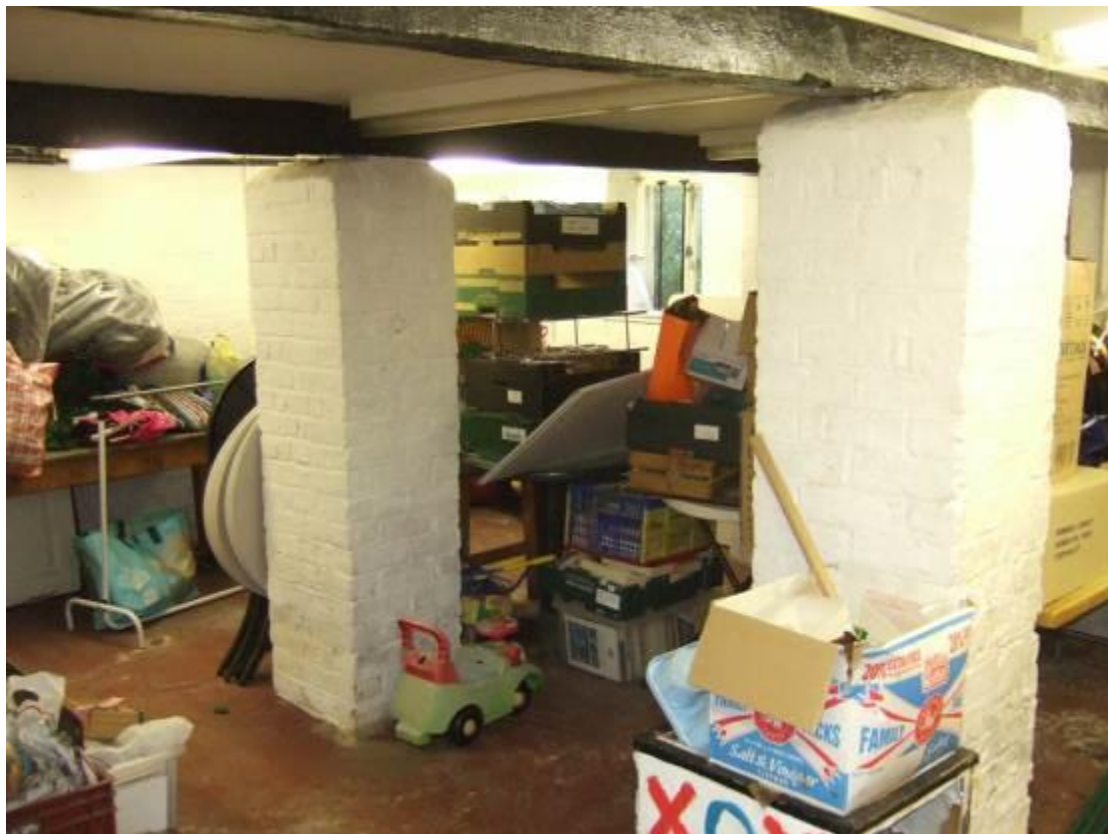
In March 1989 the late Doug Cluett invited me to look at a well which **has** been found beneath the floor of this cellar.

The well had an internal diameter of 1.22m. The shaft was lined with rather poorly laid brick. It had a depth of 0.12m and rested on 6cm of wood which in turn rested on sand and gravel. The total depth was about 1.22m. In some places the brick was missing from the sides lining was one brick width thick and that it was backed by vertical wooden planks. One plank was 14cm wide and no more than 1cm thick, The ground behind the plank was orange sand with patches of lighter sand and pieces of chalk and flint.

Figure 93. Cellar 26 looking southwest.
