The Leoni Bridge and Lower Town Pond; a short report

Andrew C Skelton

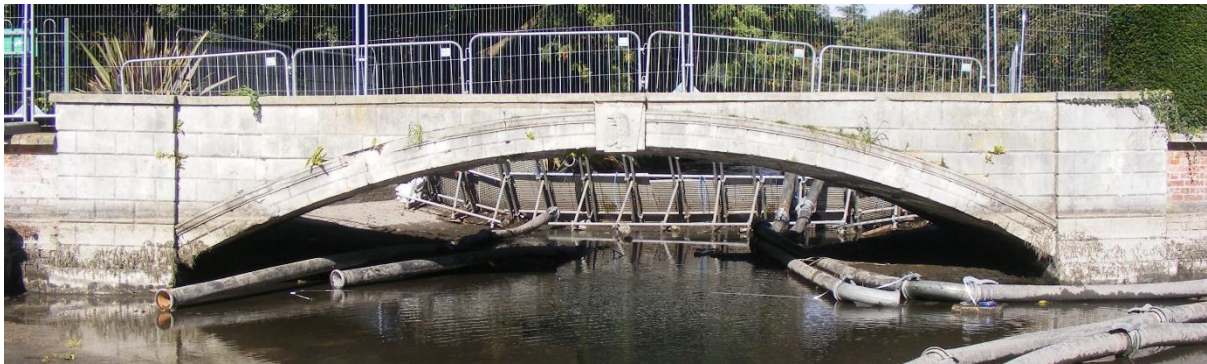
Fig 1 – The Leoni Bridge, south elevation from the Lower Town Pond bed.

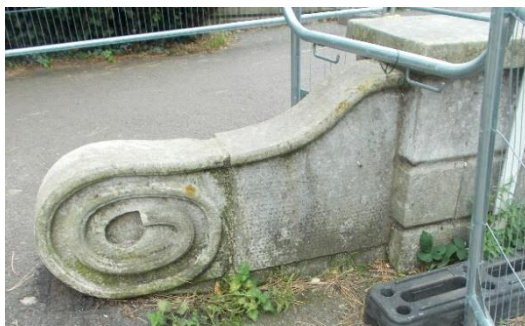
Fig 2 – north elevation, eastern volute

The ashlar courses, with a deep ‘V’ cut rustication, extend to seven courses in number, the uppermost course being deeper than the rest. On the north (canal) side, the parapet structure is c.11.60m long, extended to c.13.90m with the attached elongated volutes, with pitted surfaces, to east and west (fig 2). The central part of the volute is missing.

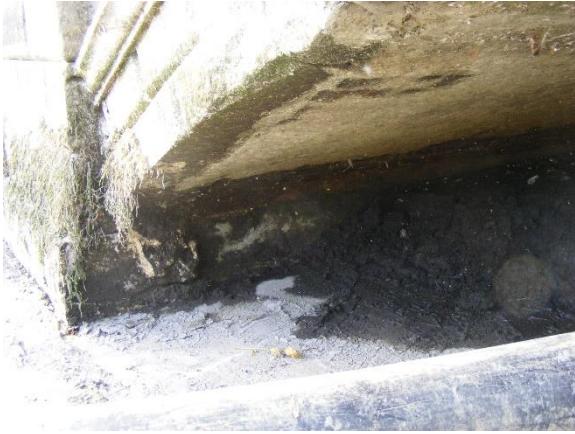
The brick arch vault springs from shallow but wide Portland stone plinths which form the lowest, deepest course of the bridge abutments, clearly visible under the arch and extending west and east (fig 3). These plinths are offset only to the south and north where they slightly break forward from the bridge elevations; and to the east of the east of abutment, etc); it is likely that the abutments built on them (which continue the break upwards through the elevation), are also of brick faced with stone.

Fig 3 – the Portland stone base of the western abutment, and the springing of the brick vault.

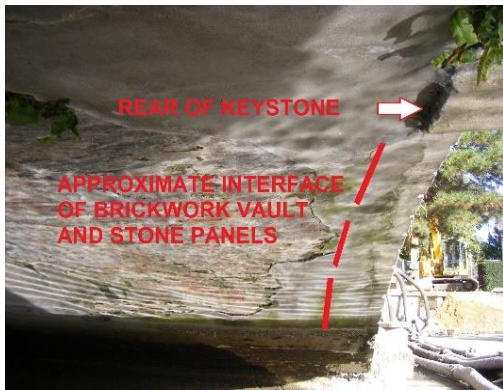
The soffit of the brick arch is mostly covered with a thin cement scree, much eroded in the centre but surviving virtually intact near the elevations. Where it has eroded, the rusticated ashlar elevations are about 120-150mm deep, through-bonded into the brickwork of the vault (fig 4). Close inspection of the surfaces indicate that the stone elevations above the ornamentation of the arch are comprised of variable sized, geometrically cut, stone panels displaying multiple whole or part rusticated ashlar blocks. This is shown on fig 5, where the functioning joints of the south face of the east abutment are outlined in red.

Fig 4 - the vault soffit, looking east.

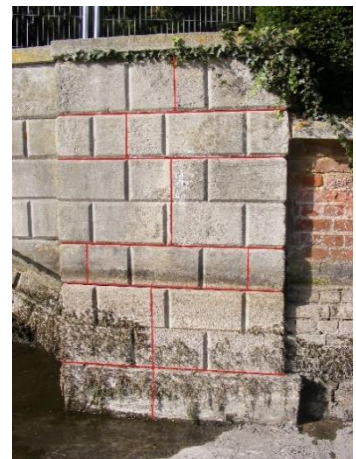
Fig 5 - the south elevation of the eastern bridge abutment, stone panels jointing.

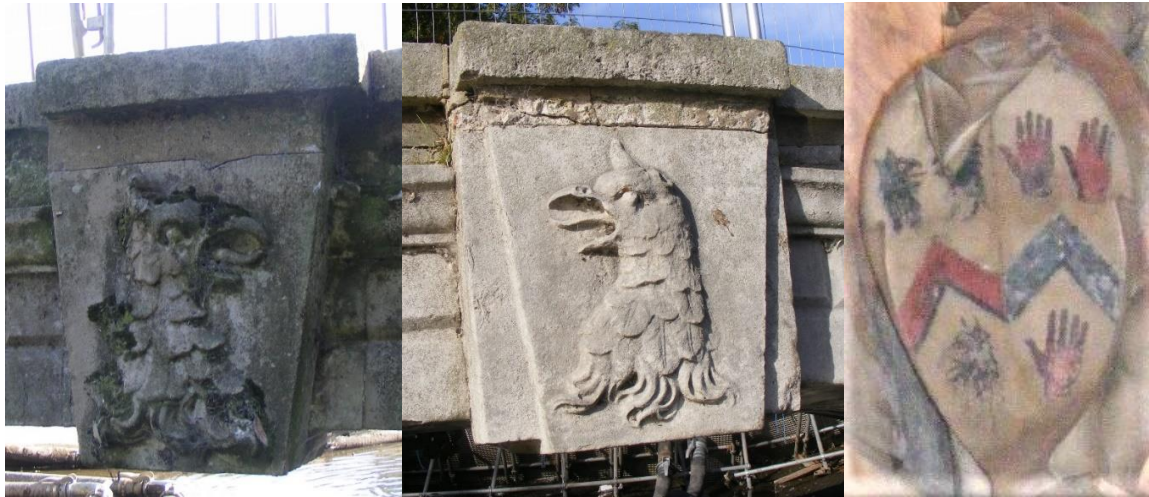
Fig 6 and 7 (left and centre); The north and south facing keystones. Note the thick band of mortar between the top of each stone and the coping above. Fig 8 (right) – The Scawen arms impaled with those of the family of Dame Mary Scawen *nee* Maynard, from her monument in All Saints Parish Church, Carshalton, c.1700.

The parapet is capped with a plain coping course, but this has been reset on a concrete/mortar base which is deepest over the keystone (figs 6 and 7). Views of the façade from the pond floor confirm that the vaulted span has almost imperceptibly sagged between the abutments, necessitating at some point the relevening of the coping, not expertly done (figs 1). This appears to have been executed before 1974, perhaps as early as the 1920s and 30s (based on historical photographic evidence; Sutton Local Studies, SBC 712 and 91, ‘Grove’). The copings over the eastern abutments have the remains of a matching iron spigot set in their far south- and north-west corners, while central to the keystone copings is a similar iron spigot set in lead, perhaps to secure small decorative statuary.

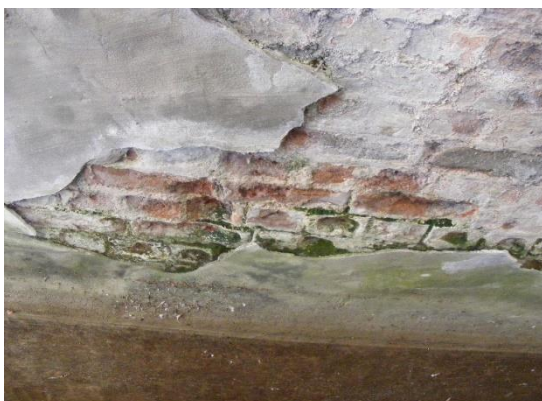
Fig 10 – the vault soffit, showing the degraded concrete scree and brickwork.

The writer noted that the cement coating of the soffit of the arch vault has exfoliated in places, leaving large areas exposed, especially in the centre. The vault brickwork appeared generally good, although there were one or two patches where individual bricks have eroded to a depth of 5mm or so (fig 10). The historic sagging of the vault has already been mentioned. The rusticated stone facing in the elevations also appears in general sound, although one panel on the north-facing elevation (west side) has slightly come away from the backing brickwork

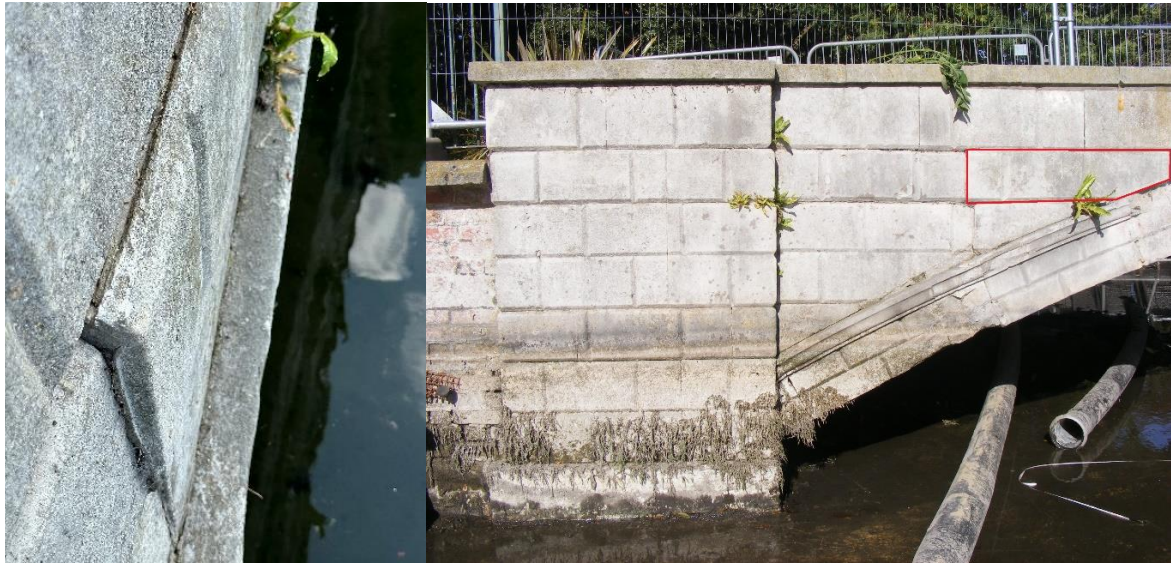
Figs 11 and 12 – spalled stone panels on the north and south elevations

(fig 11), as with one panel on the south (also west side, indicated on fig 12). Despite this, the masonry appears solid but could deteriorate with the ingress of percolating water/ice. Elsewhere, a few stone panels have been defaced and details lost, including sections of the arch moulding and rustication (figs 13, 14 and 15). Most of the joints appear clean, with only a little vegetation growing within degraded mortar joints. Finally, it should be noted that the northern elevation is ‘dirtier’ than that to the south.

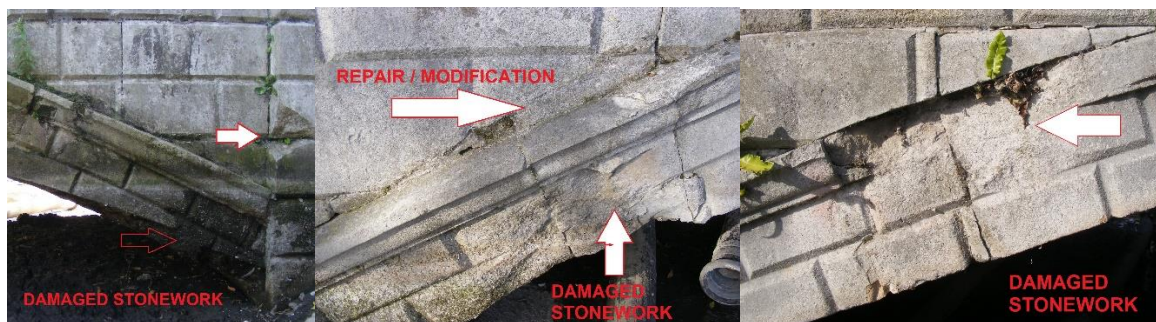
Examples of damage to the elevations - Fig 13 (left) North elevation, west side; figs 14 and 15 (centre and right) South elevation, west side.

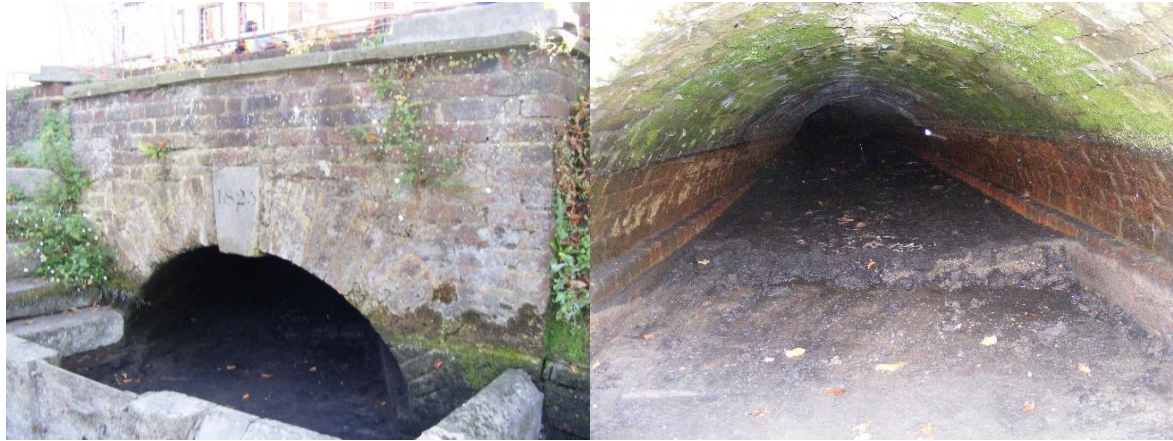
The Hog Pit culvert arch, situated in the south-east corner of the pond, is the outfall of the culvert from the Hog Pit pond in Carshalton Park (fig 16. **A**). It has a datestone of 1823, which comes within the ownership of the Pond by Joshua Ryle of the Grove. Ryle (died 1828) appears to have refurbished parts of his Grove estate before he built his house in the late 1820s; a boundary stone inscribed 'JR 1826' survived into the early 20th century. The Hog Pit arch brickwork appears contemporary, although the upper parts and coping are a rebuilding (fig 17). The culvert is segmental in section (fig 18).

Fig 17 and 18; Lower Town Pond, south east corner, the Hog Pit arch (1823).

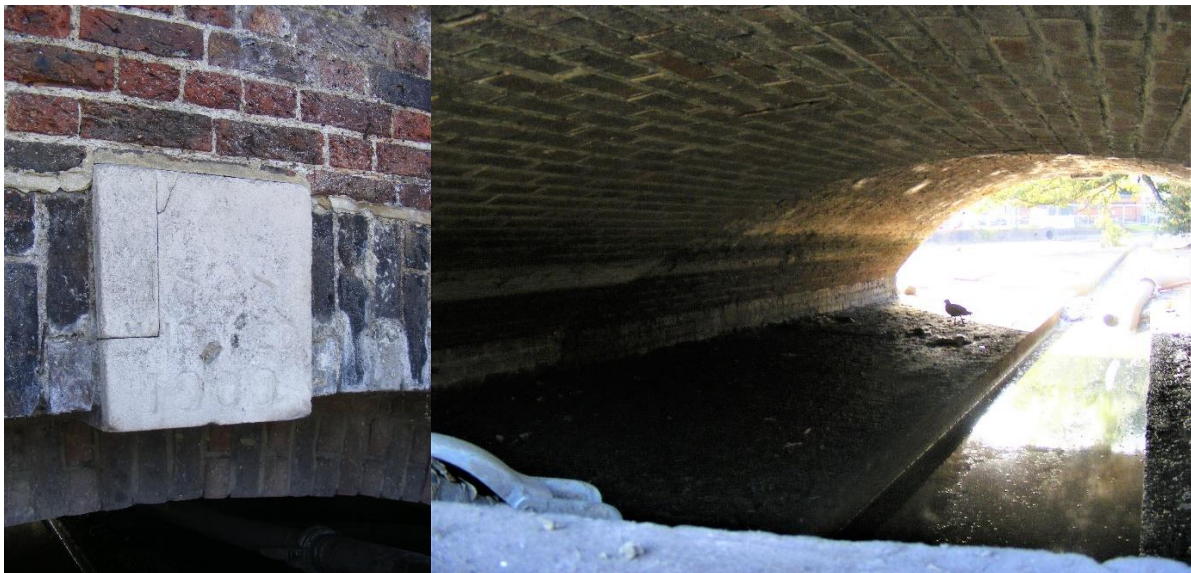
The North Street Bridge (fig 16, **B**) has a datestone of 1828, and has a later inscription added on completion of the bridge widening in 1909 (fig 19). The view of the vault shows the bridge extension on the Upper Town Pond side, away from the camera (fig 20).

Figs 19 and 20; Lower Town Pond, North Road Bridge datestone (1828/1909) and vault soffit.

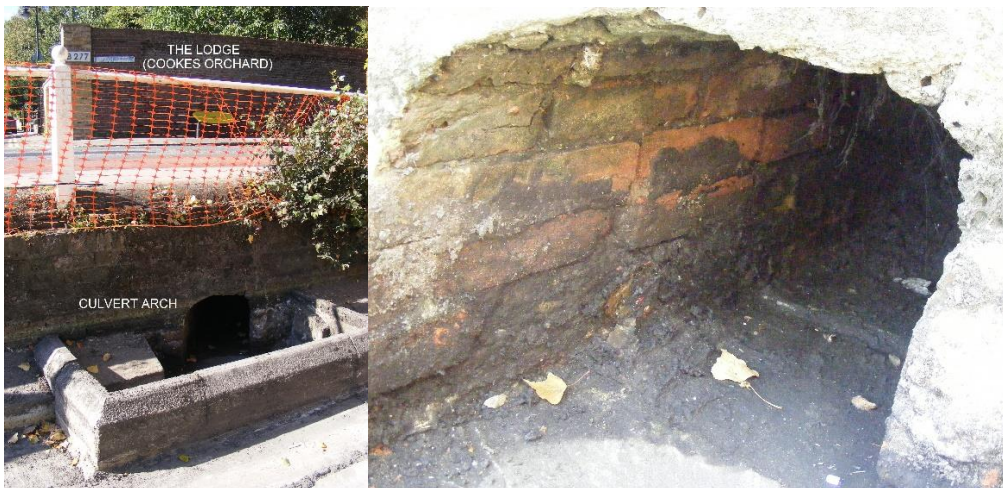
The second feature is an arched outfall in the pond west wall for a culvert running diagonally west of north-west from it under North Street towards the corner of the Lodge Lands – formerly Cookes Orchard, the kitchen garden to Stone Court until 1785. This drained a short canal and bathing place which lay along the southern boundary of the Lodge estate, shown on plans from the later 18th century (fig 16, **F** and **G**). The canal has been cut in half by the War Memorial Garden, and the surviving eastern half with the bathing place was filled in (figs 22-23).

Figs 22 and 23 – Lower Town Pond, arch and culvert from the Lodge Lands
