# The structural history of Sutton Lodge, Brighton Road, Sutton

| Address | Sutton Lodge, 139 Brighton Road, Sutton SM2 5SW |
| Author | John Phillips |
| Date surveyed | 29 April and 3 November 2010 |

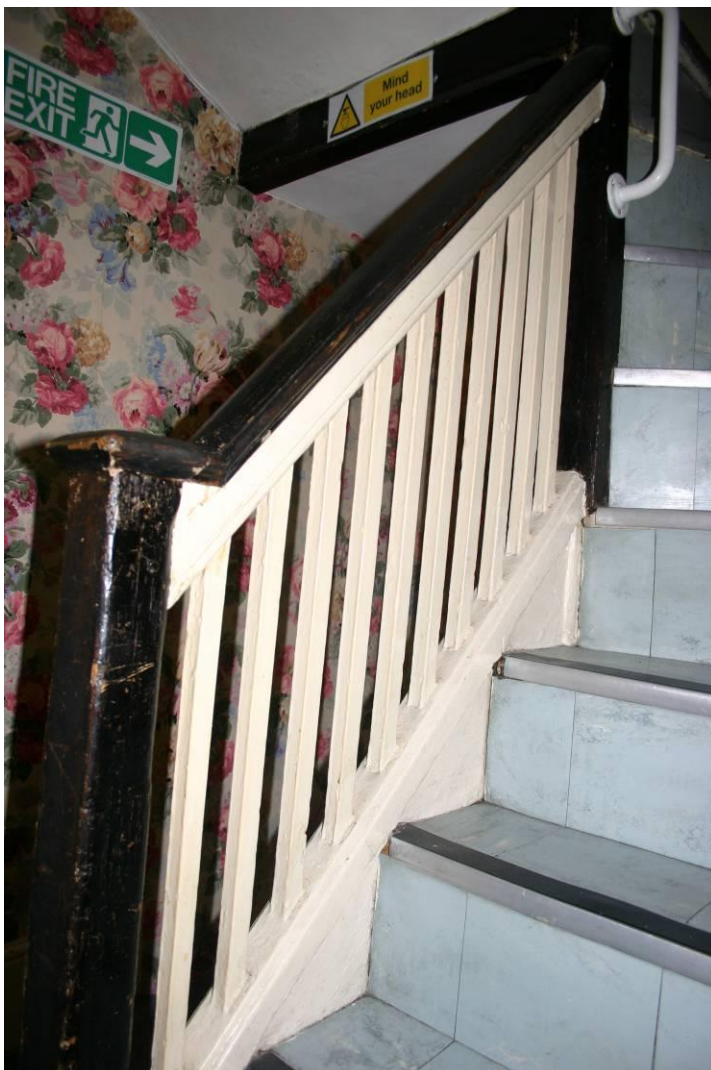
The front door opens in to a room on the south side of the central block. A staircase in a vaguely Jacobean style rises from this to the first floor (figure 11).

Figure 11. The staircase from the ground floor.

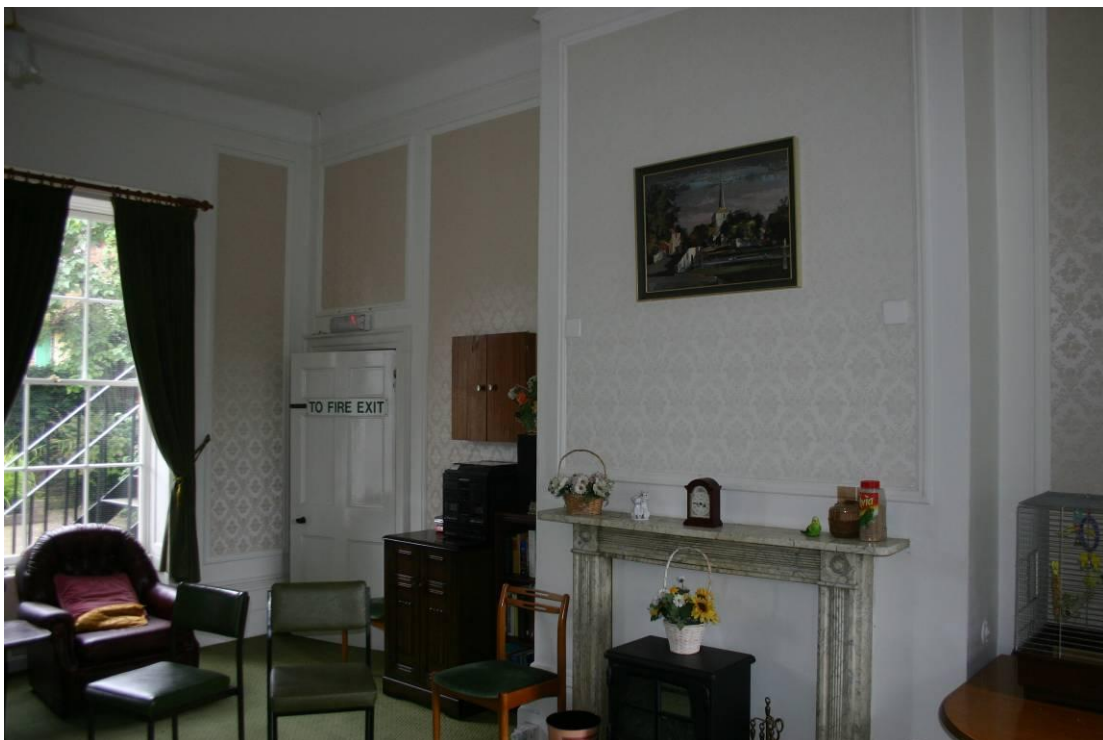
The north wing contains one large room. The floor level is above that of the main block to which the room is connected by two doors, one at the east end and one at the west. The doors are divided into six panels with two small ones at the top, similar to each other, and to the front door (figures 15 and 16).

Figure 15. Door between the north wing and the central block.
