The Greenhouse in detail

The greenhouse was built against the east end of the north boundary wall. It has been demolished but much of the floor and some other features remain. The Ordnance Survey maps suggest that it was constructed between 1896 and 1913.

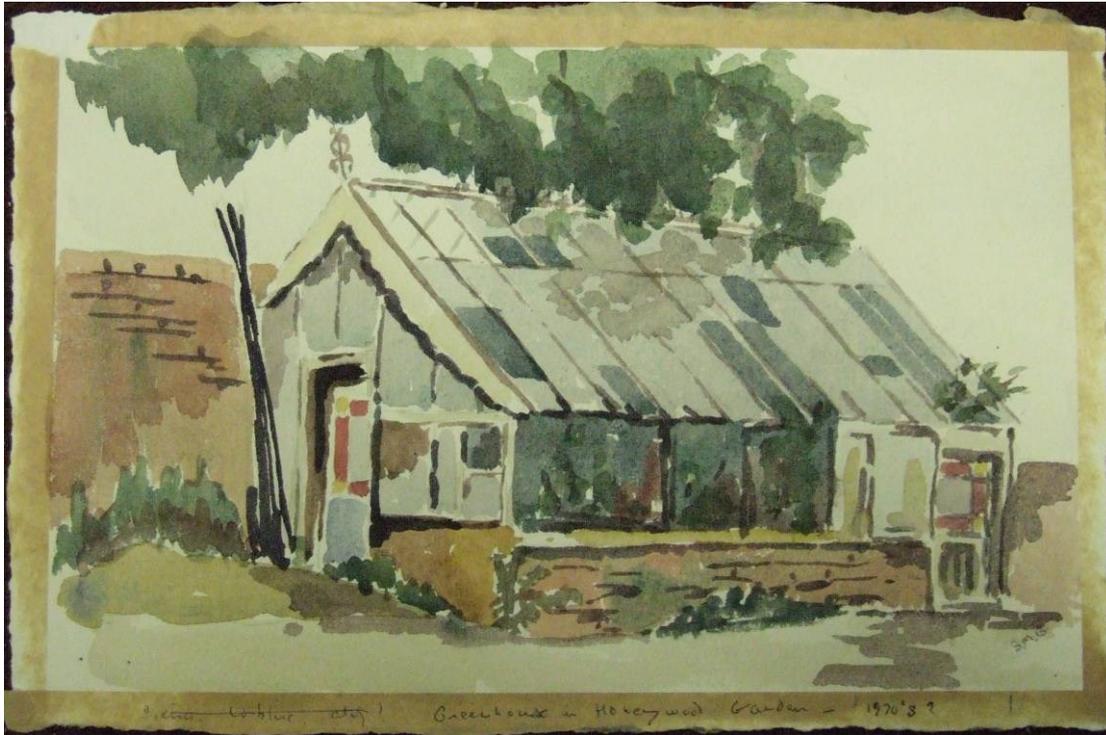
A painting by Stephanie Batstone dating from the 1970s (figure 1) shows a three-quarter span roof with the short side resting against the north wall.

The sloping top of the east wall does not accord with the roof shown in the Batstone watercolour and the high part of the north boundary wall extends beyond the greenhouse foundations. These features probably relate to earlier structures on the site, probably the buildings shown on the maps of 1847 and 1868. It is not clear whether these were greenhouses or sheds although an inventory of the landlord's fixtures in Wandle Cottage in 1869 included a greenhouse containing 'a 5 Tier Flower Stage returned [?] railed stage in front of house 2 shelves each on 4 Brackets 2 shelves on 5 brackets'.¹

Figure 1. Watercolour by Stephanie Batstone showing the greenhouse in the 1970s.

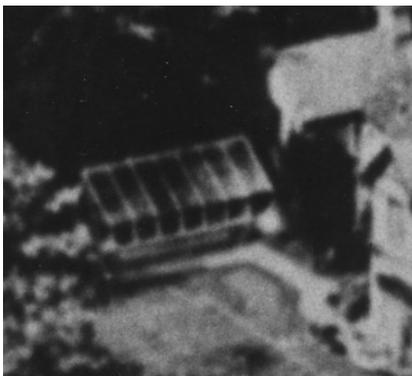
An air-photo taken in 1921 (figure 2) shows the south wall and roof divided into seven sections by evenly spaced glazing bars.

Figure 2. The greenhouse from an air-photo dated 1921.
