The rectangular pond in detail

The rectangular pond in the northeast corner of the garden is about 7.5m north – south 2.34m east – west.

The pond was cleared and studied in an archaeological investigation in the summer of 2010.¹

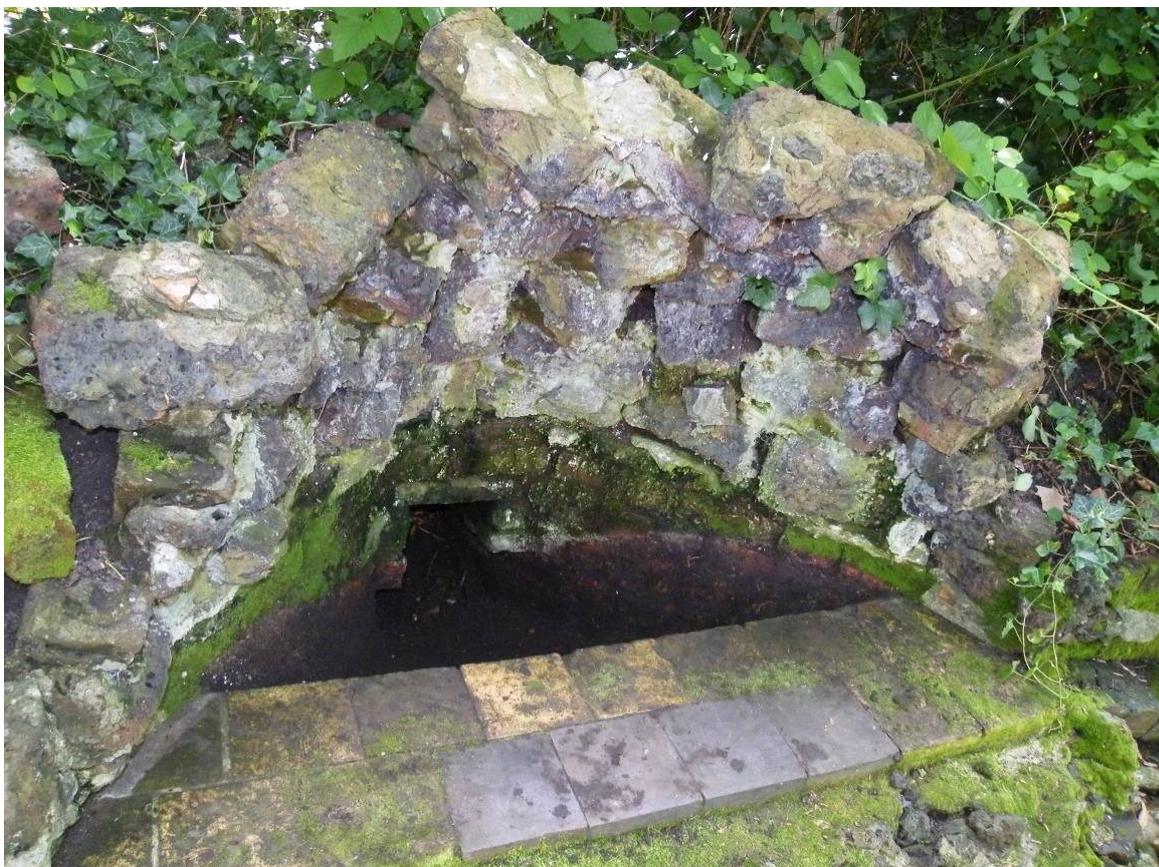
The sloping cascade consists of flint, shell and other decorative materials joined with Portland cement. The foot of the structure has been broken or eroded by seeping water exposing a core of dark earth which contained a piece of electric flex suggesting that it is of no great antiquity. The core is similar to the soil overlying the lower part of the cascade prior to clearance.

Figure 16. The grotto and cascade. Note the electric wire protruding from the bottom left hand side of the cascade.

The foot of the cascade has been broken or eroded by seeping water exposing a core of dark earth which contained a piece of electric flex suggesting that it is of no great antiquity. It was not part of the 1990 garden work as there is a photo taken at the time showing pond with the lower part of the cascade covered with newly laid or newly cleared soil (figure** 44). A second photo shows Sandra Willis, the parks service landscape architect, standing by the south end of the pond before it was cleared (figure 19). The floor was covered with ivy and other weeds but there appears to have been a substantial amount of soil in the bottom. Sandra Willis planned to turn the pond into a bog garden and she may have had additional soil laid. This is consistent with the stratigraphy found in the 2010 excavation. This showed that the south side of the cascade overlay a deposit of dark soil and rubble. Similar soil also overlaid the lower part of the cascade. There must, therefore, have been two deposition episodes, one before the cascade was constructed and one after. There two deposits were, however, very similar and could not be clearly distinguished in the excavation. Both contained recent finds. If the cascade was not built by Sandra Willis in 1990 it must be the result of some other fairly recent episode. The obvious candidate was a Manpower Services Commission job creation project which restored various features along the Carshalton Wandle in 1983-4. The weirs of Margaret's Pool and the Wandle Lodge pond immediately behind Honeywood were rebuilt at this time but I have not found any evidence for work in the garden at Honeywood. It is however, likely.⁴

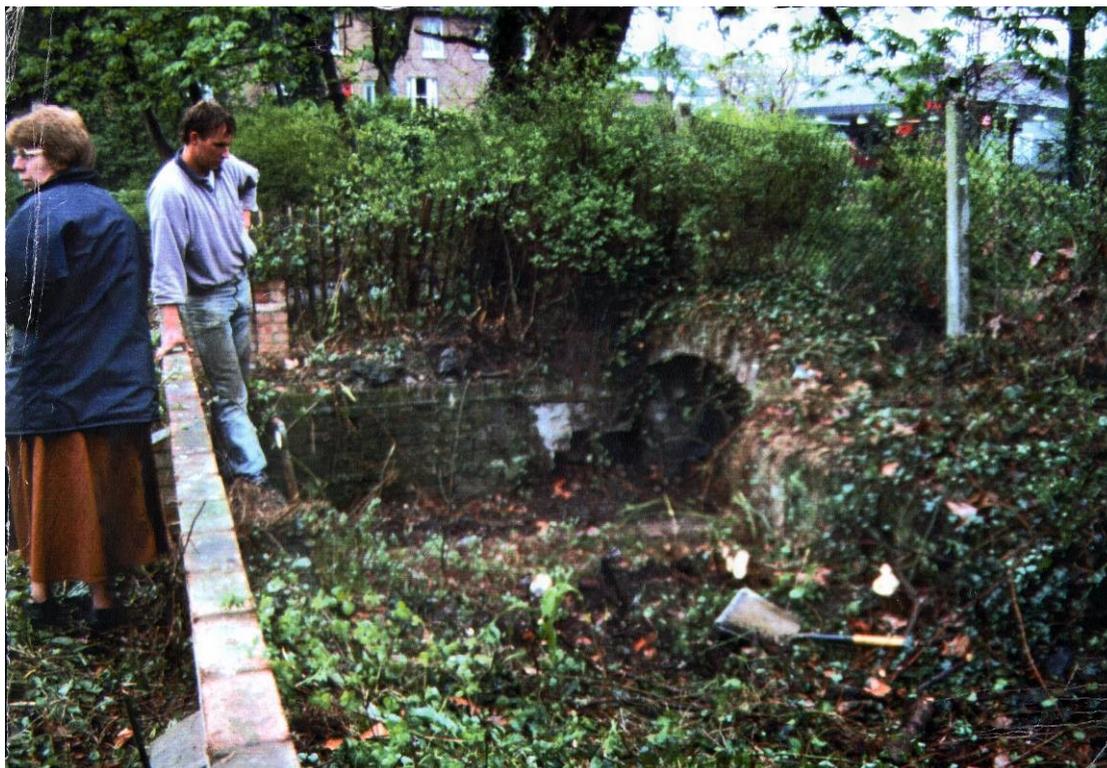
Figure 17. The grotto base on 10 August 2012.

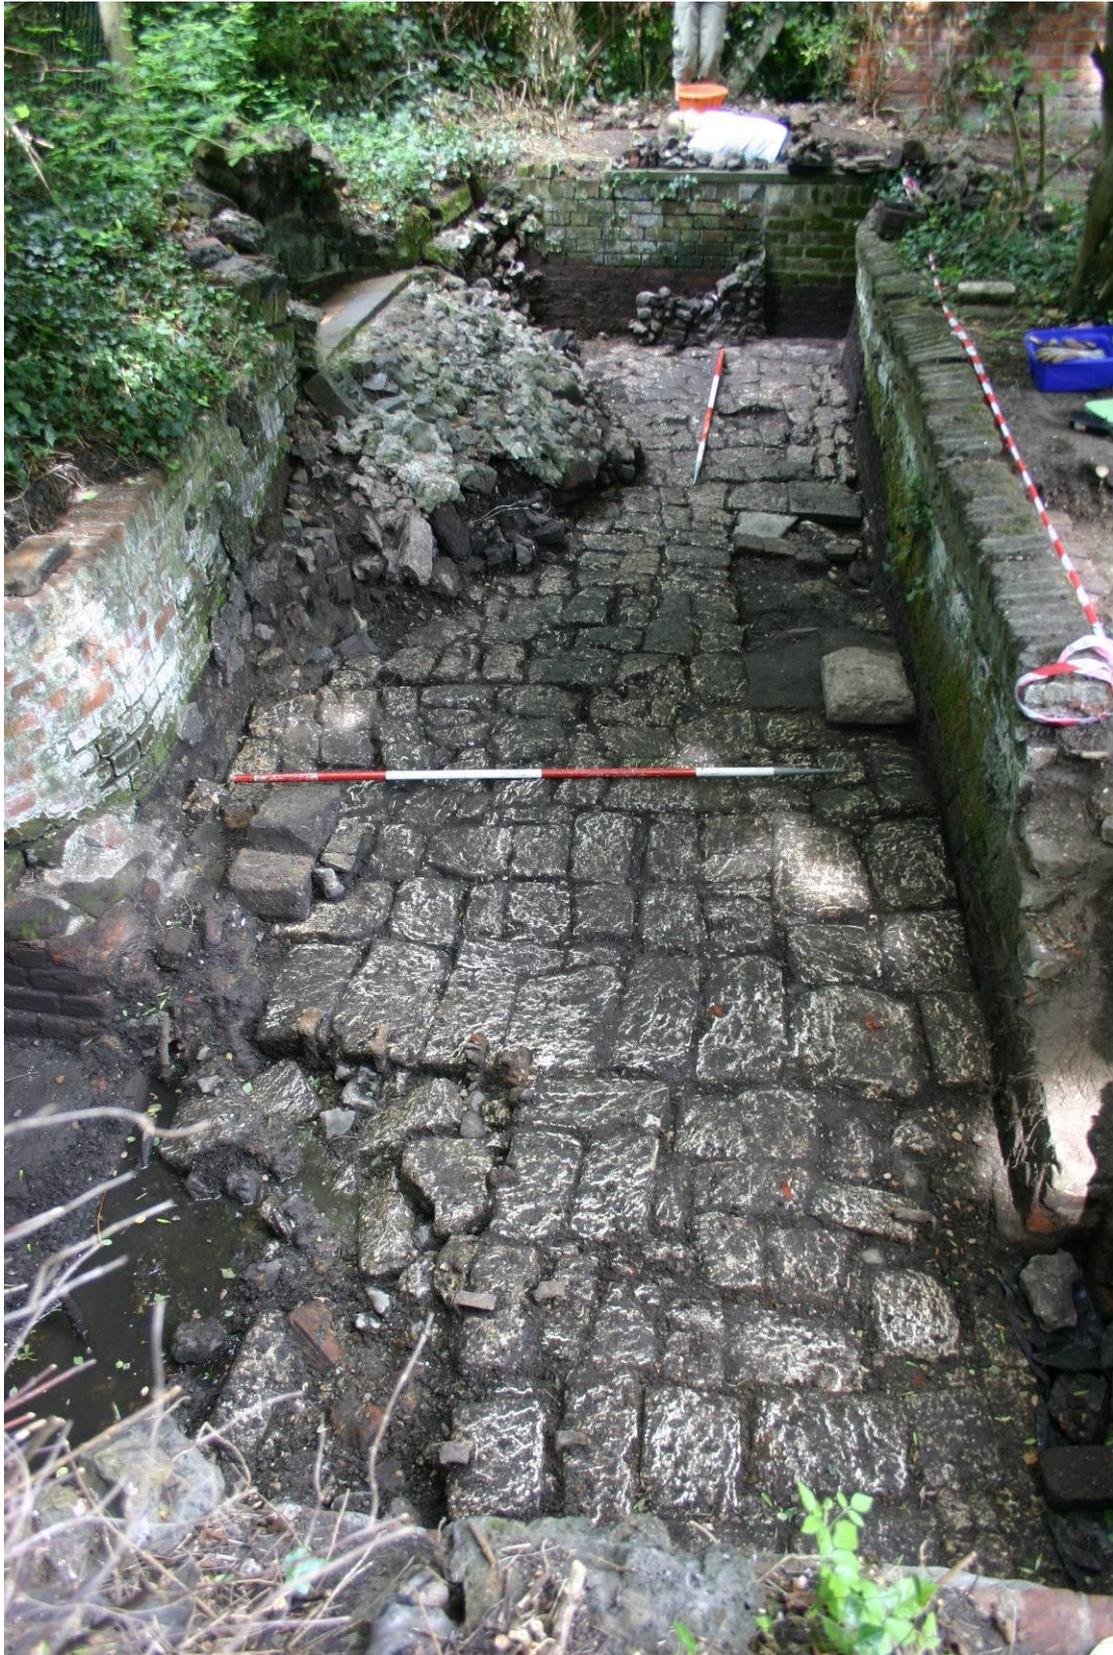
The pond floor was covered with a thick layer of earth contained many very recent finds. This was cleared in 2010 exposing a floor of large chalk blocks of variable character. A line of large blocks carries the line of the entrance channel across the pond (figure 20). To the north of this the blocks gradually become smaller and less well arranged those at the north end being particularly small and irregular. There are several gaps in this area either where the chalk blocks are missing and there is dark soil over gravel or they have been replaced by other materials. The area where the stream crosses falls into two parts. At the west end below the weir the blocks are missing or displaced and a hollow has been washed in the underlying gravel. This is clearly a plunge pool eroded by the water falling over the sluice. The blocks survive at the eastern end. A series of iron pins have been installed along the upstream edge of the surviving blocks to keep them in place. In some places the grotto cascade can be seen to cover the chalk blocks.

Figure 20. The pond floor showing the materials used.

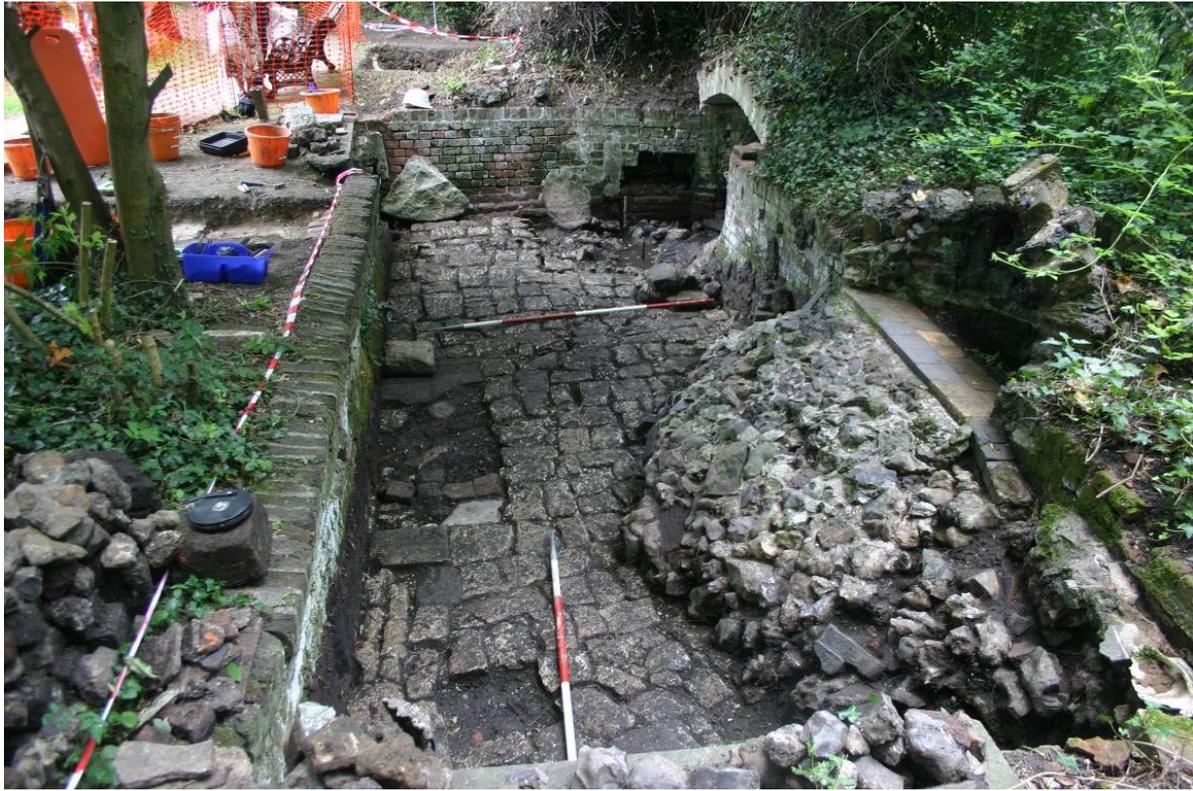
The west wall of the rectangular pond is of brick. Towards the north end there is a little grotto-like niche above a small sloping cascade. The south end of the wall curves around to form the north wall of the channel which brings water into the pond. The curved section runs across the broken stub of an earlier wall which appears to have run along the east side of the channel (figures 20, 21 and 23).

Figure 21. The pond floor looking north.
