Design for the excavation of a former outbuilding of Carew Manor Beddington by the Carshalton and District History and Archaeology Society.

| Site | Beddington Park |
| Revised | 13 April 2015 |

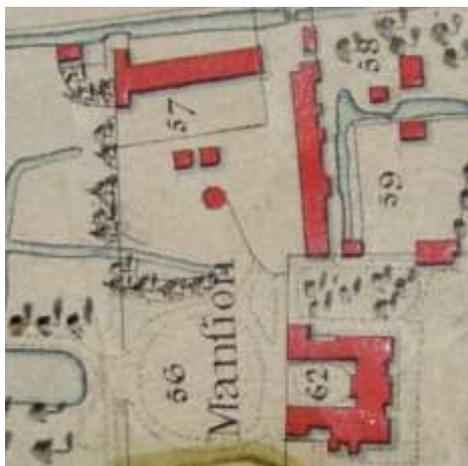
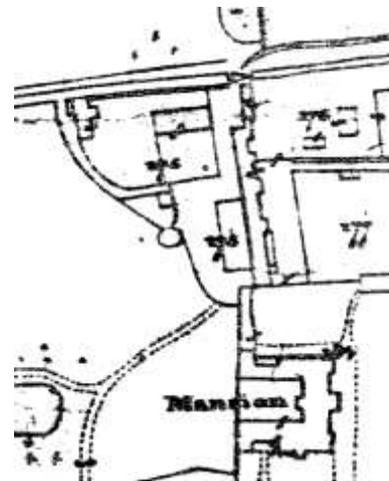
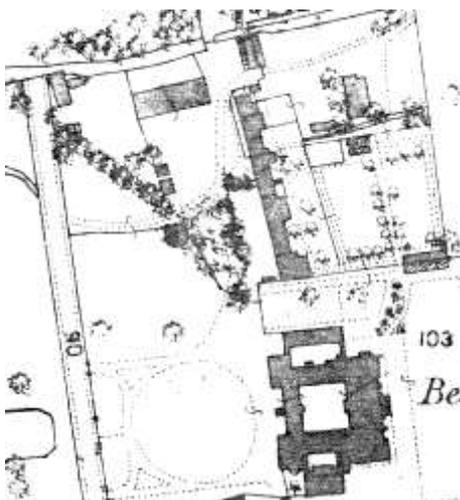
Figure 1. The outbuildings to the northwest of the house from the enclosure award map of 1820 (above left) and the tithe map of 1840 (above right) and the first 25 inch Ordnance Survey map of 1868 (left). Beddington Park Cottages are the long north-south aligned range. The suspected stable is shown on the 1820 map top centre. It had been partially demolished by 1840.

The enclosure award map of 1820 (Figure 1) shows a service court to the northeast of the house. This centred on the Dovecote which is still standing. There was a long range of building on the

We know very little about the range on the north side of the court. The maps suggest that in 1820 it had a length of about 64m and that the main part was about 12m wide. The cross-wing at the western end had an approximate length of 24m and a width of 6m. The western end of the building was demolished between 1820 and 1840 leaving the northern end of the cross wing.

The stabling, coach-houses and cottages were in the east side range which became Beddington Park Cottages. The carpenters shop and deal shed lay east of Beddington Park Cottages while the dovecote can be equated with the surviving structure. The 1868 Ordnance survey map shows a small range directly north of the Cottages which was probably the dog kennels. This leaves the farmyard with the barn, cow sheds and granaries unaccounted for and presumably in the north range.

The house and outbuildings were acquired by the Lambeth Female Orphanage Asylum in 1864. The remaining part of the northern range survived to be shown on the 1868 Ordnance Survey map. In 1874 the Orphanage carried out a series of repairs to the outbuildings. At that time 'the Committee directed that the old paling round the stable yard be cleared and that the roof of shed near the river at the northwest corner should be repaired'.⁵ In 1876 the outbuildings were sold to Canon Bridges and were incorporated in the park and subsequently let as a dairy farm.⁶ Bridges must have demolished the remaining part of the northern range as it is not shown on the 1896 Ordnance Survey map.
