Oaks excavation 2011 – initial summery of the results

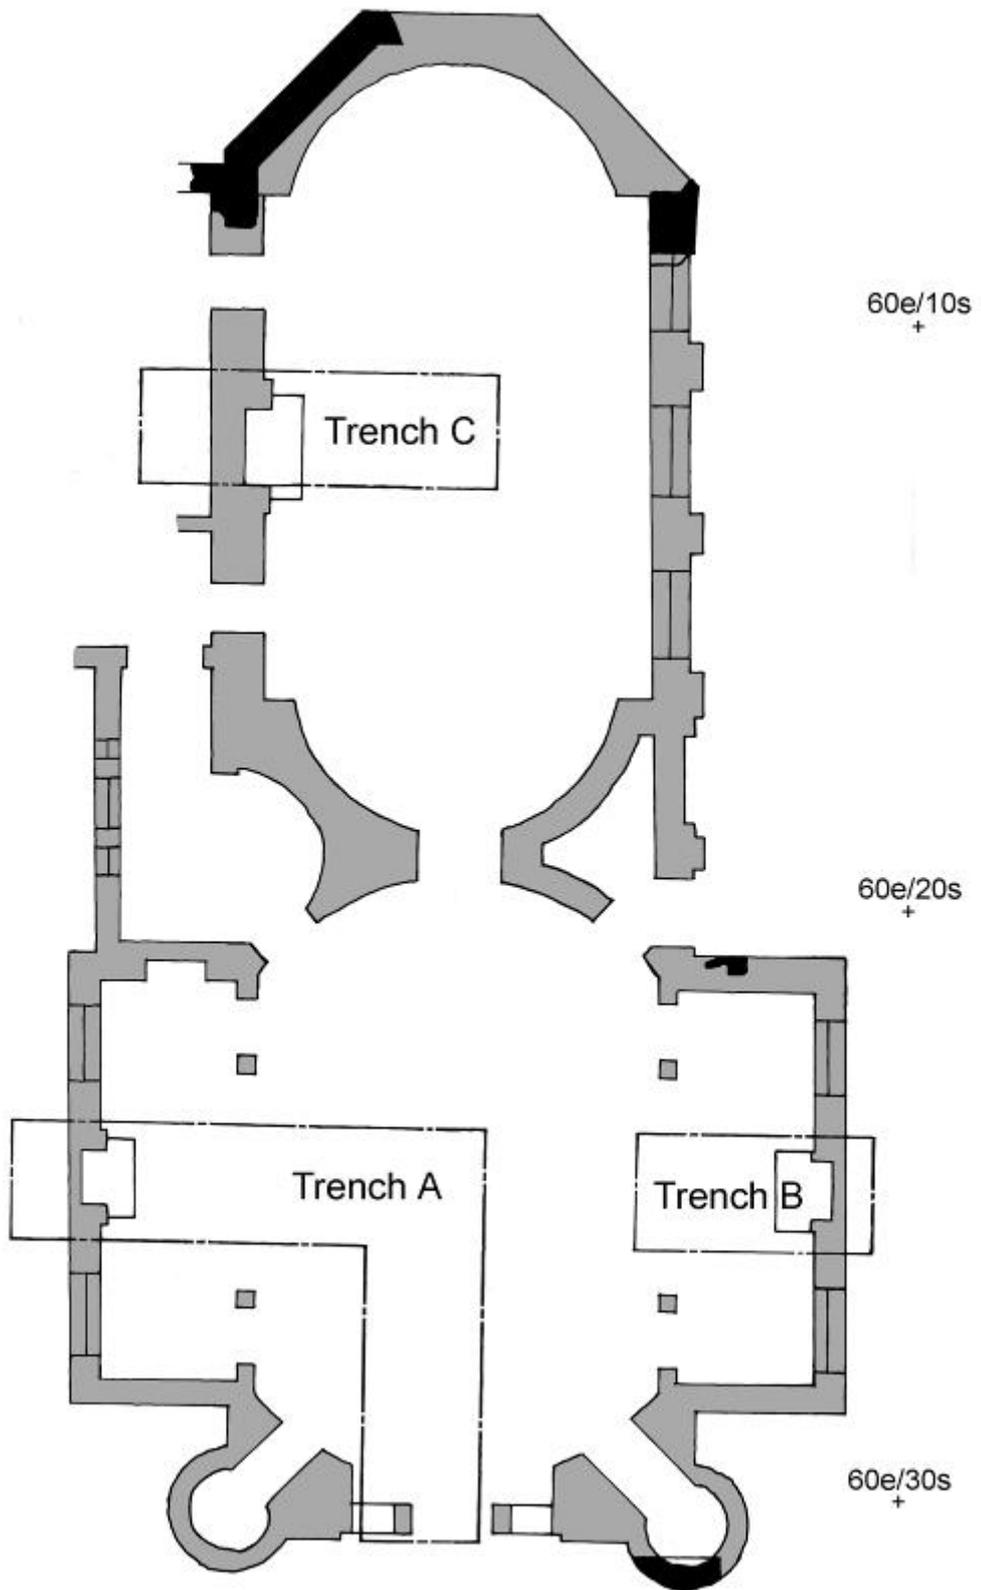
The former east wing with the position of the trenches.

It seemed likely that the pit was in the southern room as this was built for Derby. We therefore opened trench A to look for it and also trench B to look for a mysterious ‘escape tunnel’ – assumed to be a drain.

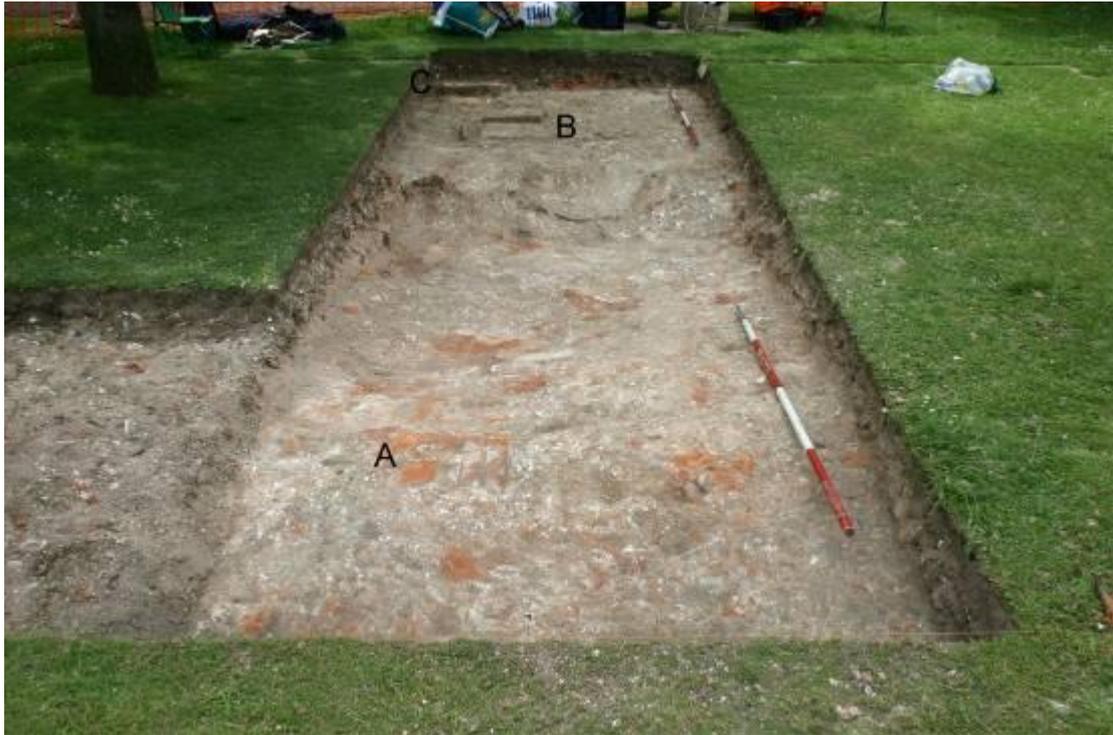
Trench A looking west. The floor supports are marked A and B. The former is close to centre of the room on the proposed site for the cock pit. The west wall of the wing can be seen in the background (C).

Trench A uncovered part of the north and west walls of the wing and two brick pillars which probably supported the floor. One of these pillars was near the centre of the room on the presumed site of the cockpit which was evidently elsewhere. At this point trench B had not gone very far and was abandoned as there was no further point in looking for the ‘tunnel’ on the site.

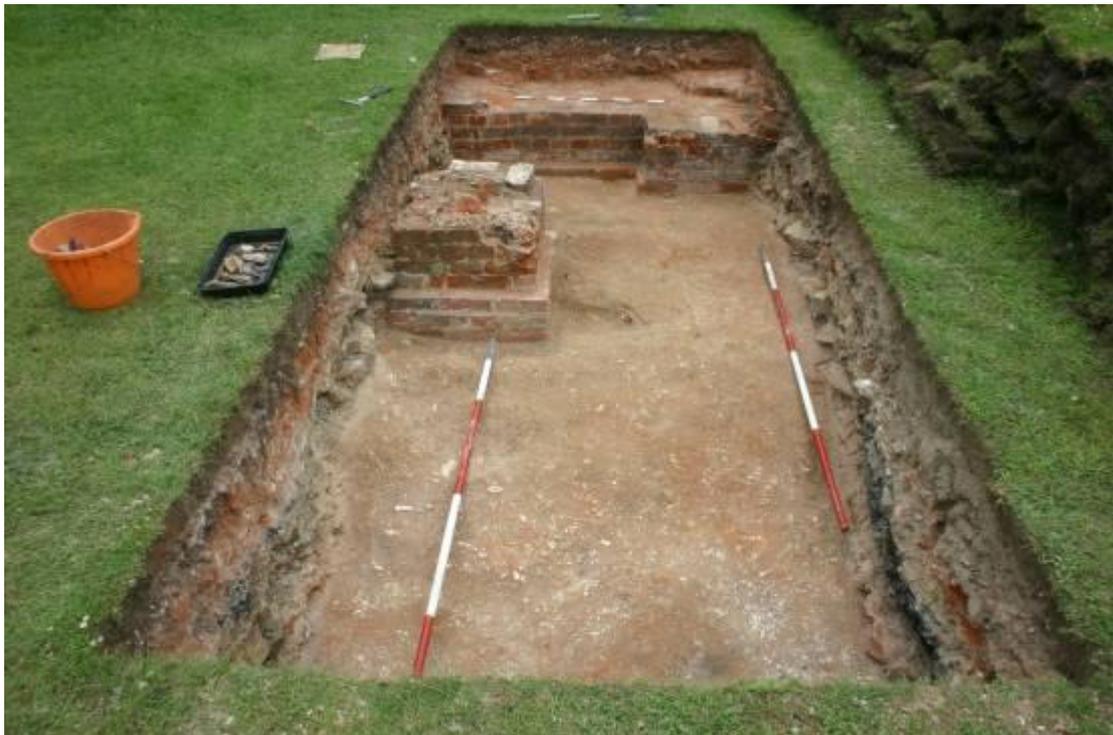
Trench C looking west with the pillar to support the floor and the west wall in the background. It is much more substantial than Adam's work exposed in the other trench.

Attention then moved to trench C where we found the west wall of the room and a pillar to support the floor. The rest of the trench was filled with a deep layer of rubble which had been left when this part of the house was demolished in 1959/60. The rubble contained several hundred fragments of plaster which had once decorated the room. When the rubble was clear we found a layer of sandy clay spotted with chalk. This was also present at the bottom of trench A and seems to have been the soil which existed beneath the wooden floors. It may have been deposited in the 1750s for form a level area in front of the house or it may date from the construction of the rooms. The chalky clay at the north end of trench C was flat and packed down and we considered whether it was the base of the cockpit. On balance I think it unlikely. The flat surface is more likely to have been made by the trampling of workmen’s boots when the room was being built.

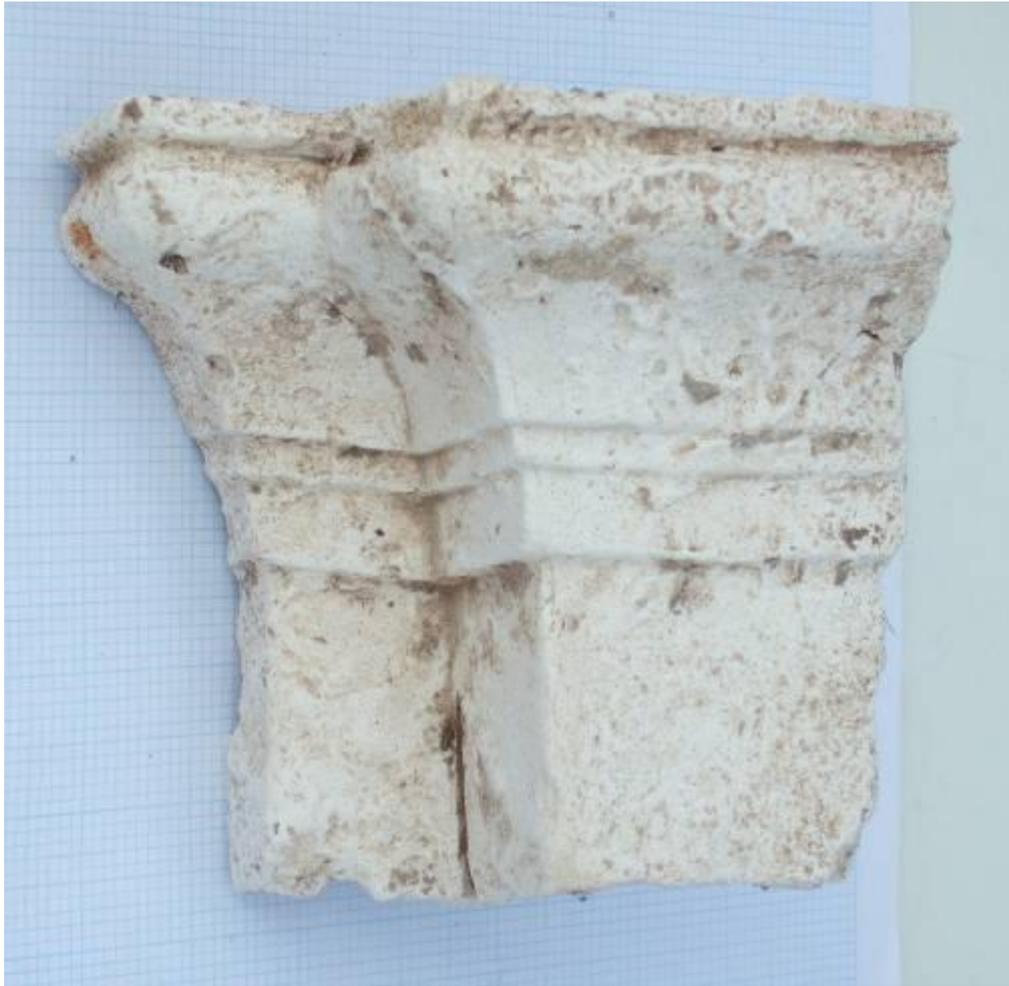
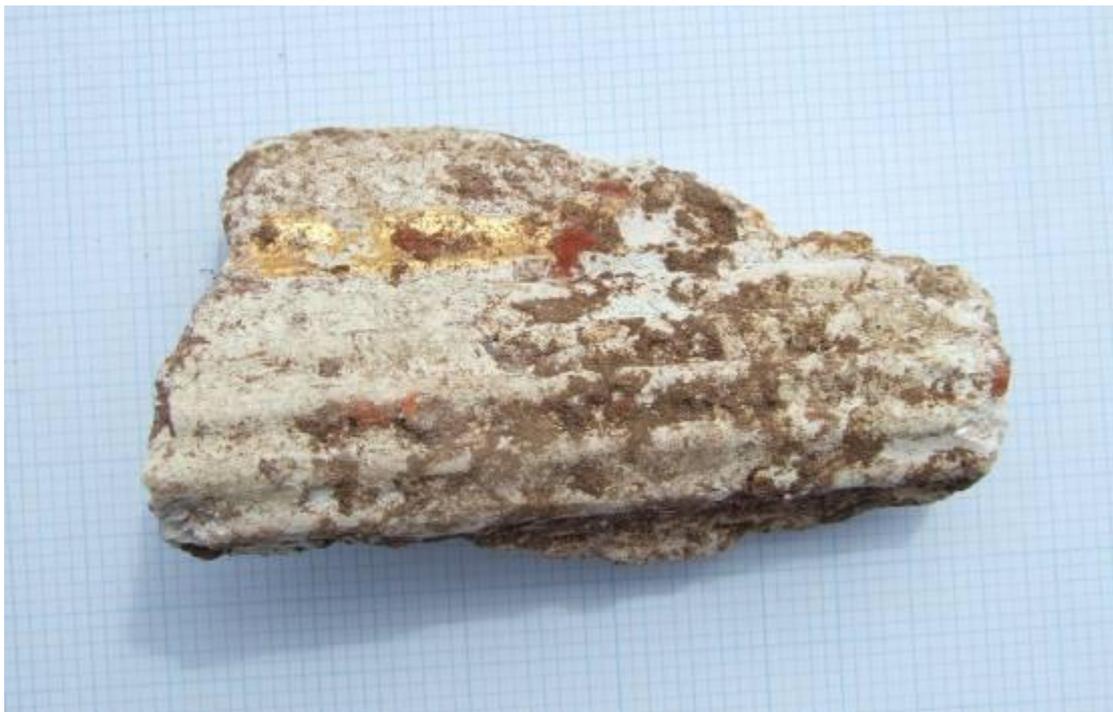
Above and below: plaster from trench A. We do not yet know whether this is part of Adam's decorations or a later modification.

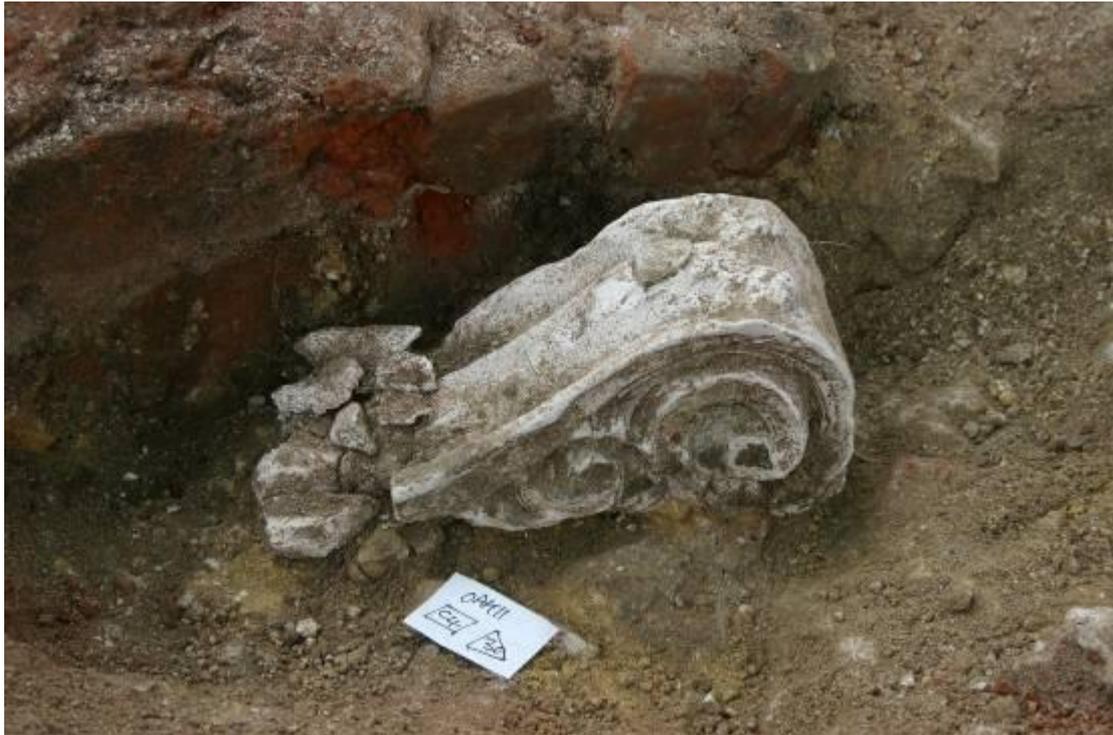
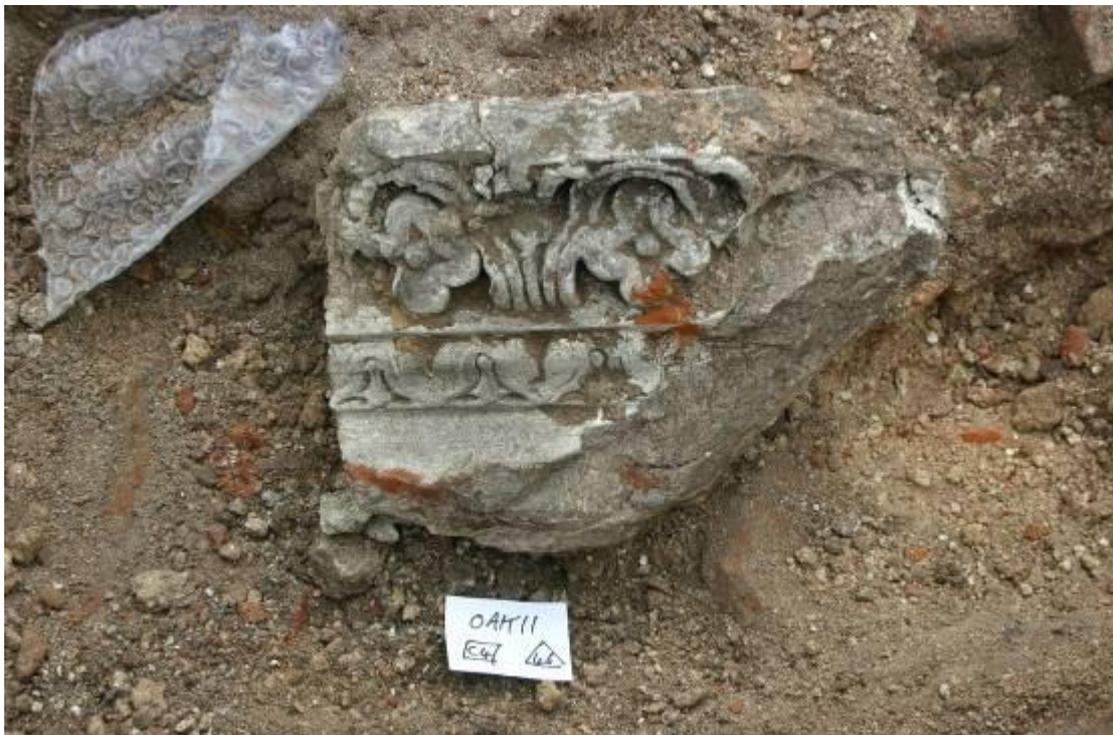
Above and below: plaster from trench C. This is part of Robert Taylor's decorations made for John Burgoyne about 1765. Both pieces would have come from the cornice where the wall joins the ceiling.
